GPS Validation of Lidar Elevation Models Report for Central and Eastern Prince Edward Island

Dr. Tim Webster and Candace MacDonald
with field support from
Kevin McGuigan, Charity Moulard, Nathan Crowell,
and Peter MacDermott

Applied Geomatics Research Group
NSCC, Middleton, NS

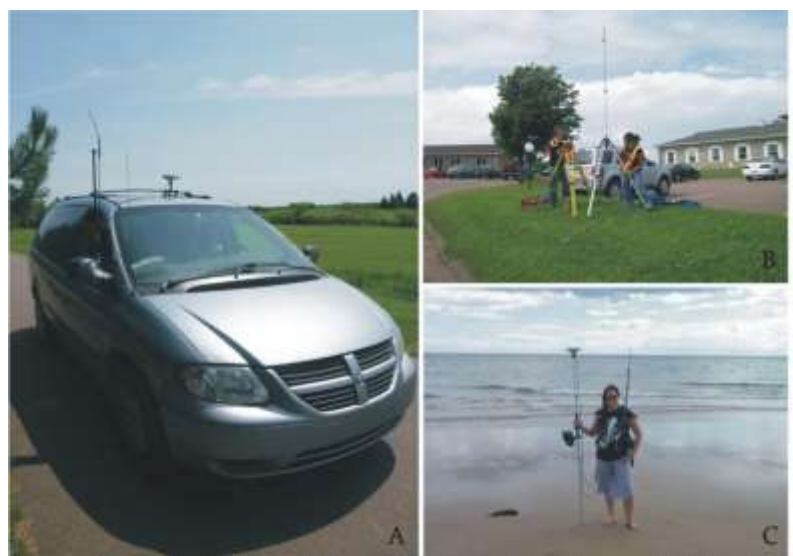
Figure 1. Equipment setup. (A) van RTK setup, (B) setting up a base station over HPN027, and (C) Collecting RTK GPS beach transect.

Lidar data should be validated against data with a known accuracy greater than that of the lidar survey. Real Time Kinematic (RTK) GPS (Figure 1) has a horizontal and vertical precision of a few centimetres and greater than that of lidar, therefore can be used to verify lidar products such as the digital elevation model (DEM) and digital surface model (DSM).

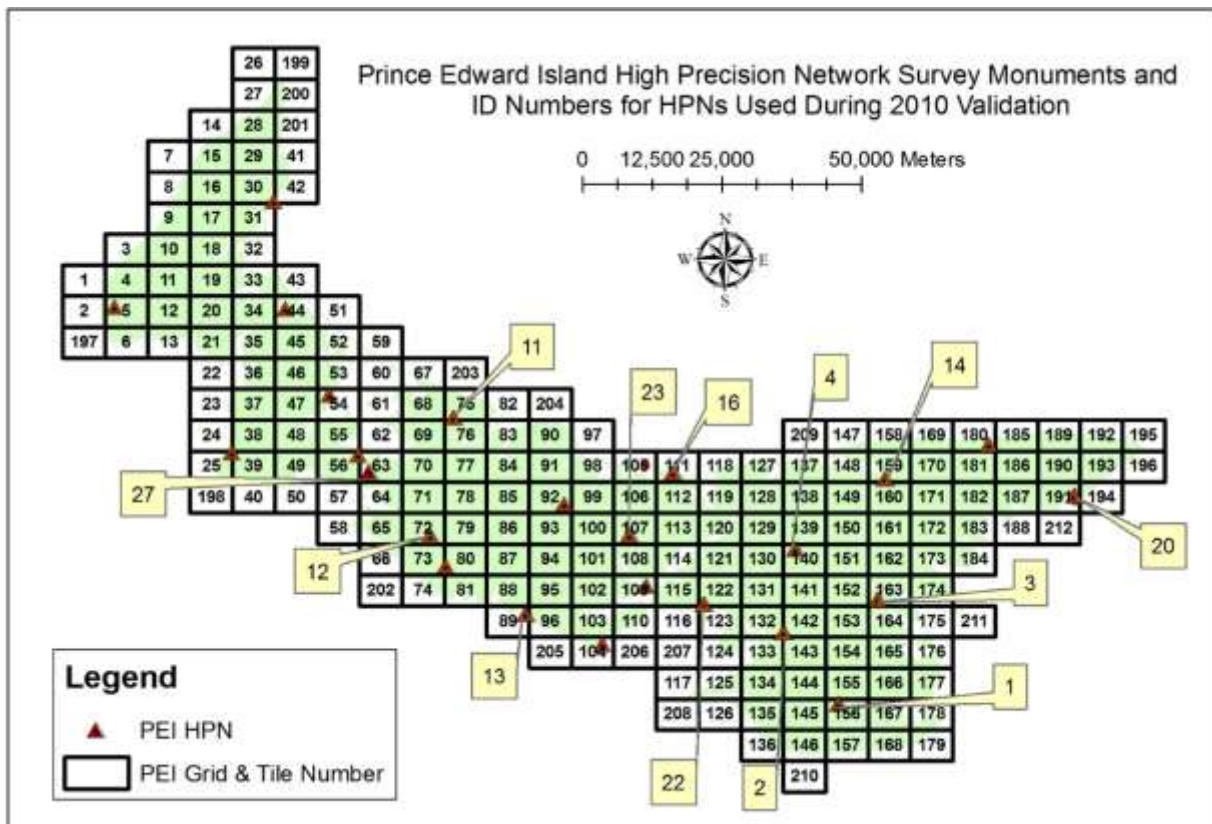
Figure 2. HPN monument locations across PEI, and ID numbers for ones used for RTK collection, July 26-29, 2010

The lidar DEM was provided to Applied Geomatics Research Group (AGRG) in Middleton, NS for validation. AGRG collected GPS validation data on July 26-29, 2010 using 13 of the high precision network (HPN) survey monuments located across PEI (Figure 2). The purpose of the validation analysis was to determine the quality of the lidar DEM and ensure that it accurately reflects heights within 0.30 m vertical.

The DEMs to validate were provided as individually tiled blocks corresponding to the 1:10,000 map sheet grid tile numbers on the grid provided by the PEI government (shown in Figure 2). To validate the vertical accuracy of each of these DEMs, the GPS points were tiled according to the same grid. The validation of each individual tile DEM was evaluated by comparing each GPS point with respect to the value of its corresponding cell on the lidar-derived DEM. Analysing the height difference ($DZ = DEM - GPS$) of all the measurements in a tile tells how far the lidar DEM is above (positive DZ values) or below (negative DZ values) the true ground elevation, assumed to correspond with the height derived from the GPS data. All GPS points within a lidar DEM tile were used to calculate the mean DZ value and the standard deviation of DZ.

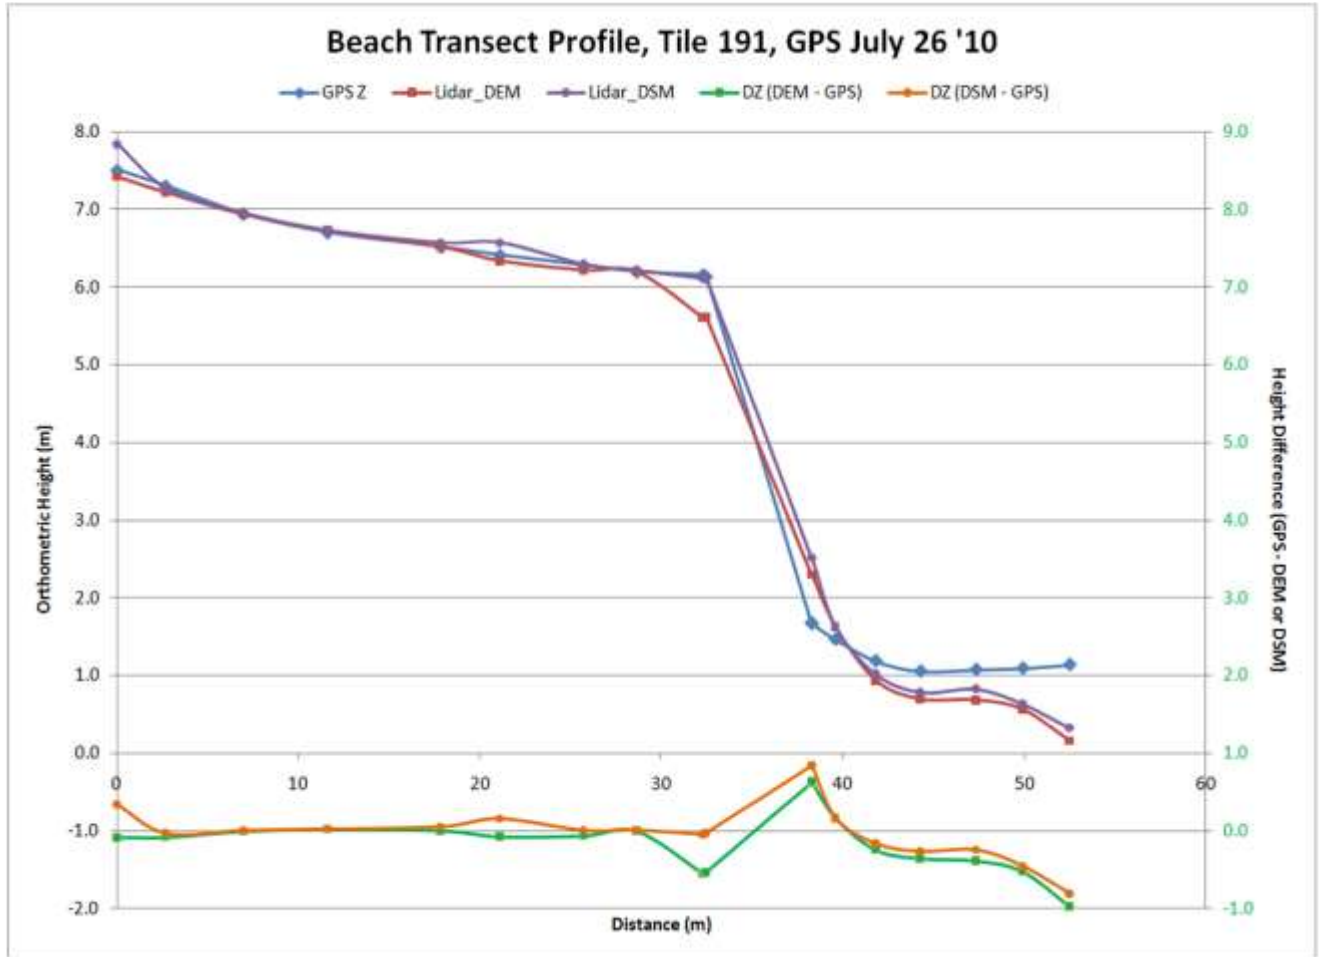
Figure 7. Transect GPS points (landward to seaward) compared with the lidar DEM and DSM along with the DZ of each surface (lower green & orange lines) showing a probable ground classification error at the cliff edge.

Profile analysis for tile 191 (Figure 7) shows a potential error in the lidar ground classification, where the top edge of the cliff is classified as non-ground due to the steep angle and height of the cliff. These cliff edge lidar points were part of a non-ground class. Therefore, the edge of the cliff would have been excluded during the construction of the DEM, however they were included during the DSM construction (Figure 7). The bottom offset between GPS and lidar surfaces, where the foot of the cliff has receded landward may reflect active erosion of the cliff since the lidar survey in 2007. The pattern of erosion from the foot of the slope and building up of the material at the base is characteristic of the beach erosion process. The profile in Figure 7 of the Lidar DSM for the same transect shows the cliff edge exists and was in almost the same location in 2010 as it was in 2007. Cliff misclassification is a common problem when using lidar for coastal areas. It is important to understand and identify this problem if the lidar DEM is to be used for erosion and flood risk surveys.

In the case of using the lidar derived DEM as a bench mark for future or past erosions studies, this error could have significant potential implications when assessing things like change detection if it is not corrected or compensated for. We would recommend caution when using the lidar DEM for coastal areas that have elevated shorelines (typical of bedrock and glacial till bank cliffs) and to always examine the DSM to determine if a classification error has occurred.

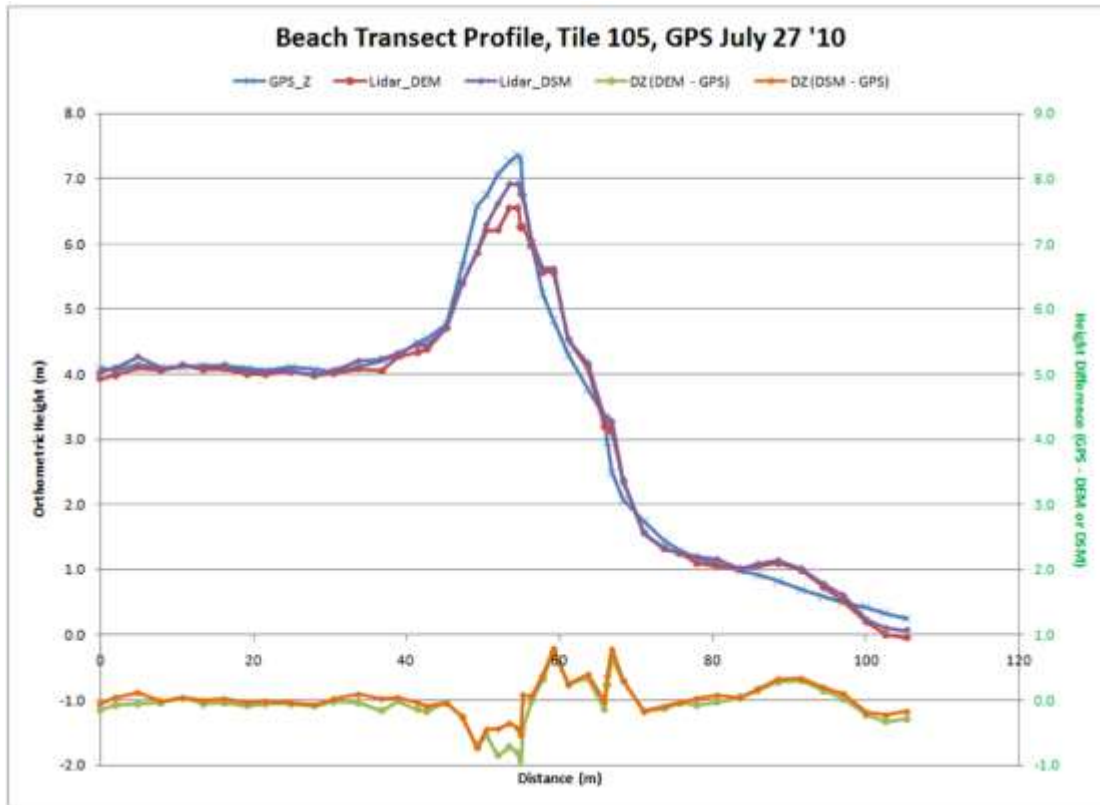
Figure 8. Transect GPS points (landward to seaward) compared with the lidar DEM and DSM along with the DZ of each surface (lower green & orange lines) of a dune at Cavendish Beach Provincial Park.

Profile analysis (Figure 8) of the transect in block 105 (Figure 5) shows a higher, and narrower dune in 2010 than in 2007. The DSM surface is higher than that of the DEM, possibly due to vegetation. Aside from one mound of sand that was present in 2007 but missing in 2010, the GPS closely aligns with DEM and DSM values for this transect.

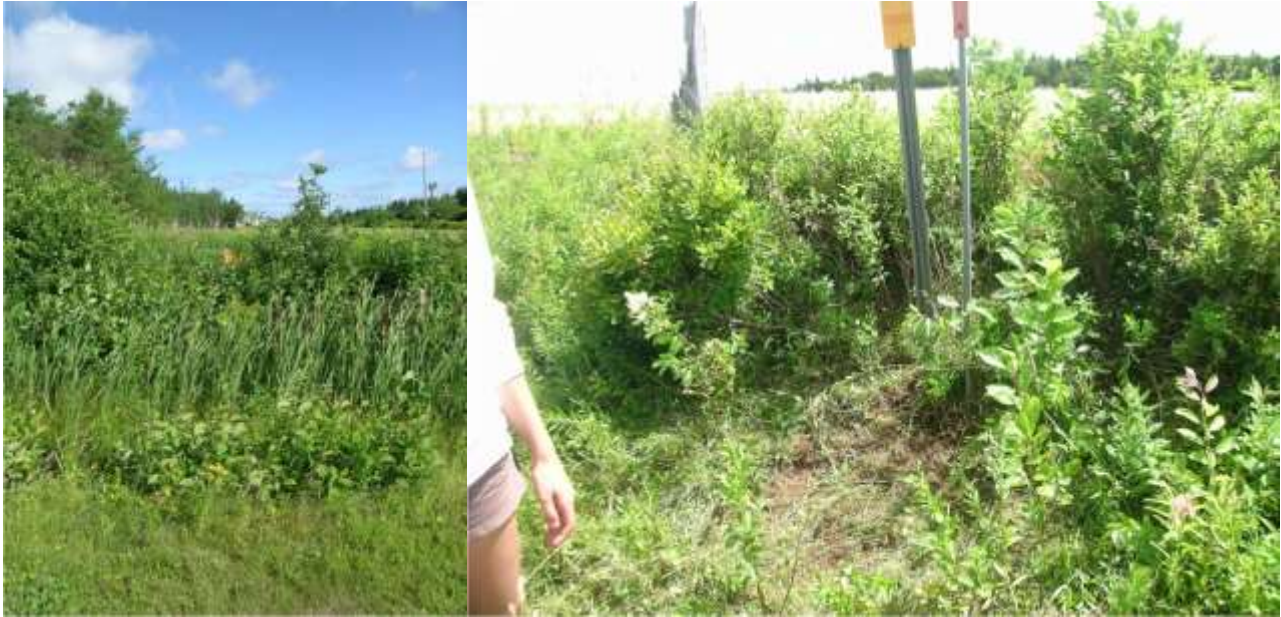
Figure 9. Inaccessible HPN015 (on left) and missing or buried HPN019 (on right)

During the course of GPS collection two HPN monuments were visited but were unable to be used. HPN015 from Clearspring, was surrounded by shoulder-high rose bushes which made it inaccessible under the tight time constraints of the project. The other monument, HPN019 in Hunter River, was not observed and would have required a metal detector and a shovel, neither of which were available at the time (Figure 9). In addition, the phone number on the monument survey marker said to call if there were any issues, however when the number was called, an elderly lady answered and has received many calls throughout the years regarding survey markers, but she knows nothing about them and requested the contact phone number be changed.
