Community High-Water Storm Surge Mapping Network

Climate Change Adaptation Fund Organization
Submitted By

Dr. Tim Webster, Research Scientist
Applied Geomatics Research Group – COGS, NSCC
Partner Organization Emergency Management Office

Submitted to
Climate Change Directorate
Will Green
Climate Change Adaptation Specialist
Nova Scotia, Department of the Environment
March, 2011

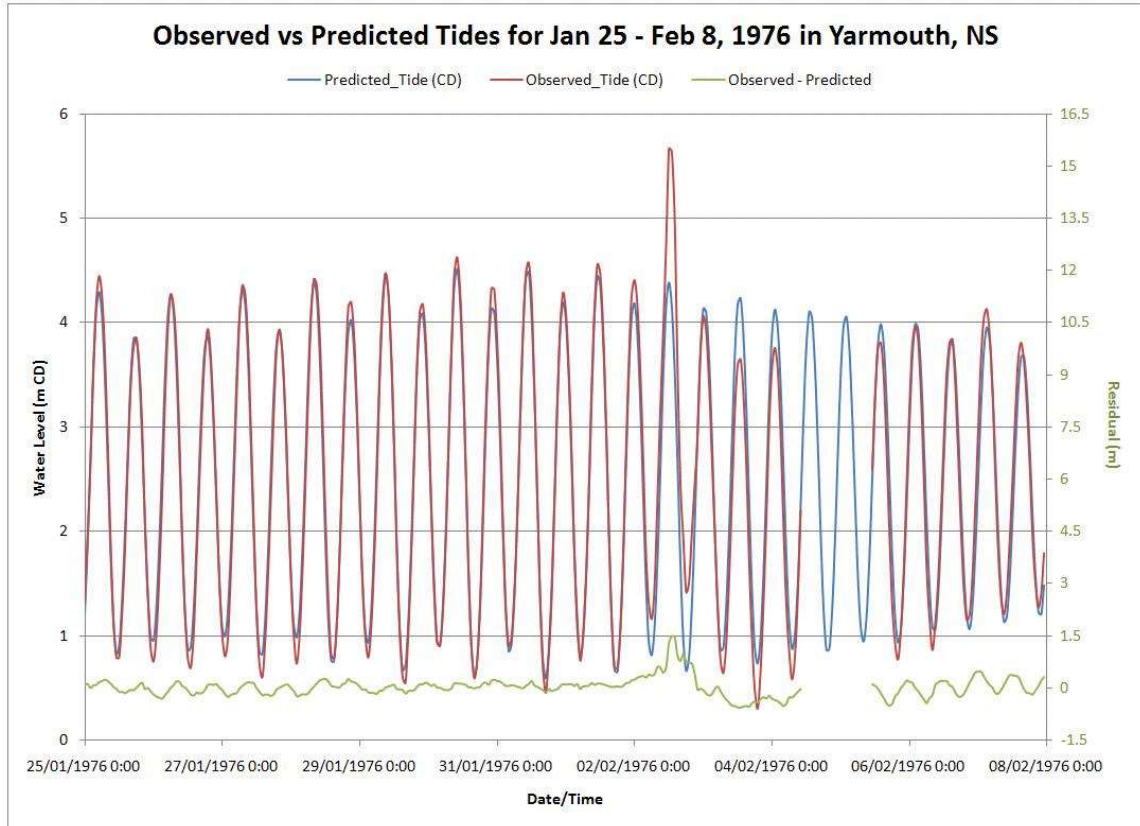
Figure 4 Tide gauge water-level record from Yarmouth for the Feb. 3 Groundhog Day storm. A 1.5 m storm surge was observed. The maximum water level recorded was 3.36 m CGVD28.

The Yarmouth tide gauge was operating during the storm event and has been extracted along with the predicted water level in order to calculate the residual differences between predicted and observed, the storm surge (Fig 4). The tide gauge data have been converted from chart datum to orthometric height above CGVD28 (Fig. 5).

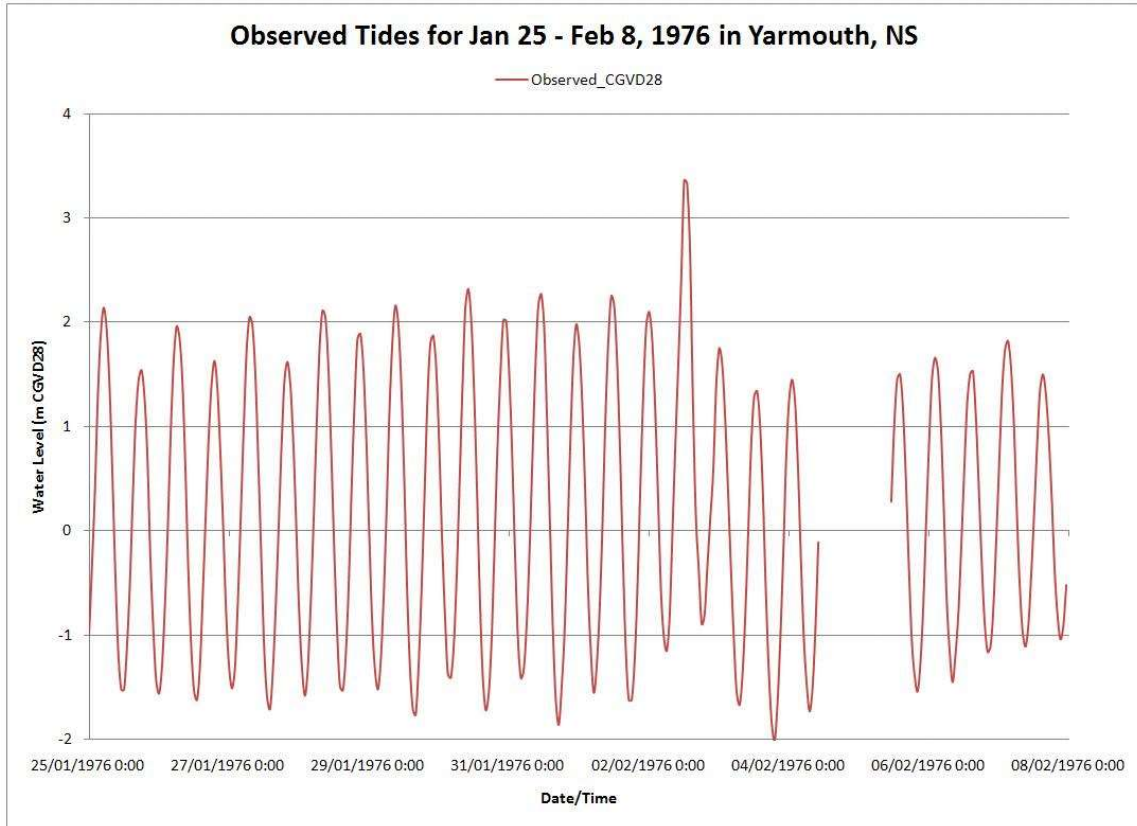
Figure 5 Yarmouth tide gauge water-levels projected to CGVD28 datum.

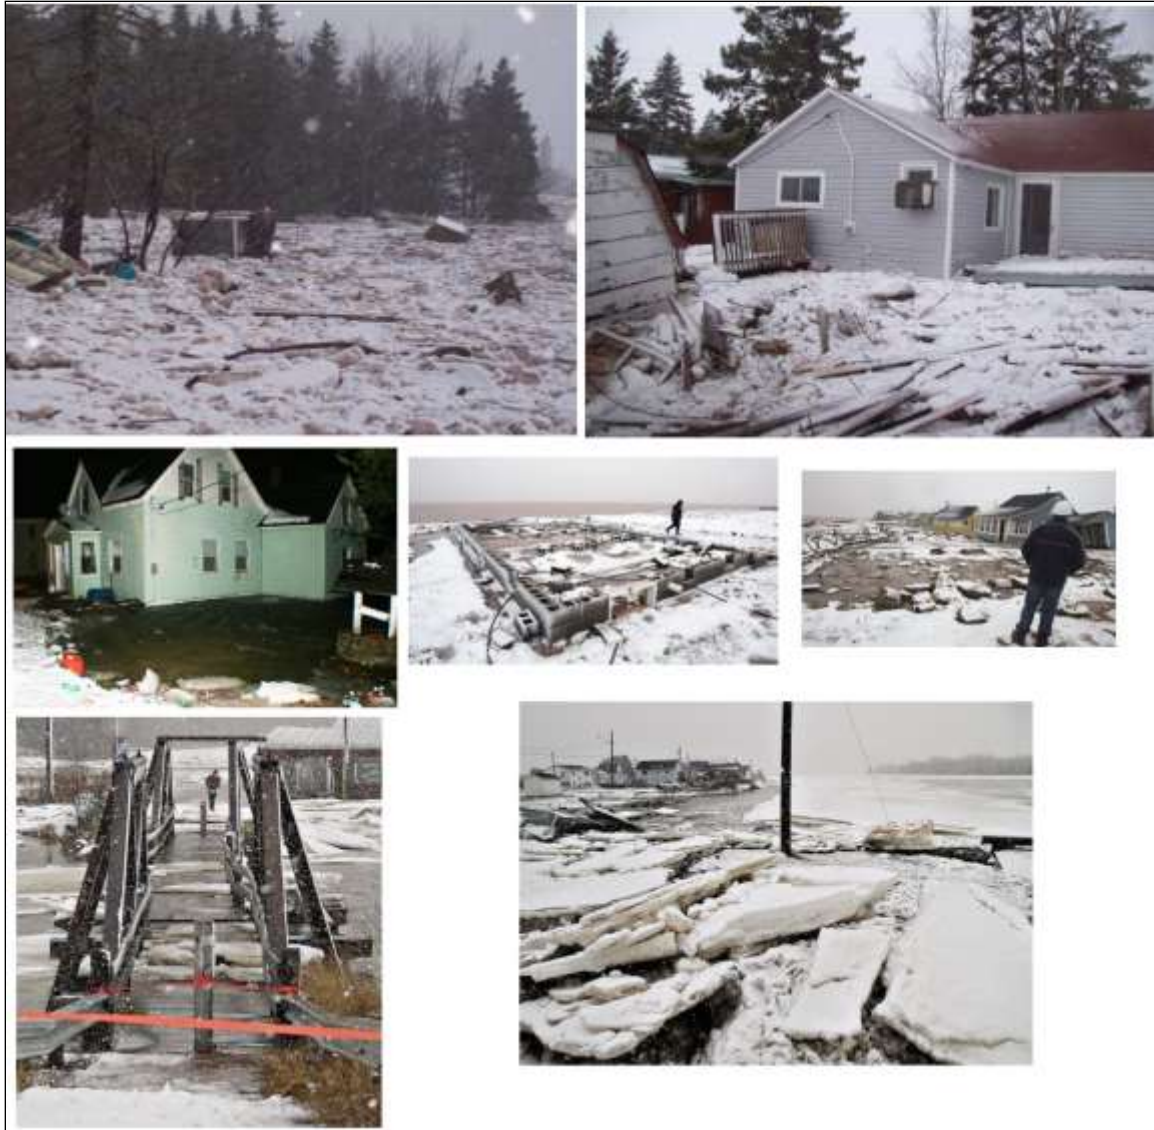
Figure 6 Port Elgin storm damage. Top photos courtesy of Kristy Boudreau. The next row of photos courtesy of Sackville Tribune, Globe and Mail, and the CBC.

On Jan. 2-3, 2010 a low pressure storm system affected the coast of the Northumberland Strait. Port Elgin, NB was severely affected and sustained coastal flooding as a result of the storm surge (Fig. 6).

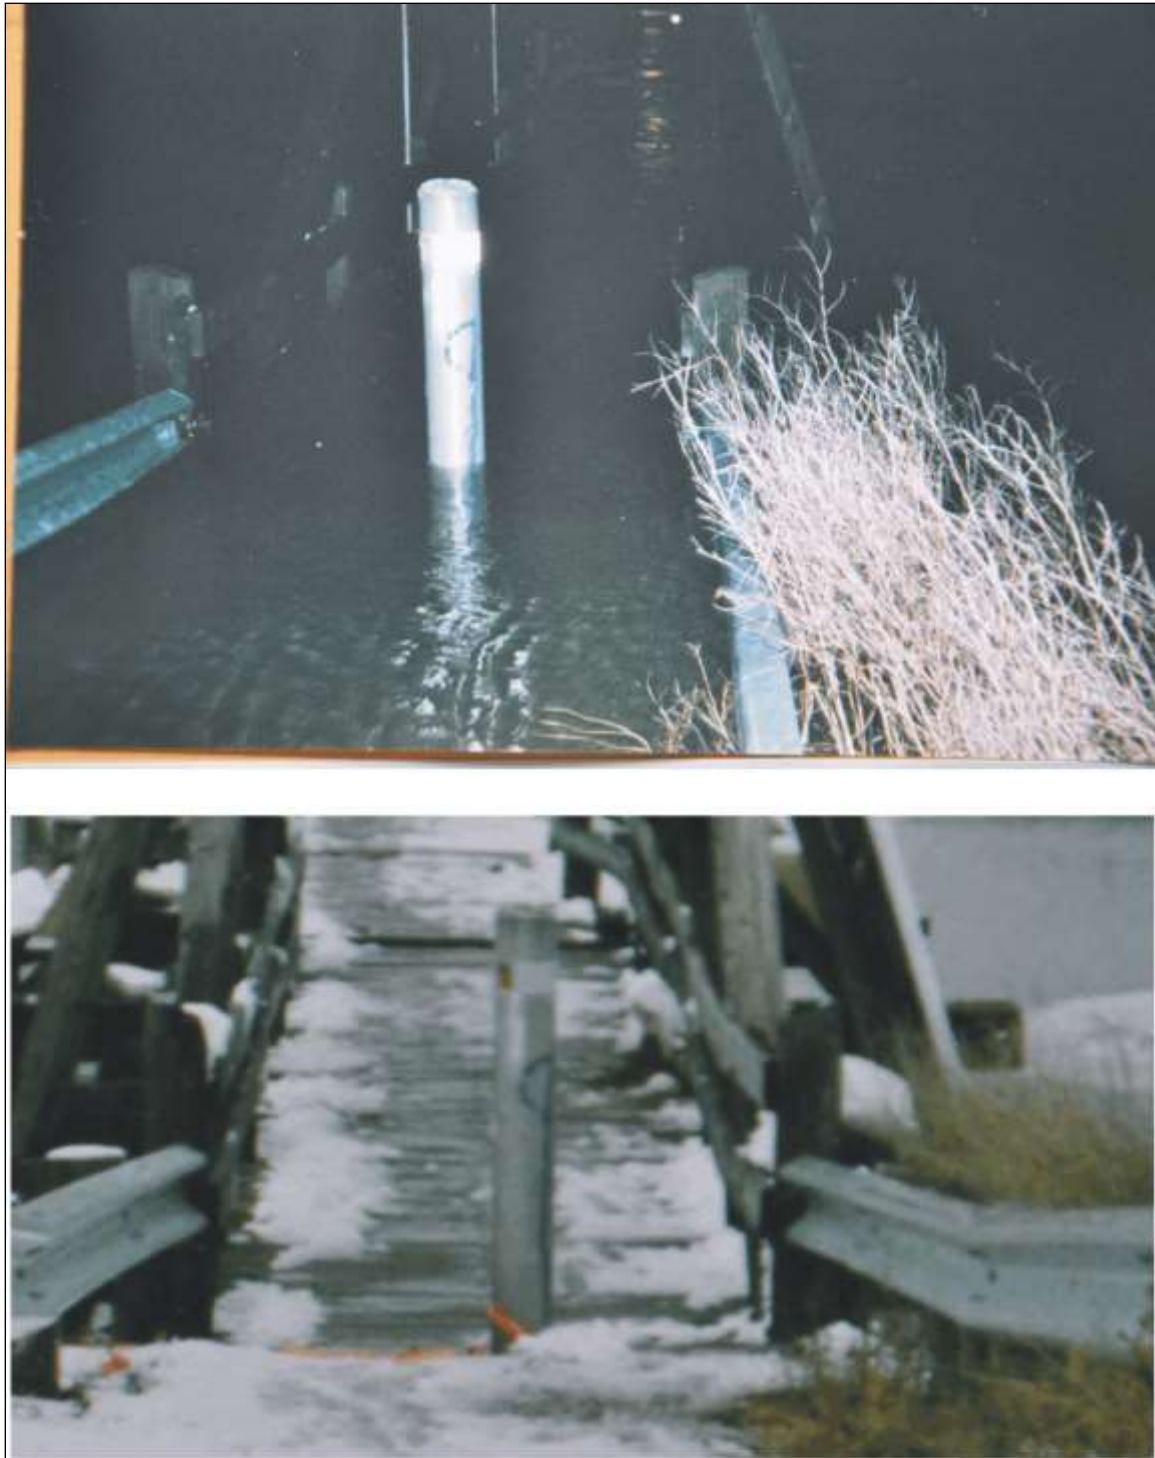
Figure 7 Foot bridge in Port Elgin covered in water during the storm surge event Jan 2, 2010 (top) and after the storm (bottom).

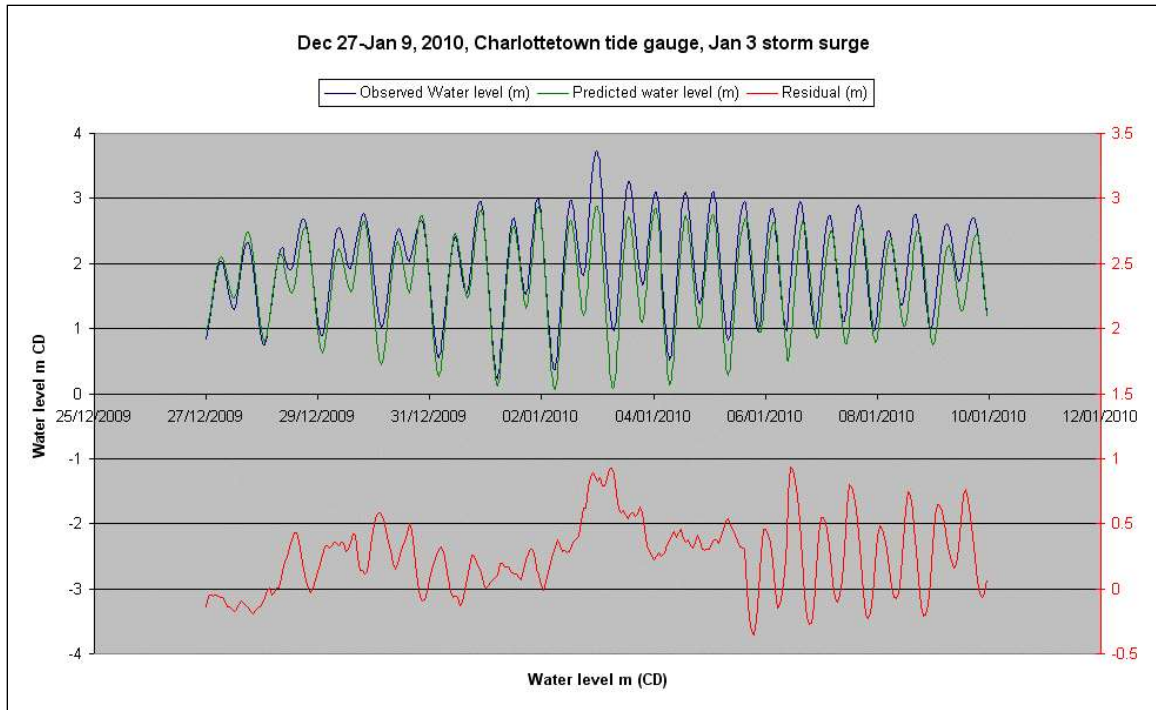
Figure 9 Jan 2-3, 2010 storm surge event as observed at Charlottetown.

The Charlottetown tide gauge was operating at the time of the storm and has been extracted to observe the water level and residual. Charlottetown is located on the opposite side of the Northumberland Strait and did not sustain the same high water levels as the south coast of the strait (Fig. 9). The Shediac tide gauge was the nearest gauge in operation on the south coast of the Northumberland Strait at the time of the storm (Fig. 10). The hourly records indicate the maximum water level of 2.14 m CGVD28.

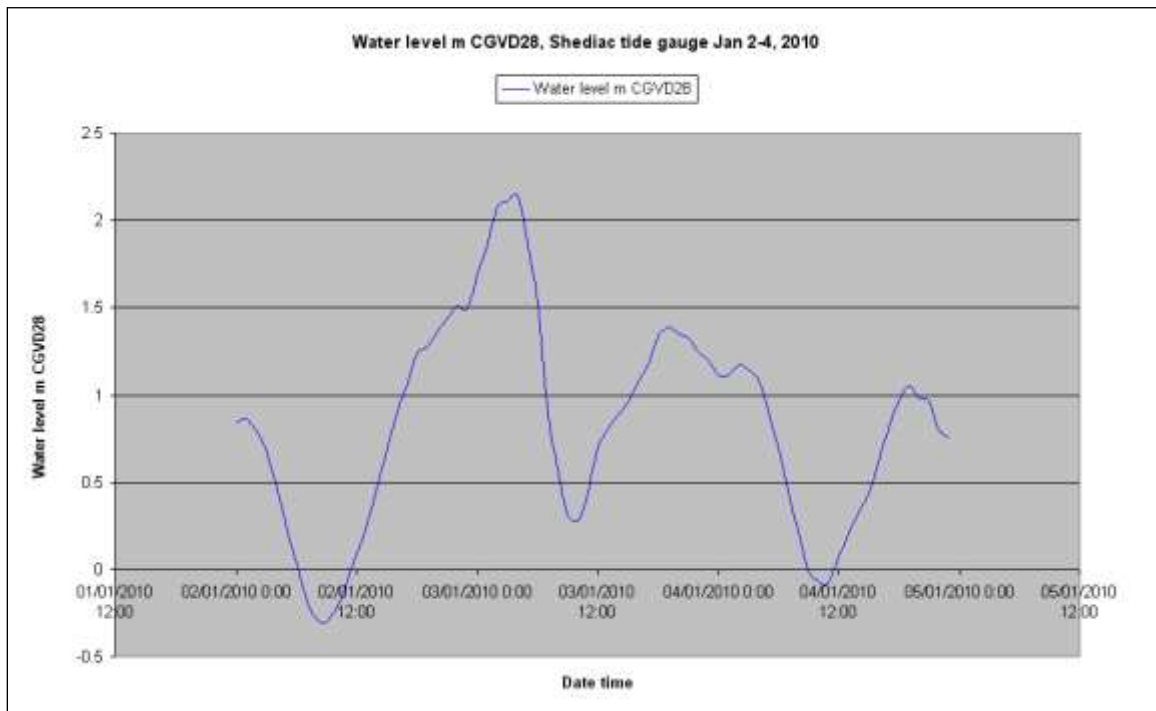
Figure 10 Shediac tide gauge, hourly readings, 2.14 m CGVD28 during the storm surge, Jan. 2-3, 2010.

The high-water mark measured by RTK-GPS indicated a level of 3.20 m CGVD28 (Appendix B) in contrast to the level at Shediac (2.14 m CGVD28) and Charlottetown (3.19 m CGVD28).

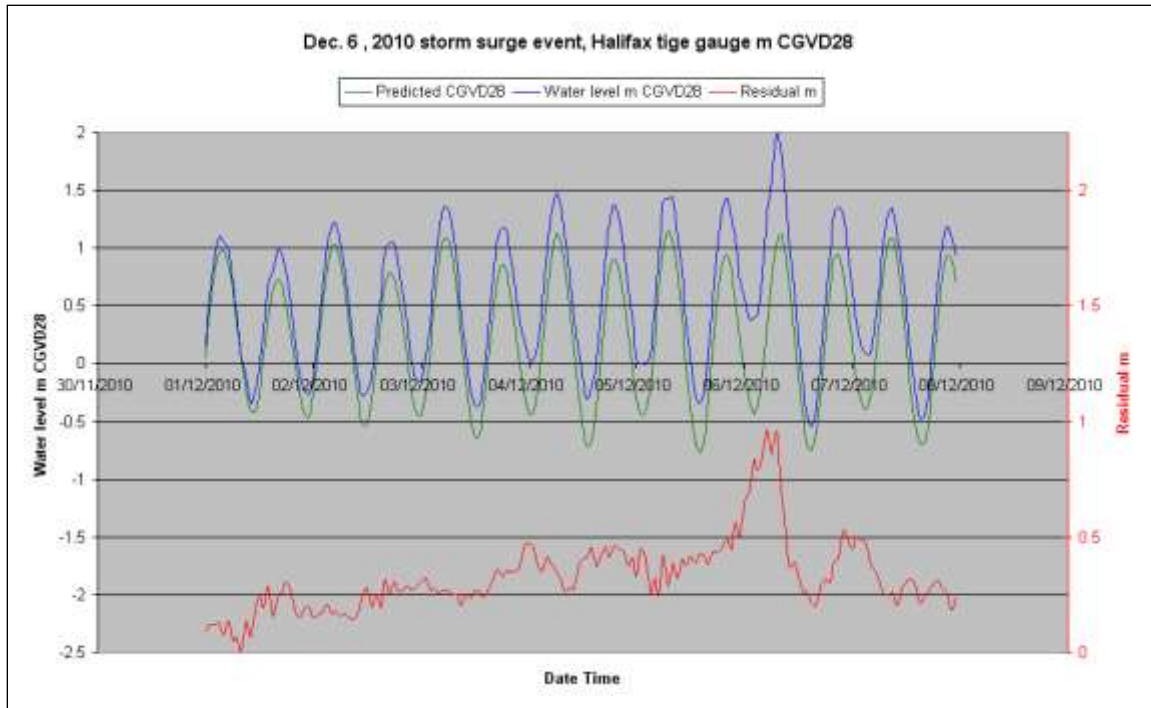
Figure 12 Halifax tide gauge record, hourly readings. The maximum water level is 1.99 m CGVD28 with a storm surge of 0.96 m.

The Halifax tide gauge was operating during the storm event and has been downloaded along with predicted tidal elevations to calculate the residual or storm surge level (Fig. 12). The maximum water level from the hourly tide gauge record at Halifax indicates high-water elevation of 1.99 m (Fig. 12).

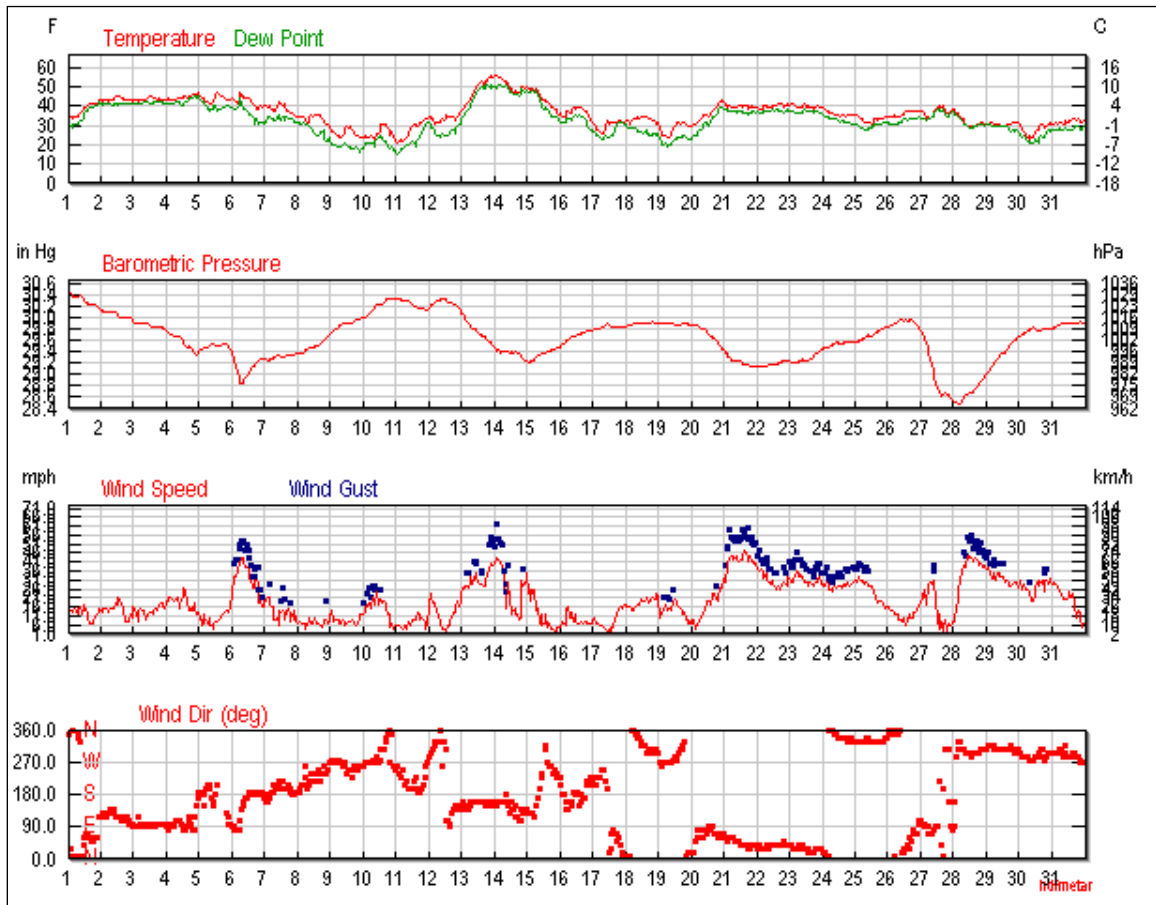
Figure 13 Daily weather records for Caribou Island. Note the low pressure and increased wind speeds for storm events Dec. 6, 14-15, 21-22, and 28th.

A tide gauge was placed at Skinners Cove, approximately 10 km east of cape John, a site that has been monitored for erosion and coastal flooding from storm surge events by the AGRG since 2005 and earlier using past historical records. Many locations along the Northumberland Strait suffered extensive damage from the storm surge associated with the Dec 21, 2010 storm. Daily weather records were downloaded from the Caribou Island weather station, near Pictou, and plotted for the month of Dec., 2010 which had several storms in addition to the Dec 21 event (Fig. 13).

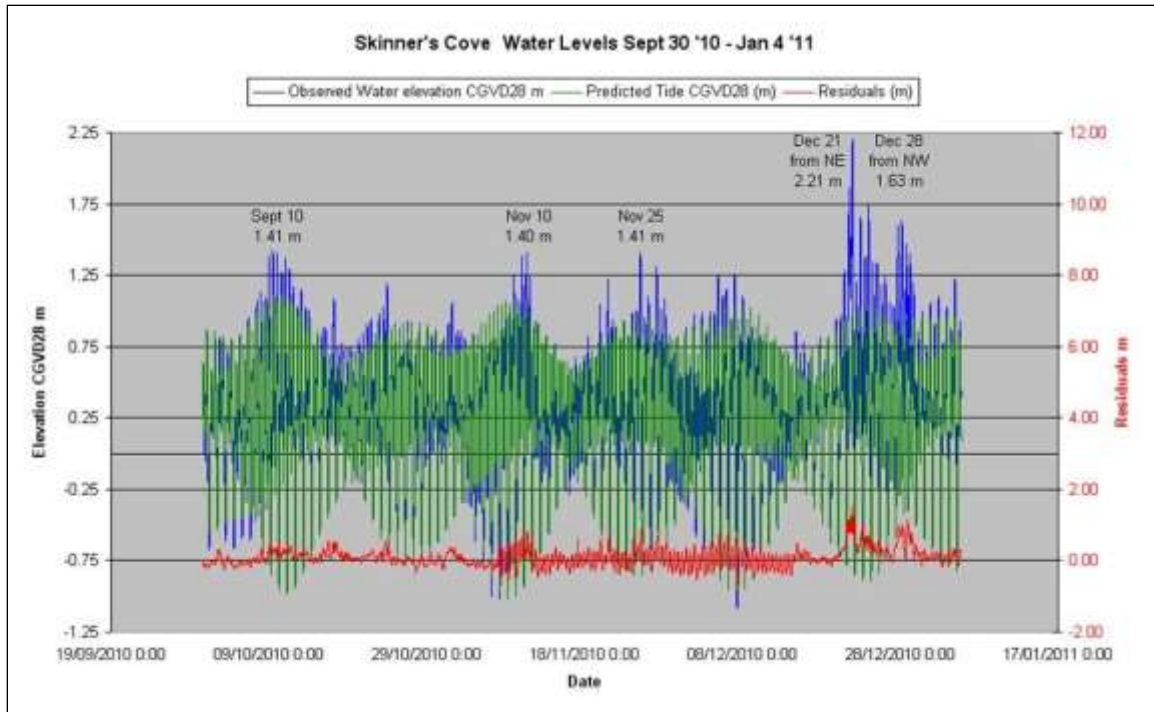
Figure 14 Skinners Cove tide gauge deployed and operated by AGRG. Several high water events were observed from Sept through to Dec 28 at this location. The Dec. 21, 2010 maximum high-water event registered 2.21 m CGVD28 on the gauge which took a reading every 15 minutes.

The tide gauge at Skinners Cove captured the high-water events for Dec. of which Dec. 21, 2010 was the highest with a recorded water level of 2.21 m CGVD28 (Fig. 14).

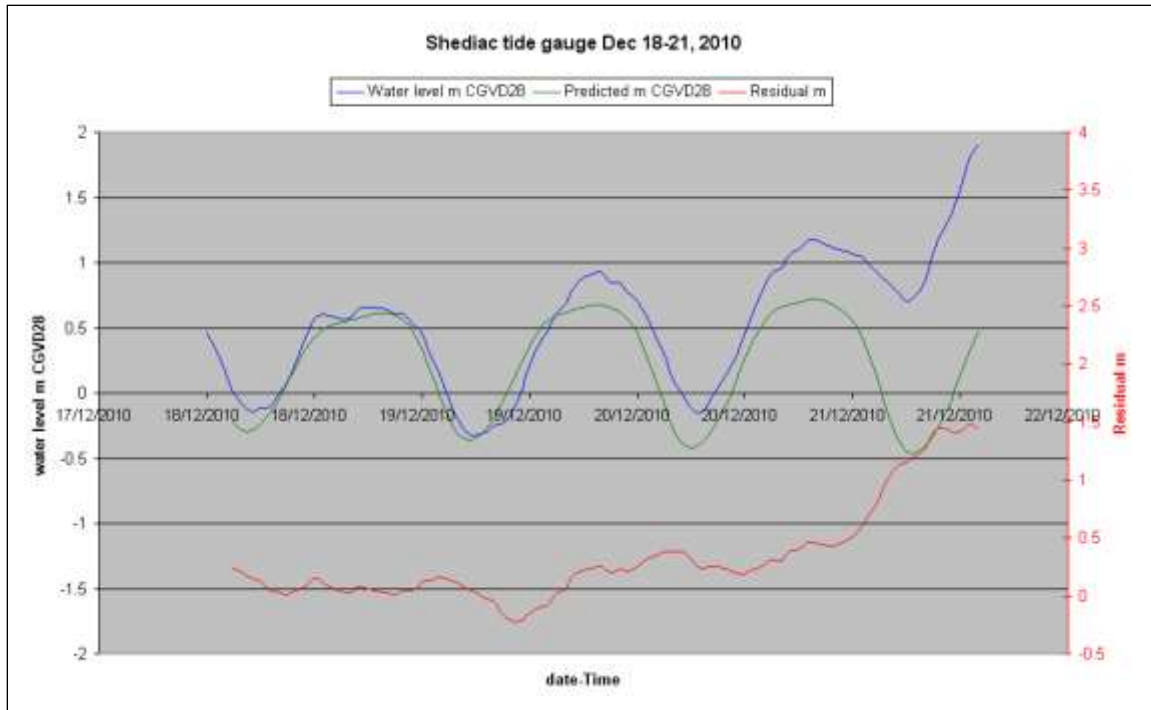
Figure 15 Shediac tide gauge record up to Dec. 21, 2010. A 1.5 m storm surge was observed until the gauge lost communication.

In addition to the AGRG tide gauge at Skinners Cove, the Shediac tide gauge was downloaded, however the storm was so severe that the communications to the gauge were cut off and the data is not available at the height of the storm (Fig. 15).

The Canadian Hydrographic Service was contacted to determine the maximum water level for this event at Shediac, which is 3.18 m CD (2.34 m) which is higher than the previous record from the Jan. 21, 2000 storm (P. MacAuley, pers. communication, Feb, 2011).

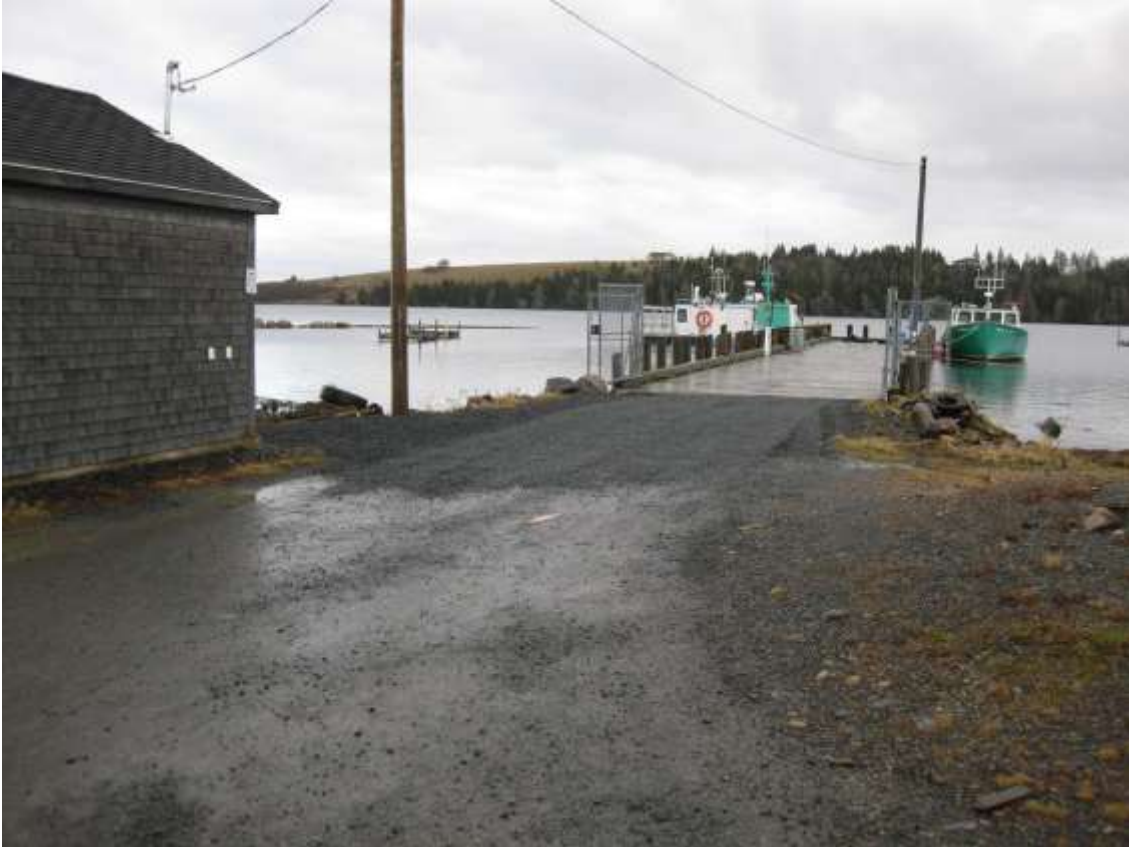
Figure 16 Bay Port wharf after Dec 6, 2010 storm surge. Nail in power pole marking the high-water elevation.

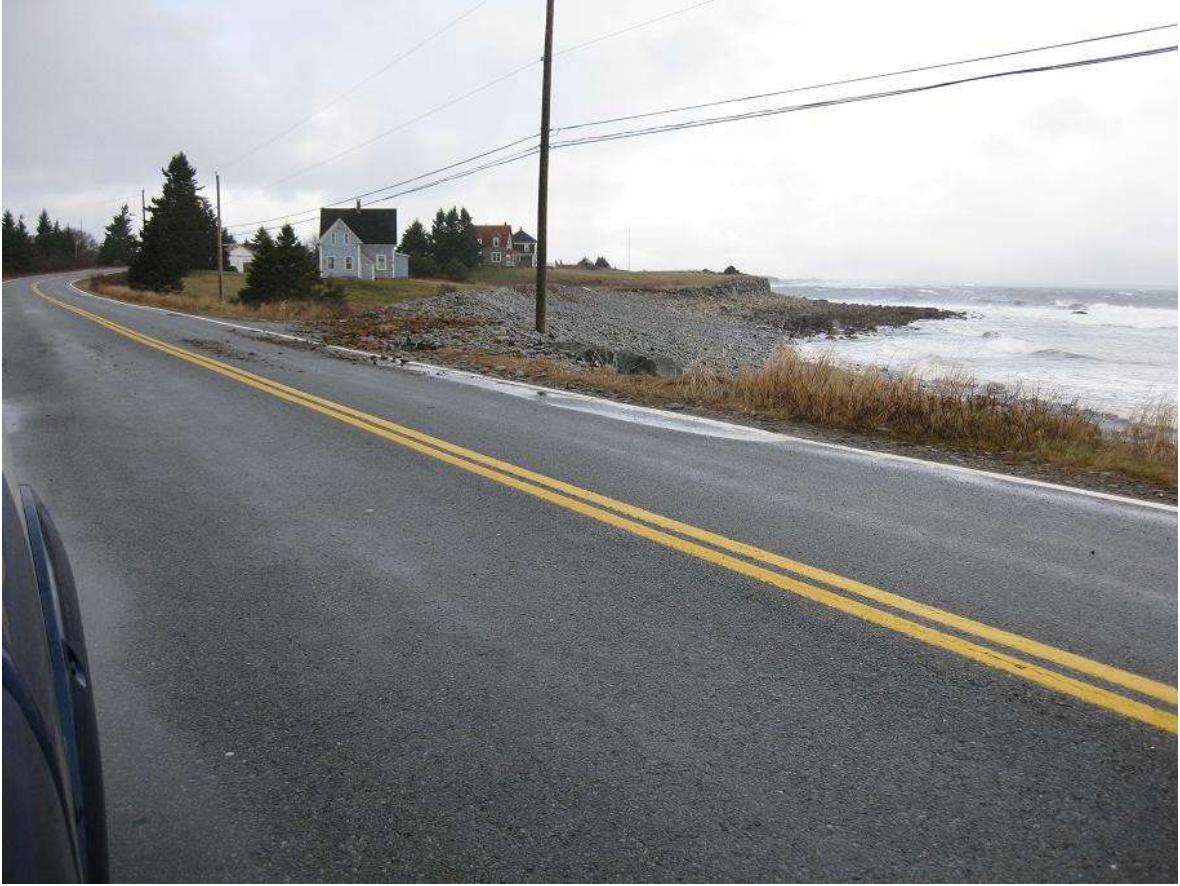
Figure 17 Broad Cove after Dec 6, 2010 storm surge. Nail in power pole marking the high-water elevation. Note the gravel from the beach deposited on the road.

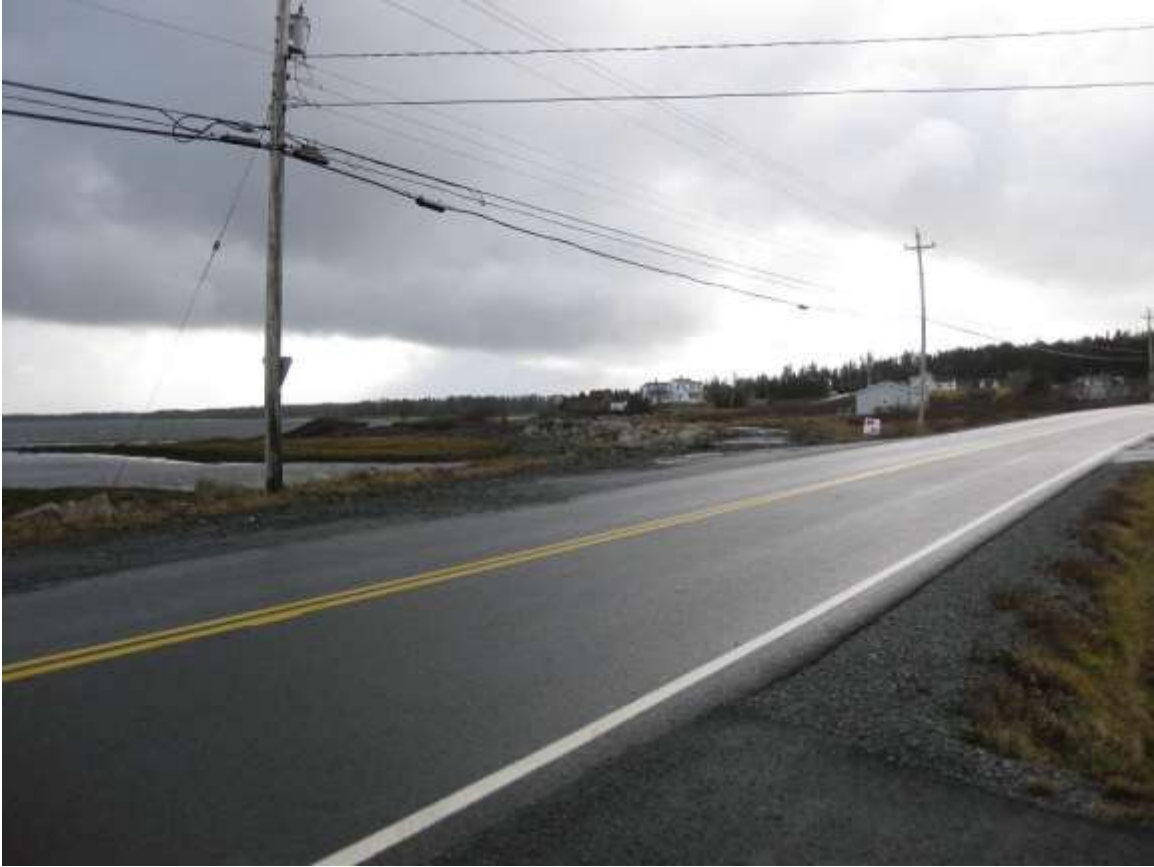
Figure 18 Dublin shore after Dec 6, 2010 storm surge. Nail in power pole marking the high-water elevation.

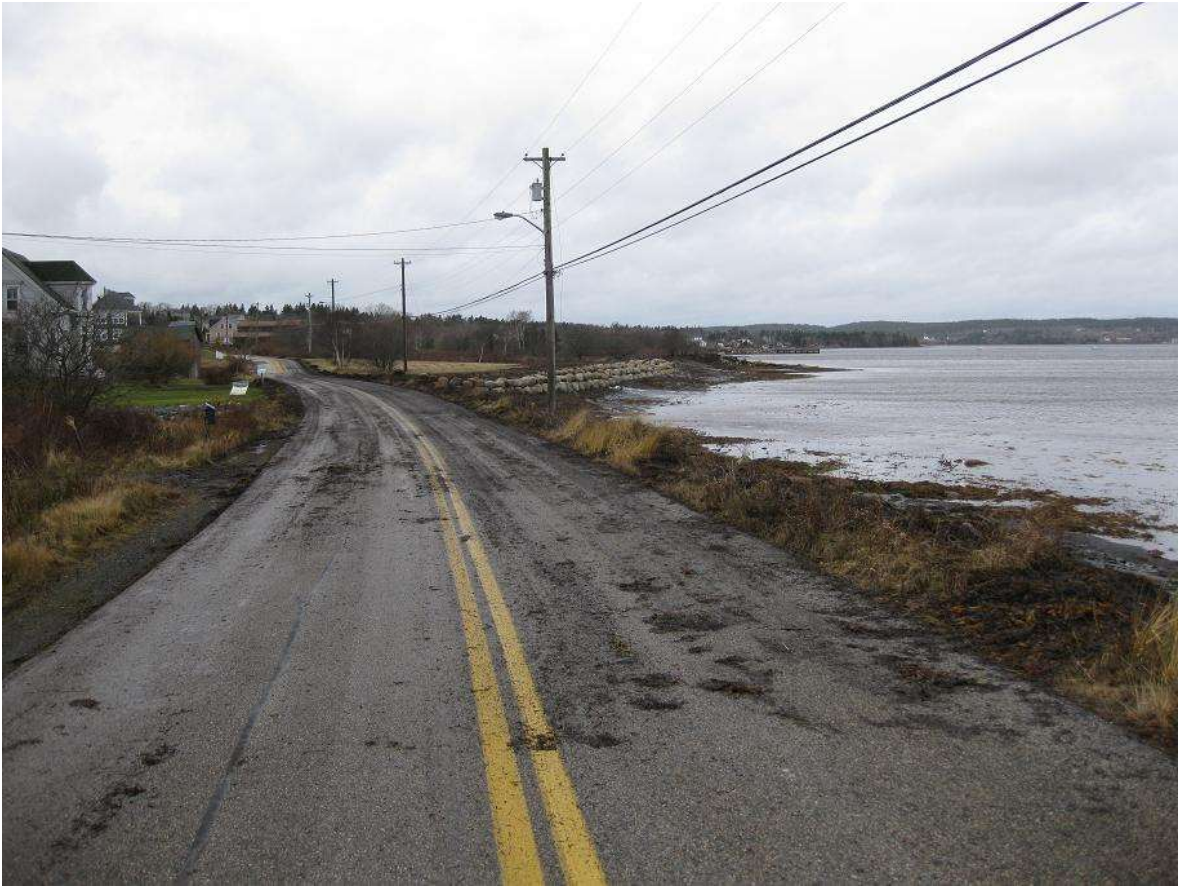
Figure 19 Kingsburg Road Cove after Dec 6, 2010 storm surge. Nail in power pole marking the high-water elevation. Note the gravel and debris from the beach deposited on the road.

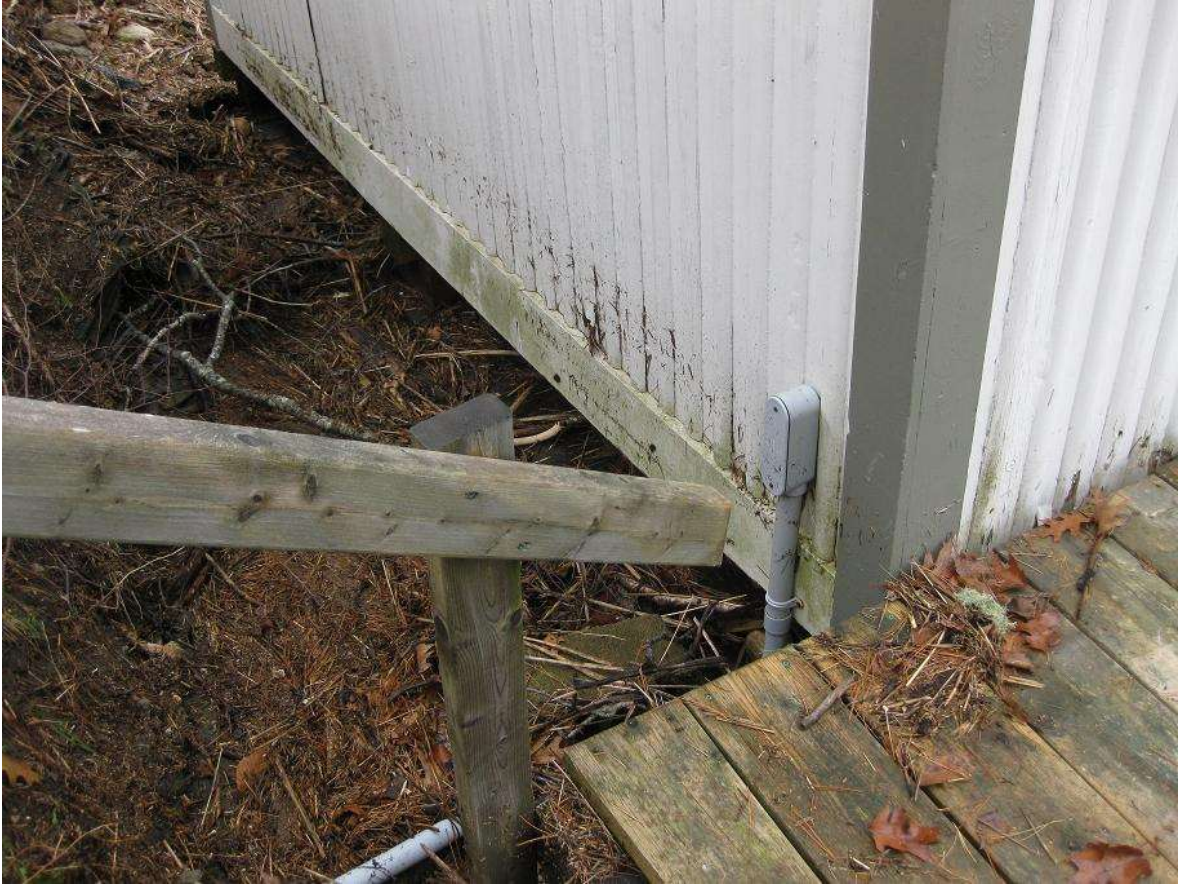
Figure 20 Upper LaHave “Mills Boat House” after Dec 6, 2010 storm surge. The debris line is marking the high-water elevation.

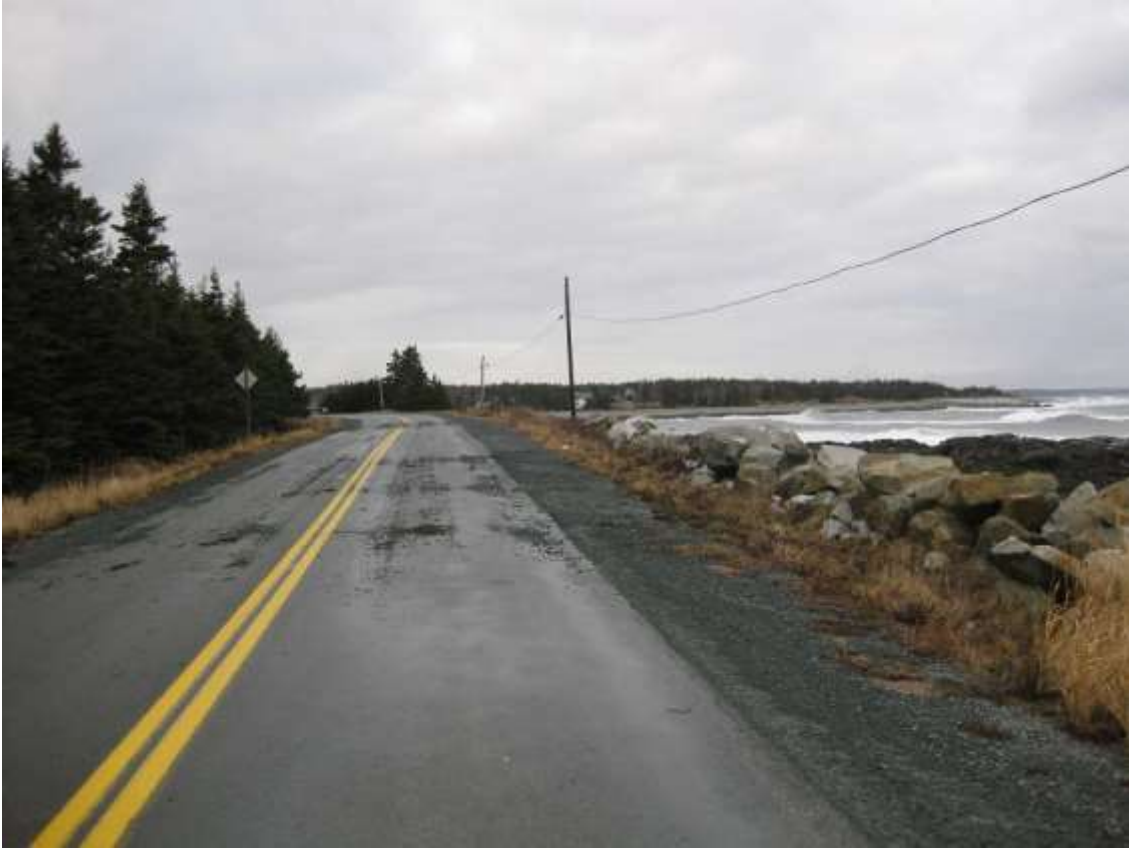
Figure 21 Western Head after Dec 6, 2010 storm surge. Nail in power pole marking the high-water elevation. Note the gravel from the beach deposited on the road.

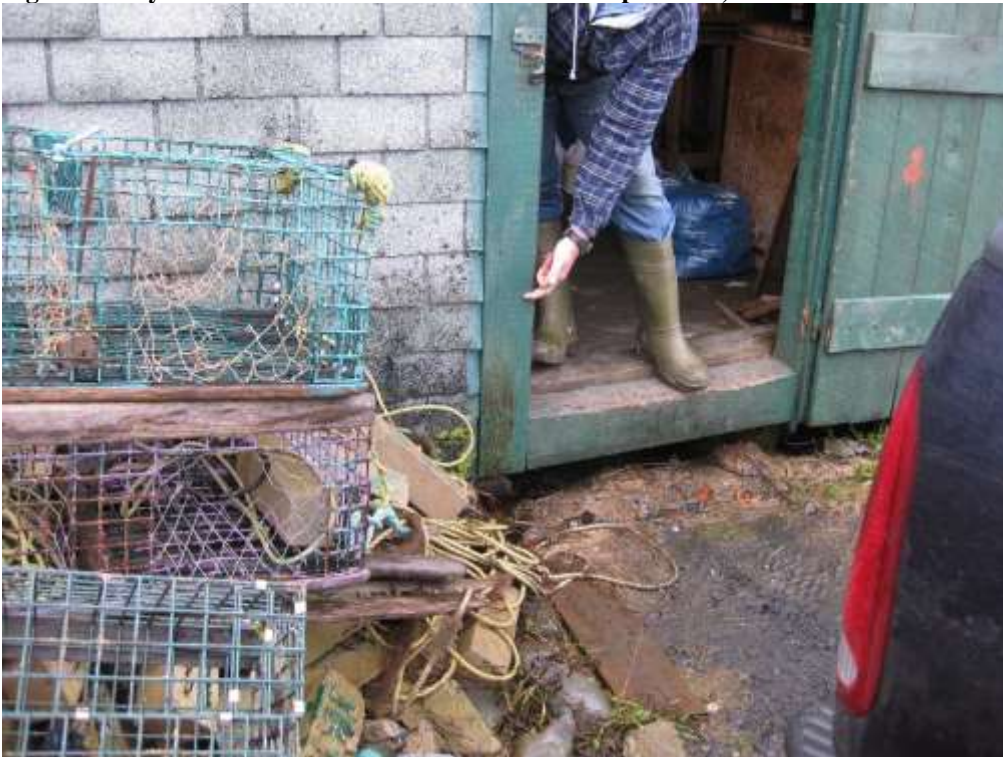
Figure 23 Witness pointing to high-watermark from Hurricane Juan, Sept 28-29, 2003.

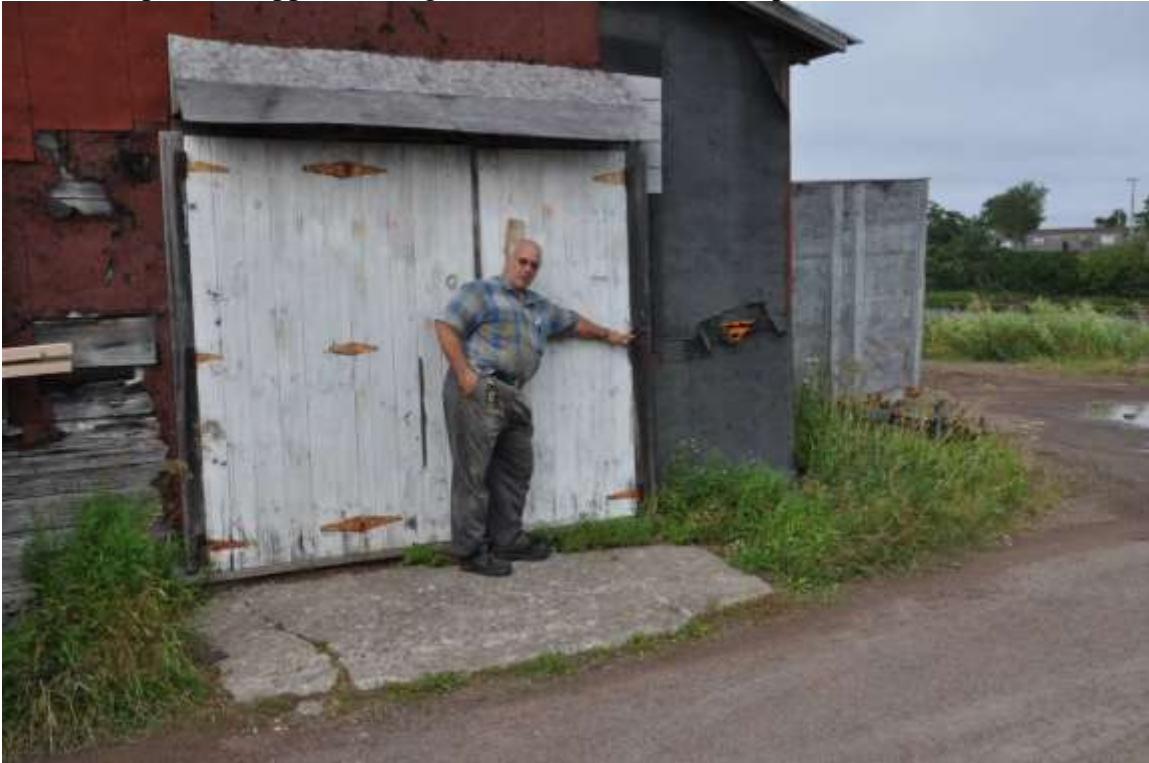
Figure 26 Port Elgin high-water level from eye witness. RTK GPS orthometric height measured 3.20 m.

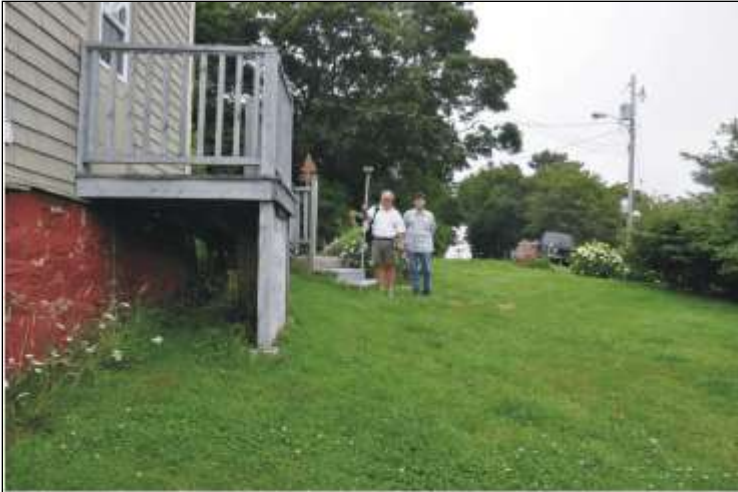
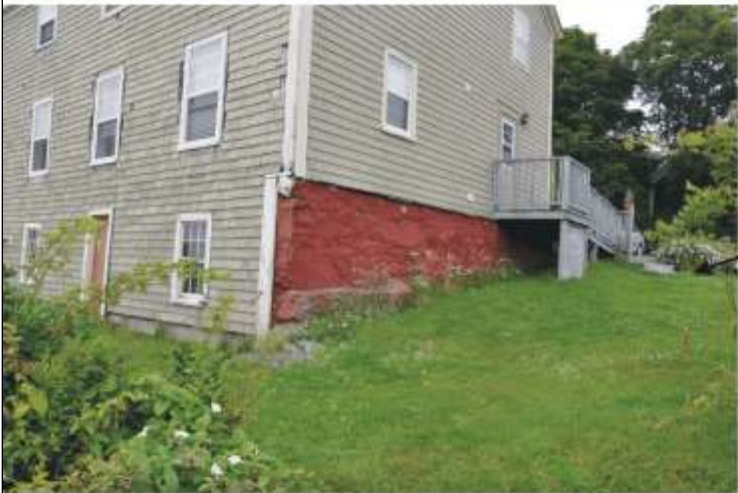
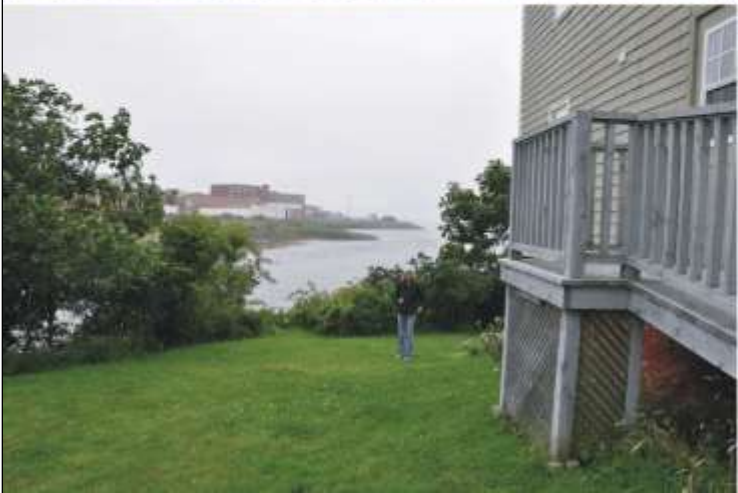
RTK water level

Water level reached the bottom of the door step on Groundhog Day Storm Feb. 1976.

Figure 28 High-water mark being surveyed in Yarmouth from Feb. 3, 1976 Groundhog Day Storm. 4.81 m CGVD28 elevation from GPS of high-water mark.

The RTK GPS elevation of the high-water marks; one based on eye witness reports of the water coming to the door step of a house (4.81 m CGVD28), and the other mark was estimated based on historical photographs of water covering a cars tires near the present Printer Works building (3.56 m CGVD28) (Appendix B).

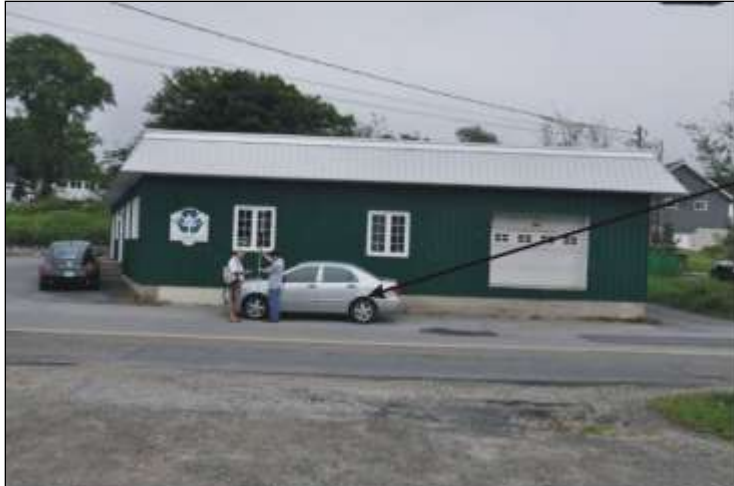
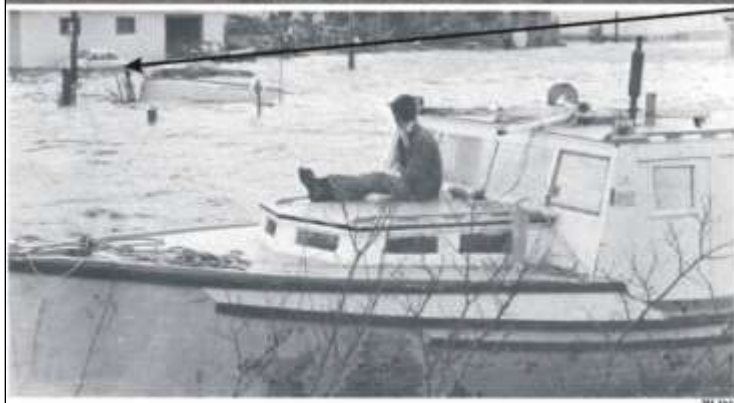
Photo showing this building with water above the tire of a VW bug car. My tires 1 inch lower.

Original Photo showing this building with water above the tire of a VW bug car.

Figure 29 High-water mark being estimated and surveyed based on historic photo Feb 1976 (courtesy of the Vanguard Newspaper). RTK GPS of the top of the tire 3.56 m CGVD28.

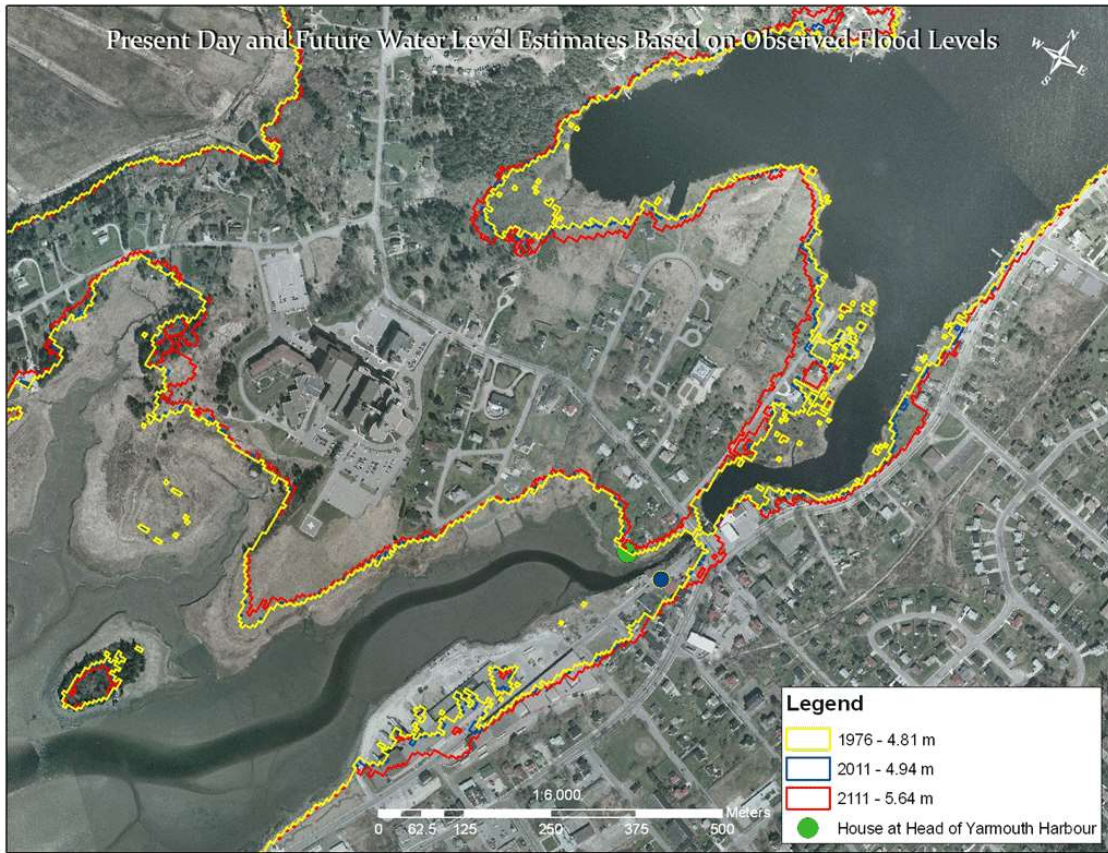
Figure 30 Yarmouth location map. Green dot is the back door step high-water mark and the blue dot is the top of car tire high-water mark RTK-GPS survey locations. The yellow line is the flood limit of 4.81 m high-water (door step elevation), the other lines represent sea-level rise in the future.
