Community High-Water Storm Surge Mapping Network

Climate Change Adaptation Fund Organization
Submitted By

Dr. Tim Webster, Research Scientist
Applied Geomatics Research Group – COGS, NSCC
Partner Organization Emergency Management Office

Submitted to
Climate Change Directorate
Will Green
Climate Change Adaptation Specialist
Nova Scotia, Department of the Environment
March, 2011

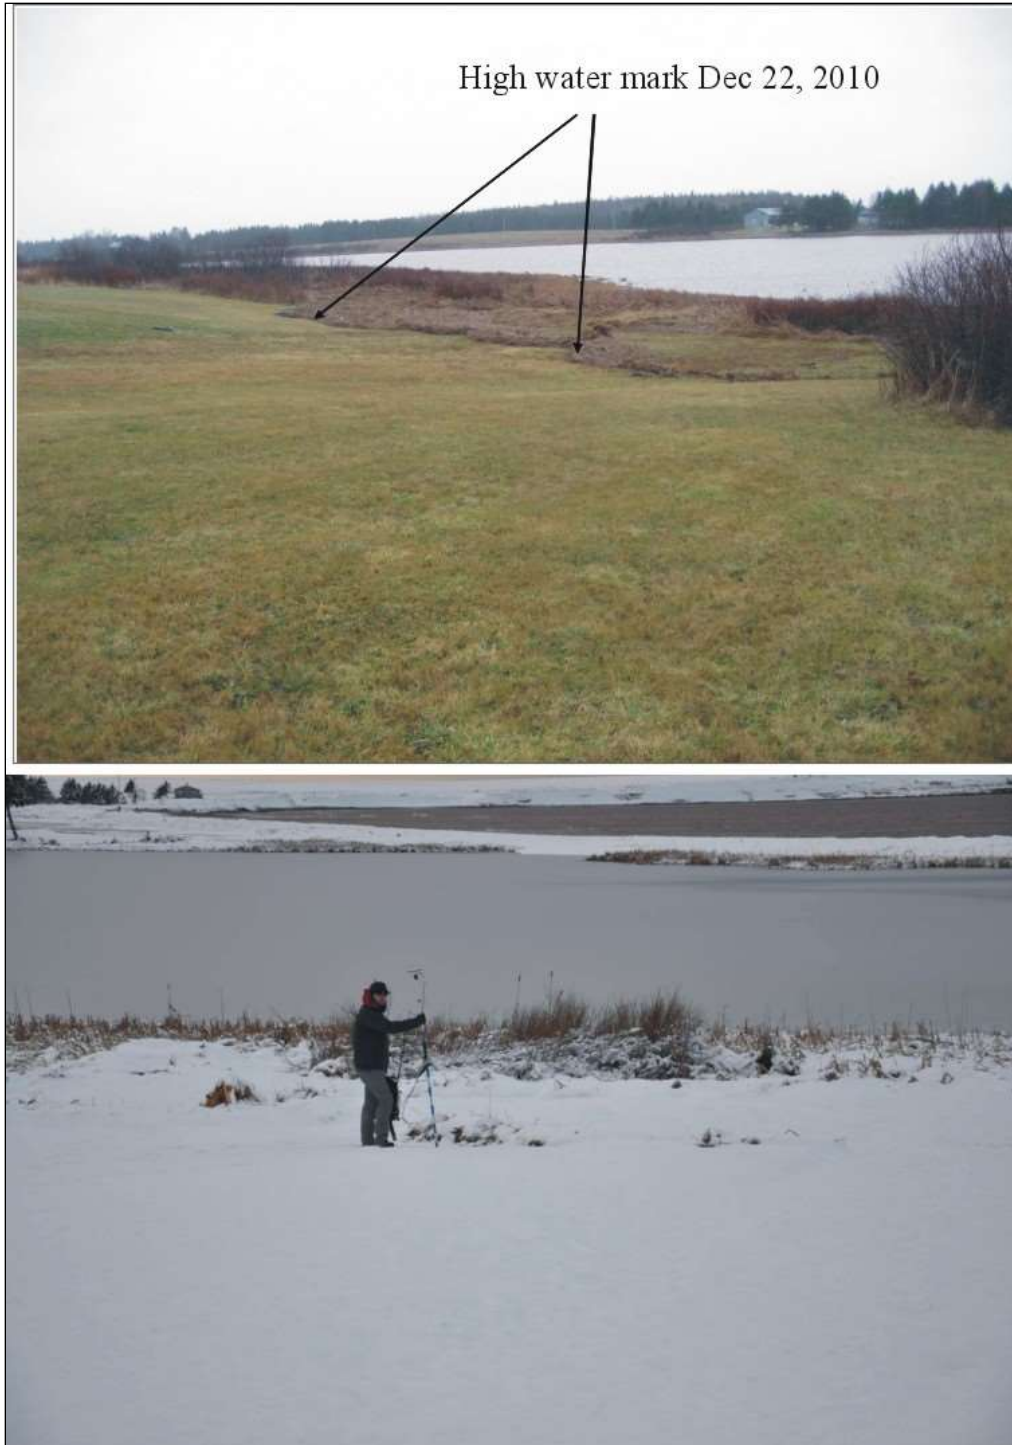
Figure 31 Debris high-water line from Dec 21-22, 2010 storm at Cape John (top photo). RTK GPS of high-water line indicates a water level of 2.38 m CGVD28.
