Mapping Coastal Sections using full 3-D Digital Laser Technology to Monitor Change

Tim Webster, PhD
Nathan Crowell, Kevin McGuigan, Malinee Kongwongthai and Candace MacDonald
Applied Geomatics Research Group
Centre of Geographic Sciences
NSCC, Middleton
Tel. 902 825 5475
email: timothy.webster@nscc.ca

Climate Change Directorate
Will Green
Climate Change Adaptation Specialist
Nova Scotia, Department of the Environment
March, 2012

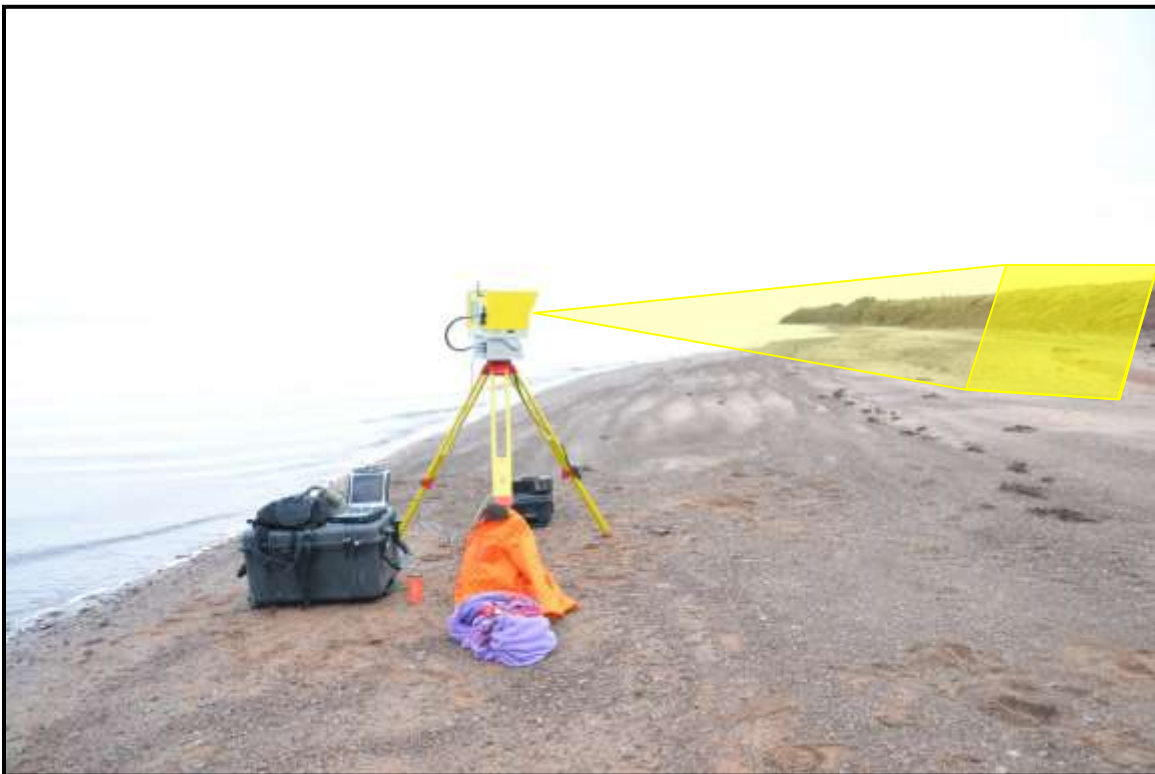
Figure 2 Typical ILRIS setup along the coast. The yellow shaded area is a cartoon to represent the 40 degree by 40 degree field of view.

We have utilized the Optech ILRIS ground based lidar scanning unit owned by the Applied Geomatics Research Group (AGRG). The system allows us to capture the full three dimensional aspects of the coastal section. It is an eye-safe laser that has a 40 degree by 40 degree field of view (Fig. 2). The scans have a spatial resolution on the order of a point every 1-5 cm in spacing and a vertical precision of 2-5 cm.

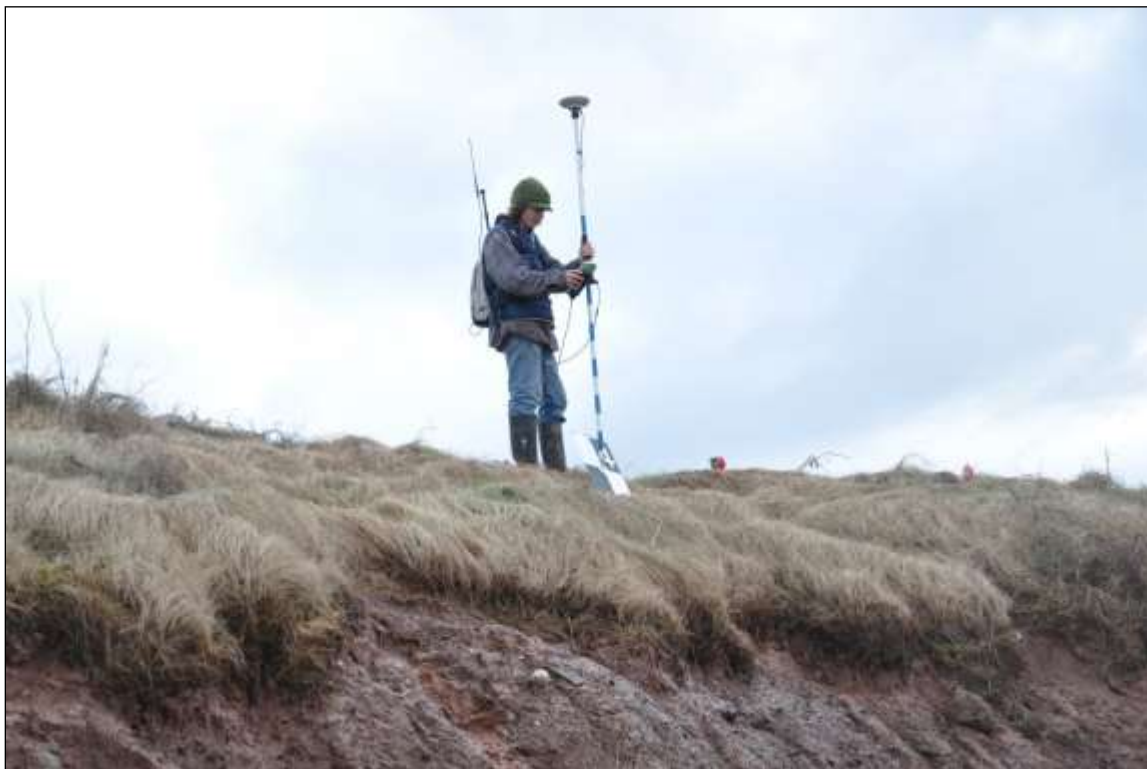
Figure 3 Example of a georeferencing target and GPS positional measurement (precise of 2 cm in Z). The targets are then located in the point cloud and (Fig. 4) and used as control points with the GPS coordinates. A first order polynomial transformation is used to convert the point cloud data to UTM NAD83 zone 20 horizontal coordinates and the elevations are referenced to CGVD28.

The ILRIS does not directly georeference the laser scans. In order to geocode the lidar point cloud, we place a minimum of 4 targets within each scene and use RTK GPS to measure their locations (Fig. 3).

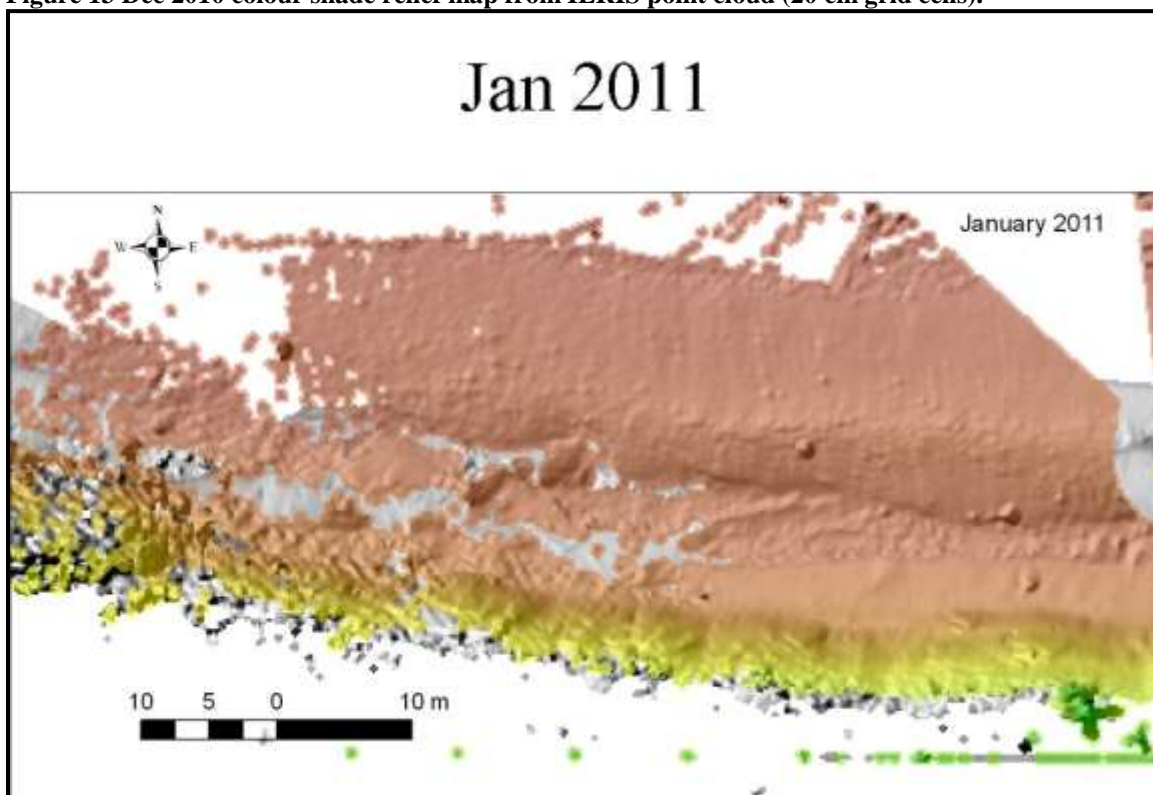
Figure 14 January DEM colour shade relief map from ILRIS point cloud (20 cm grid cells).

The individual geocoded scans from different vantage points were integrated and DEM grids constructed for each date (Table 2). The DEM grids were constructed with 20 cm grid cells using the IDW interpolation method (Figs. 10-14).

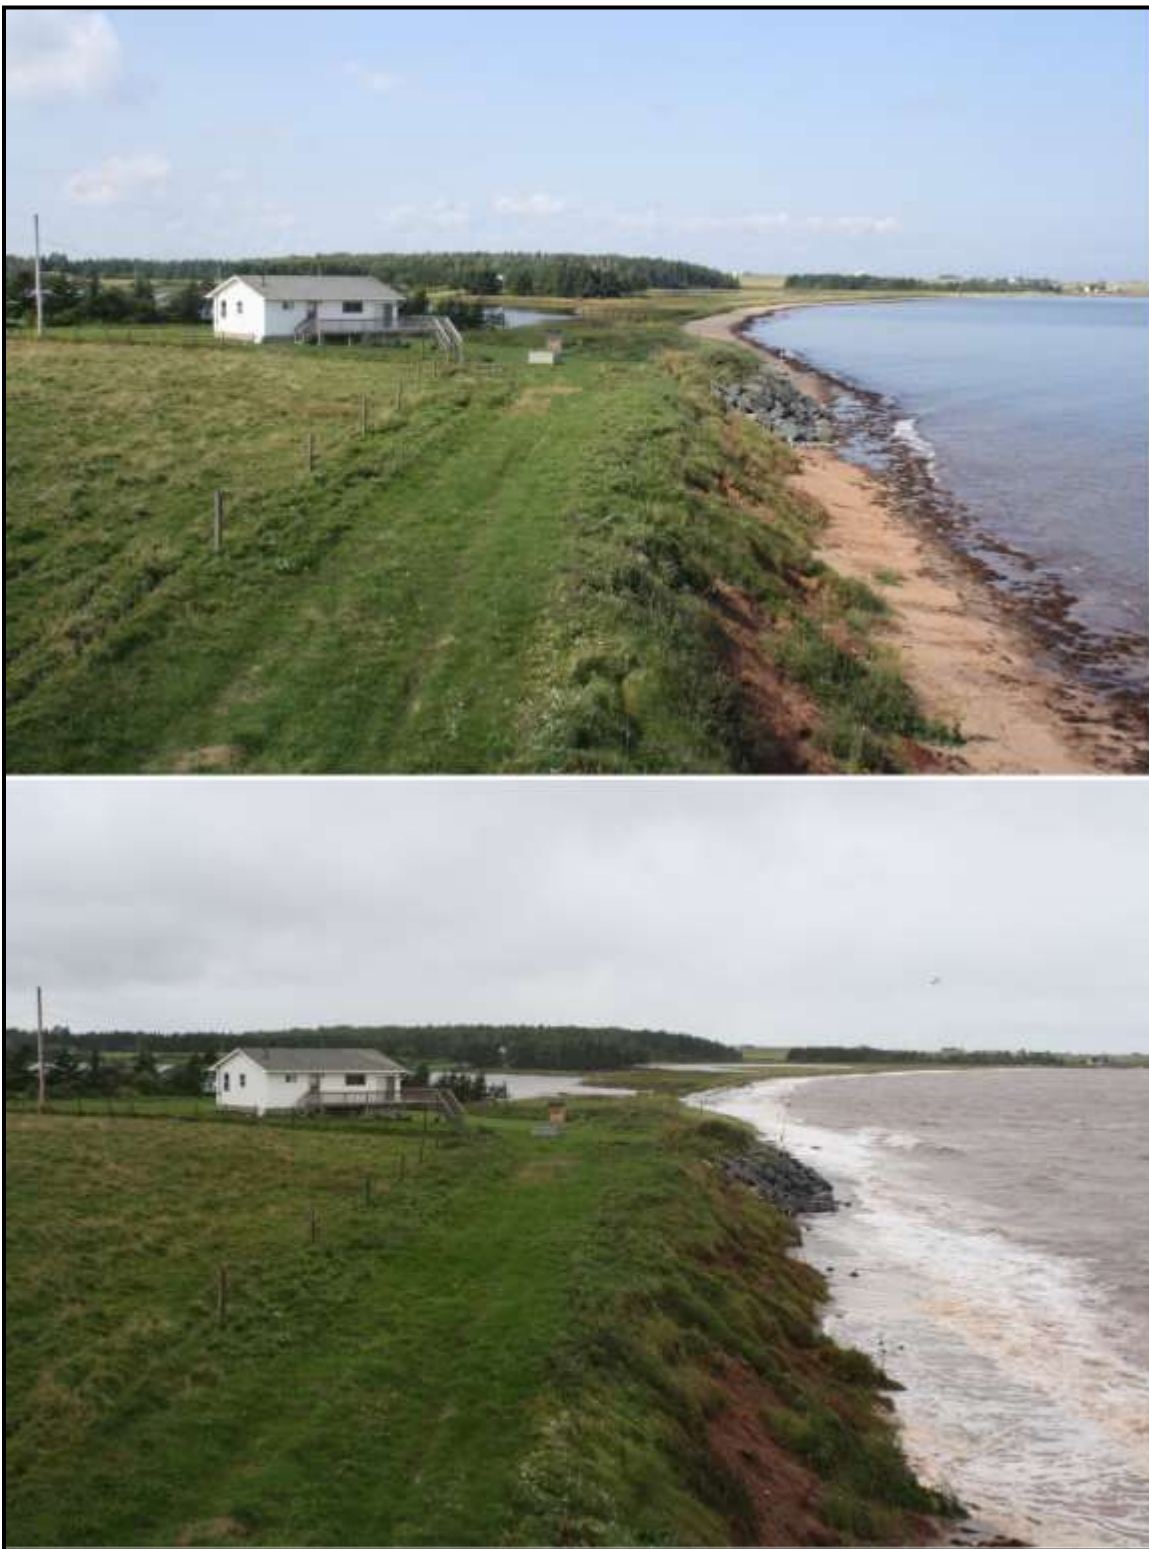
Figure 17 Example from the time-lapse camera system. Top photo is normal “spring” high tide. Bottom photo is the storm surge from Sept. 10, 2010 (1.41 m).

The Sept. 10 high-water event was captured with the time-lapse camera system (Fig. 17). This high-water event in combination with the storm surges of Nov. 10 and 25th have caused erosion of the beach sand and removal of some of the glacial till material at the foot of the bank (Fig. 18).

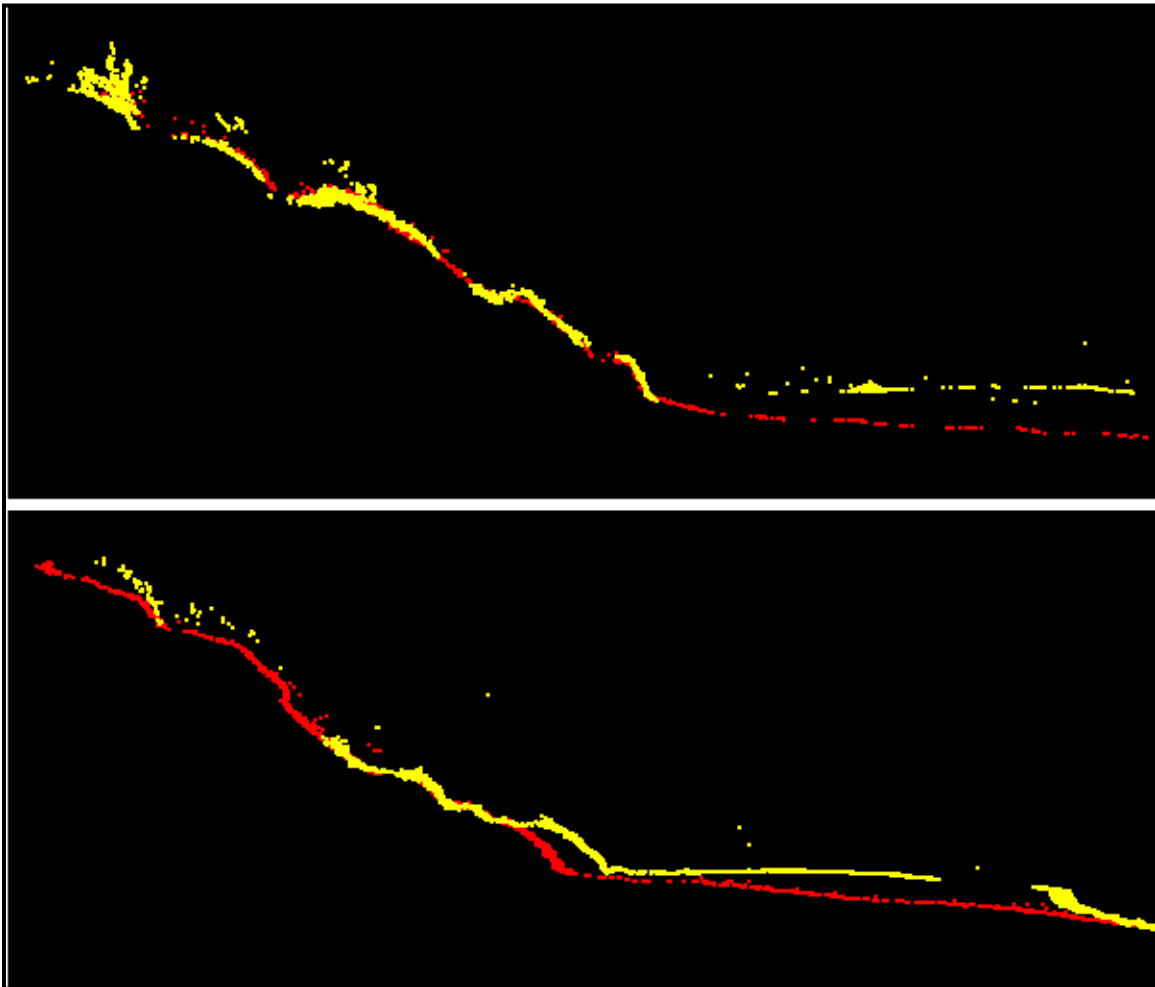
Figure 18 Comparison of point cloud profiles from June (yellow) and December (red) scans. The top image shows more vegetation present along the bank and the beach at a higher level in June than Dec. The lower image shows erosion of the foot of the bank and a lowering of the beach between June and Dec. The relief along the Y-axis is approximately 6 m and the distance on the X-axis is approximately 20 m.

The changes observed in the lidar scans (Fig. 18) are attributed to the storm surge events of Sept. 10, Nov. 10 and 25 and possibly Dec. 6, although the water did not exceed 1.25 m for the last event based on the tide gauge data (Fig. 16).

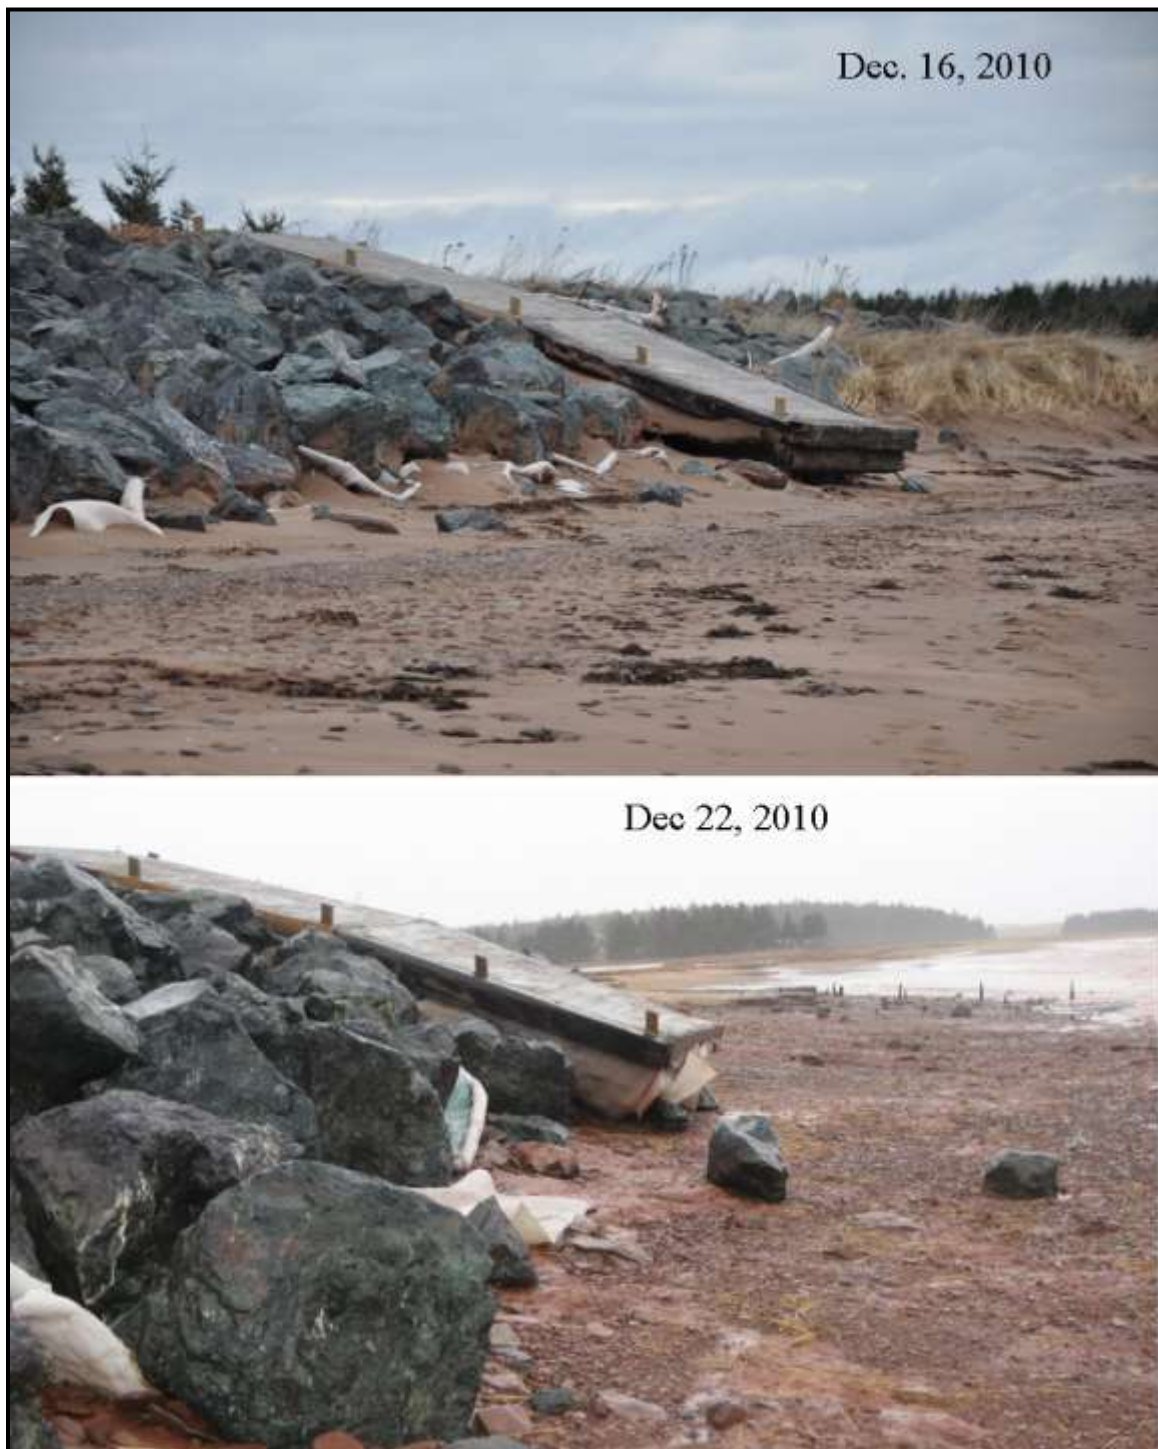
Figure 20 Erosion of the sand from the beach and destruction of the dune from the Dec. 21, 2010 storm surge event.

The Dec. 21 storm devastated coastal regions all along the Northumberland Strait with flooding and significant erosion. The sand was totally removed from the beach and the sand dune destroyed at Cape John (Fig. 20).

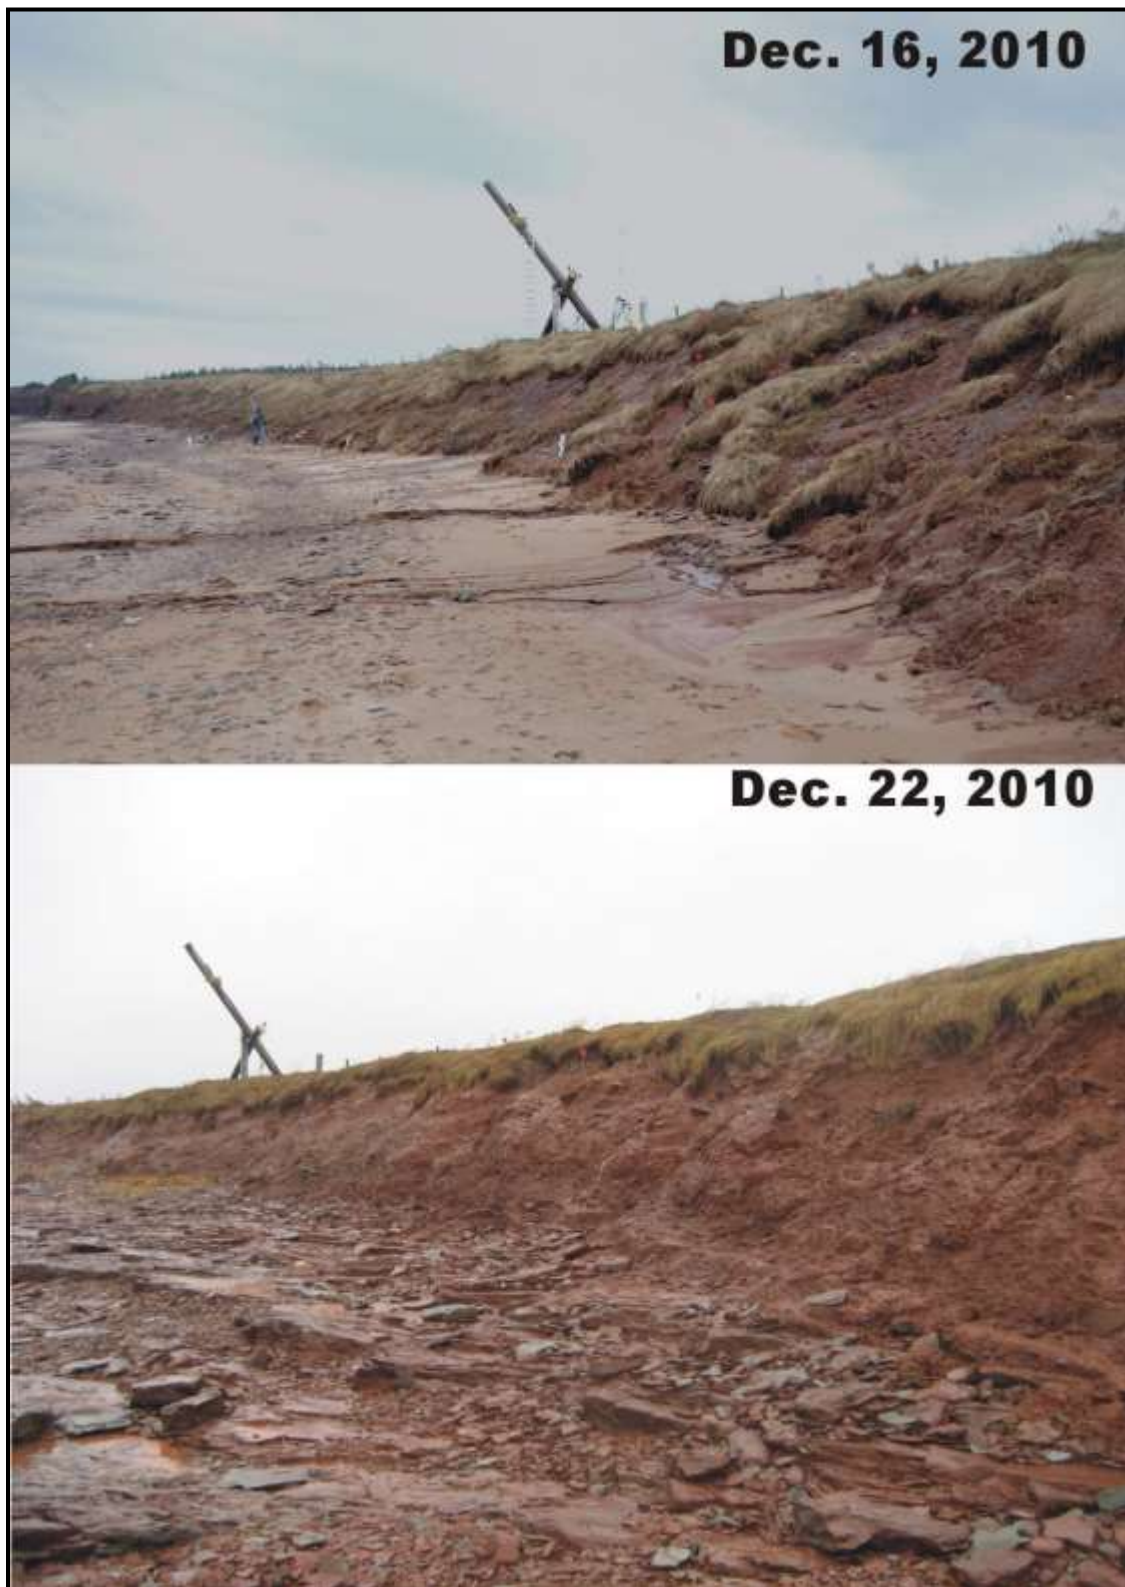
Figure 21 Erosion of the glacial till bank by the Dec. 21, 2010 storm surge event at Cape John. The pole for the time-lapse camera system and weather station are common in each photo which was taken looking east.

monitor creep and slumping and were removed (Fig. 21). As can be observed in Figure 21, all of the clumps of sod have been removed from the bank during the storm. The sand has been removed from the beach and only bedrock and larger stones remain.

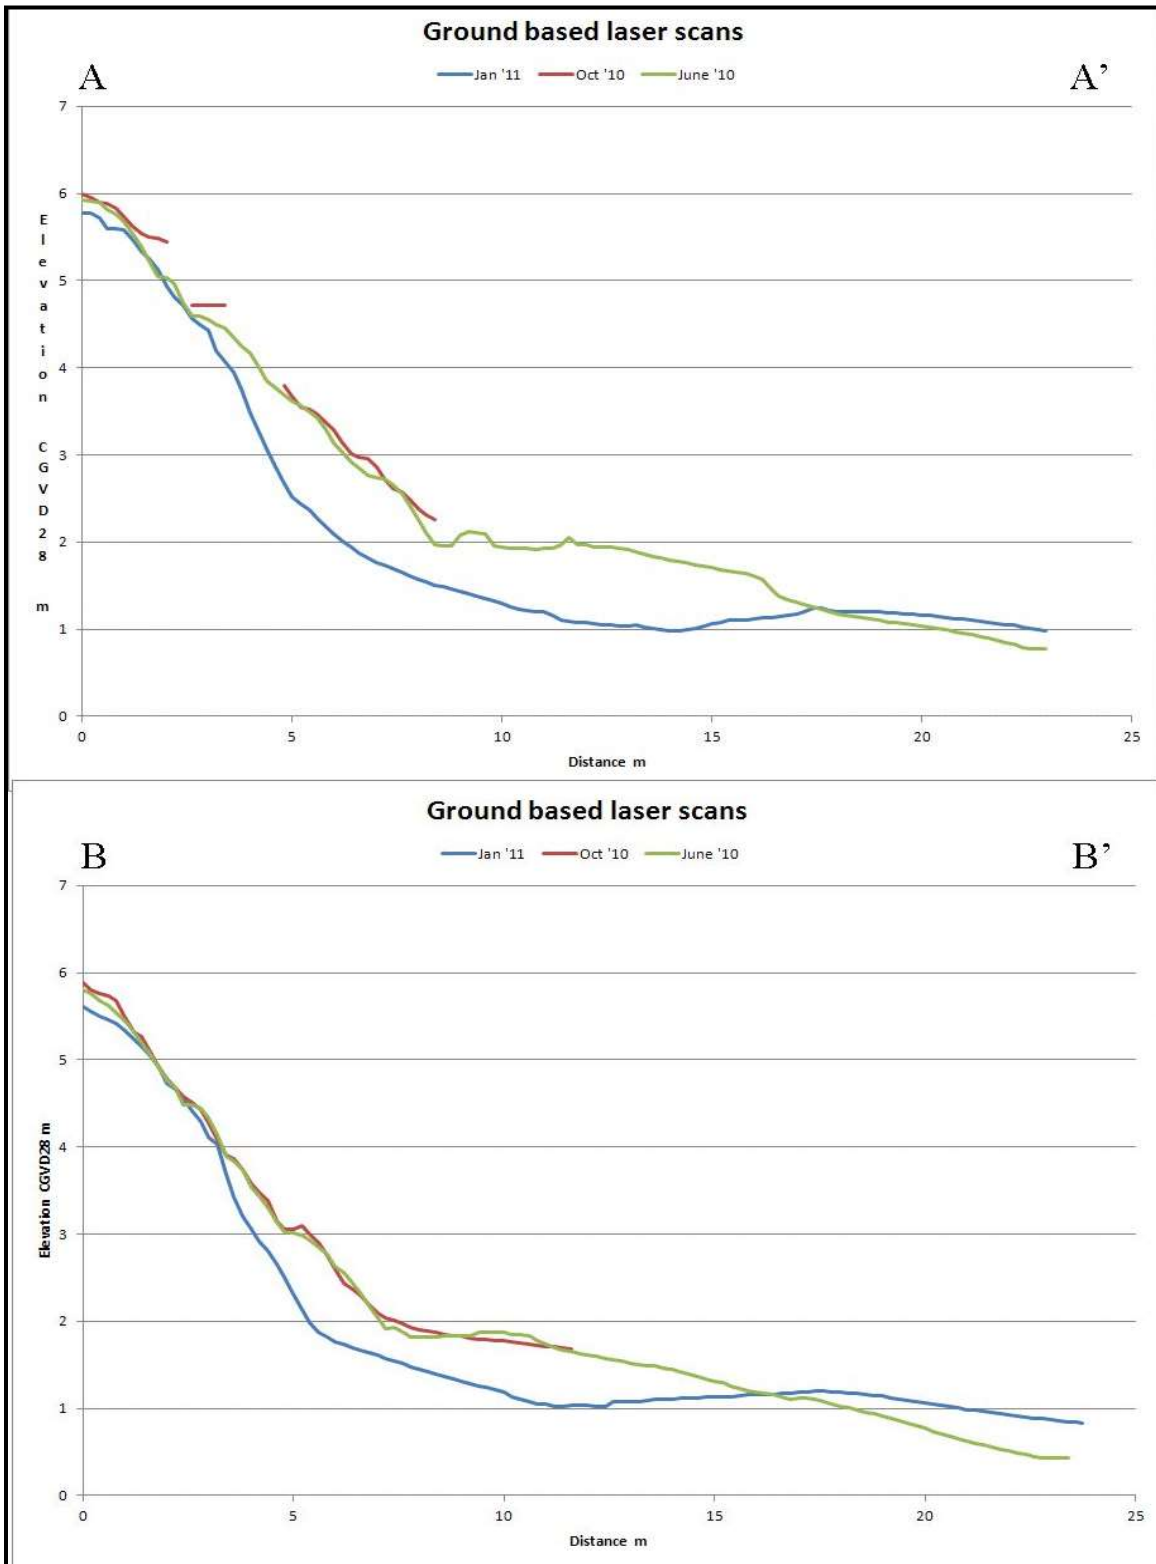
Figure 23 Profiles of DEM surfaces for A-A' and B'B' (Fig. 22). The bank appears to have been eroded to the 4.5 m elevation based on the profiles.

Unfortunately snow followed the Dec. 21 storm event prior to us being able to visit the site and collect GPS and another ILRIS scan. The depth of snow was approximately 5 cm and was not drifted when the post storm ILRIS scan was acquired on Jan. 4, 2011. GPS locations of the high-water wrack line were collected along with some beach elevations. The beach is very resilient however, as sand had been deposited back onto the beach, although not at the levels observed prior to the storm. The lidar point clouds and DEMs were used to analyze the change in the glacial till bank by examining profiles and differences in the DEM surfaces. The difference between the June, 2010 DEM and Jan., 2011 DEM shows a significant amount of change (Fig. 22). The difference DEM has been used to calculate the amount of sediment that has been removed. Along a coastal section 150 m in length, approximately 1081 cubic metres of material was removed from June 2010 to January 2011. Although we have observed erosion of the beach and at the foot of the bank from July to Dec., the most significant erosion was during the Dec. 21 storm. Profiles of the lidar DEMs for June, Oct. 2010 and Jan. 2011 for two locations (Fig. 22) are plotted in order to observe the steepening of the bank slope after the storm (Fig. 23).

23-25). The total volume of sediment removed along a 150 m section of the coast was 771 cubic metres by analyzing the Dec. and Jan. grids. Therefore according to our calculations, 310 cubic metres of material had been removed between June and Dec. In addition to examining the lidar derived DEM surfaces in maps and profiles, the georeferenced point clouds have been examined to observe the changes from Dec. to Jan.. For each profile of the point cloud, the width of the profile is approximately 1 m. Four profiles are presented that have been extracted from the point clouds from west to east. In the first profile the point cloud is symbolized by the greyscale intensity. The lighter tones on the upper point cloud represent pieces of sod that were present along the bank in Dec (Fig 25 top image). The remaining point clouds are colour coded based on their date, with the Dec. scan in green and the Jan. scan in red (Fig. 25 middle and lower images). The same general pattern is present with the bank being eroded at the 4-5 m elevation and the adjacent beach scoured with deposition farther seaward on the beach (Fig. 25). However, some subtle details are evident in the point cloud profiles that are not identified in the DEM profiles. For example, two terraced steps appear to be present in the bank of the Jan. 2011 scans (Fig. 25). The upper terrace may represent the dominant level of erosion and material above this was undercut and was subsequently removed by continued wave

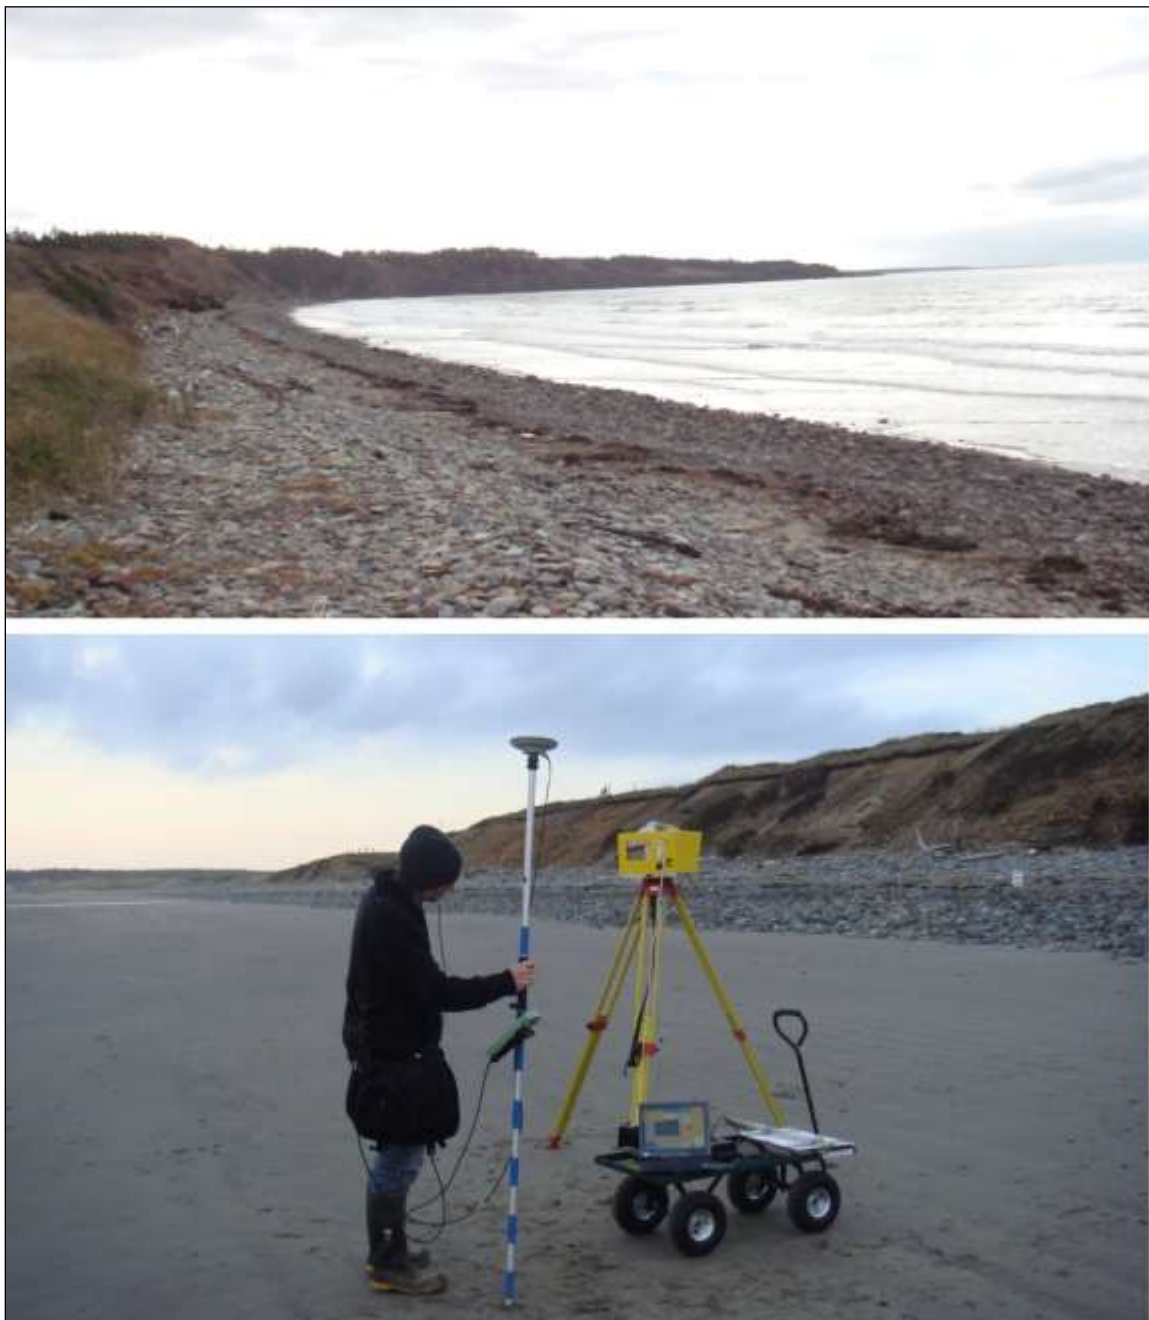
Figure 29 Tidal water level variations at Mavillette beach. The top photo is looking southeast from the beach entrance at high tide. The lower photo is looking northwest towards to beach entrance at low tide.

The tidal height variation at Mavillette is significant and with low tide, the ILRIS can be placed at a larger distance orthogonal to the coastline, thus minimizing shadows cause by gullies, for the scan setups (Fig. 29). When the tide is high, there is very little room to setup the instrument above the water line and would require scanning at an oblique angle to the coastline as has been done in the previous survey areas.

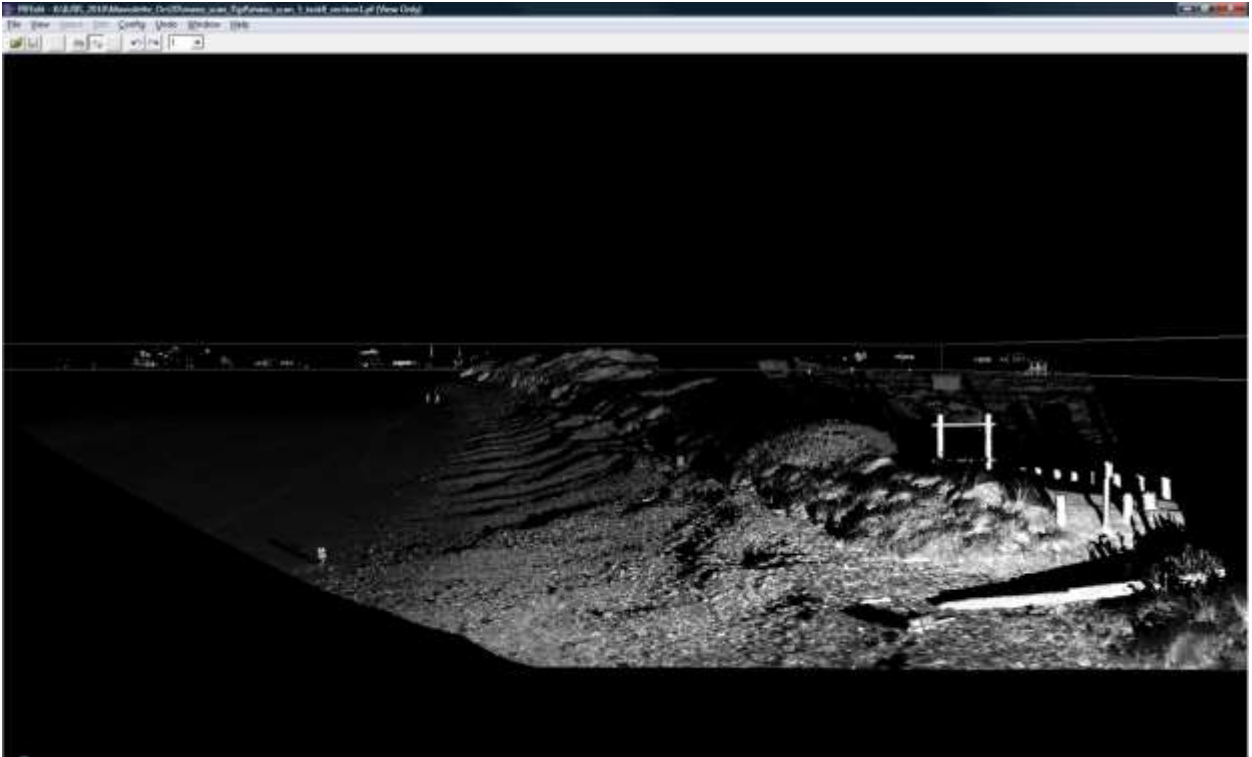
Figure 30 Laser scan of the sand dune system at Mavillette

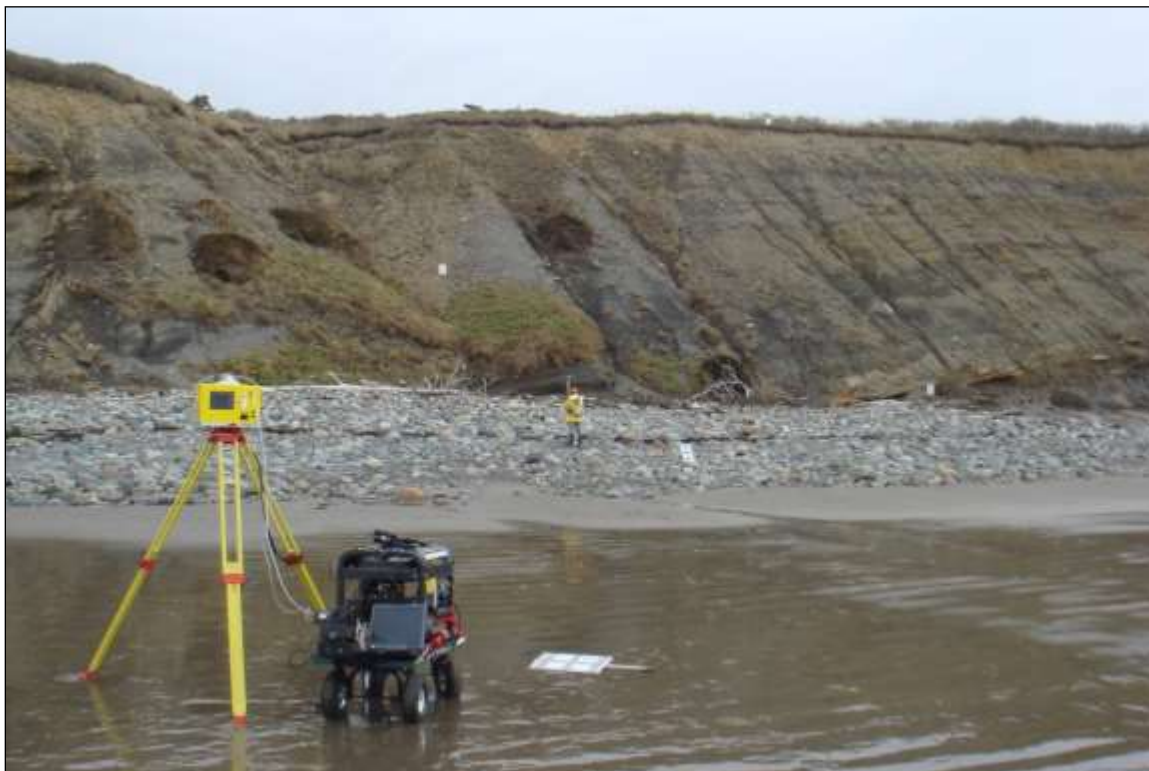
Figure 30 Photo of ILRIS setup for scanning the glacial till bank. Scan represented in Fig. 32 of this area.

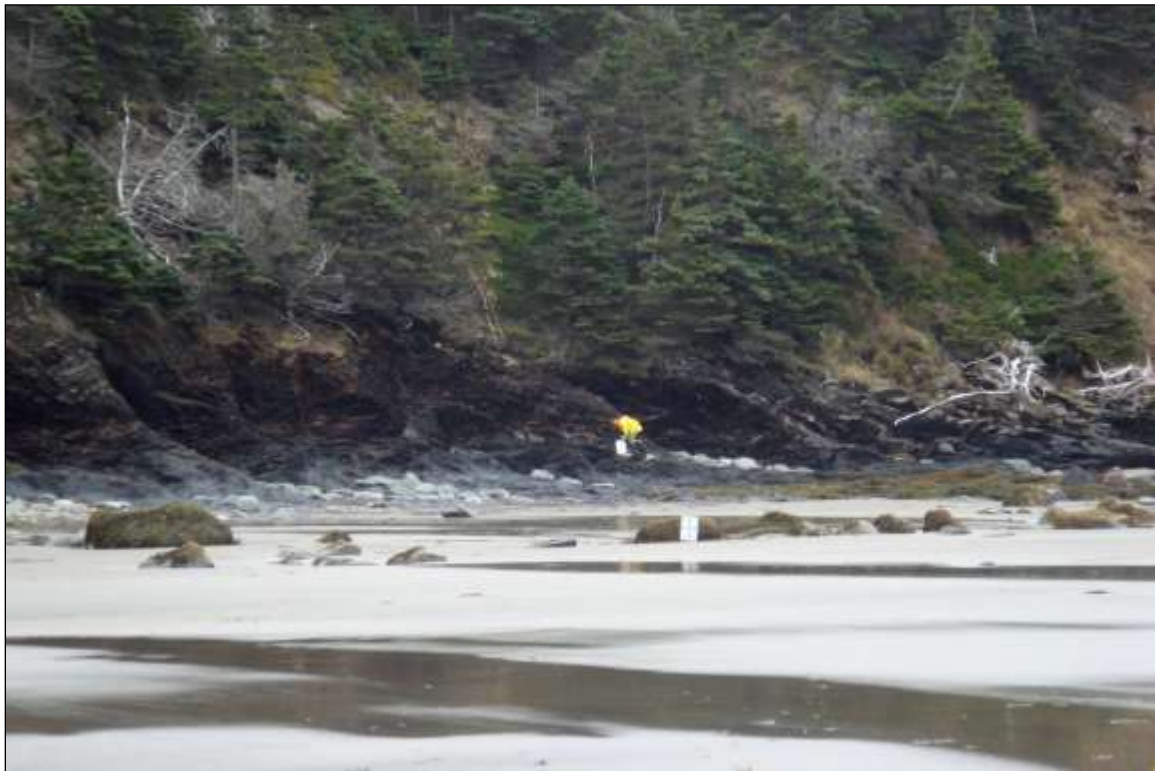
Figure 33 Photo of slumped trees in the glacial till and exposed bedrock at the foot of the bank. The bedrock is very dark as a result of the composition of the slate and tidal inundation.

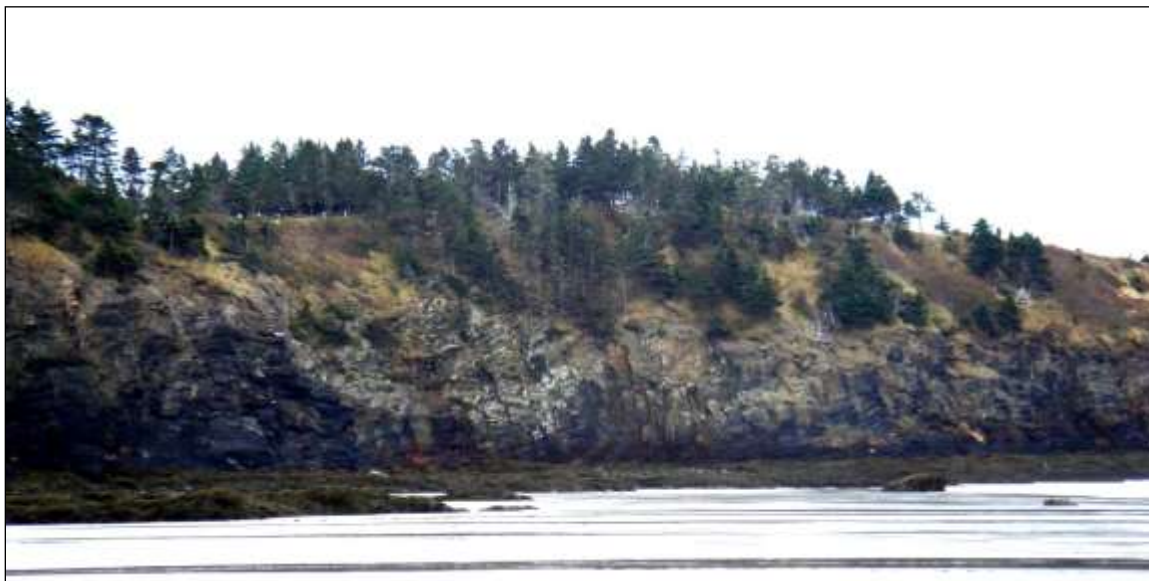
Figure 35 Photo of the bedrock cliff that forms a promontory. The glacial till sits on top of the bedrock and forms a shallower sloped bank than the bedrock cliff. The rocks are highly deformed and resistant to erosion.

As one moves farther southeast along the embayment, a promontory is formed by the bedrock cliff of the coastline. The bedrock cliffs are exposed along this section of the coast and consist of deformed metasedimentary rocks of the Meguma Group (Fig. 35 lower image). Glacial till sits on the bedrock cliff and the bank forms a shallower slope (Fig. 36). The boundary between the bedrock and glacial till shows up as a bright strip in the intensity scans (Fig. 35 lower image).

The bedrock forms a steep cliff coastline with the glacial till forming a shallower sloped bank above the bedrock. The rocks in the areas are highly deformed and metamorphosed, thus making them very resistant to erosion.

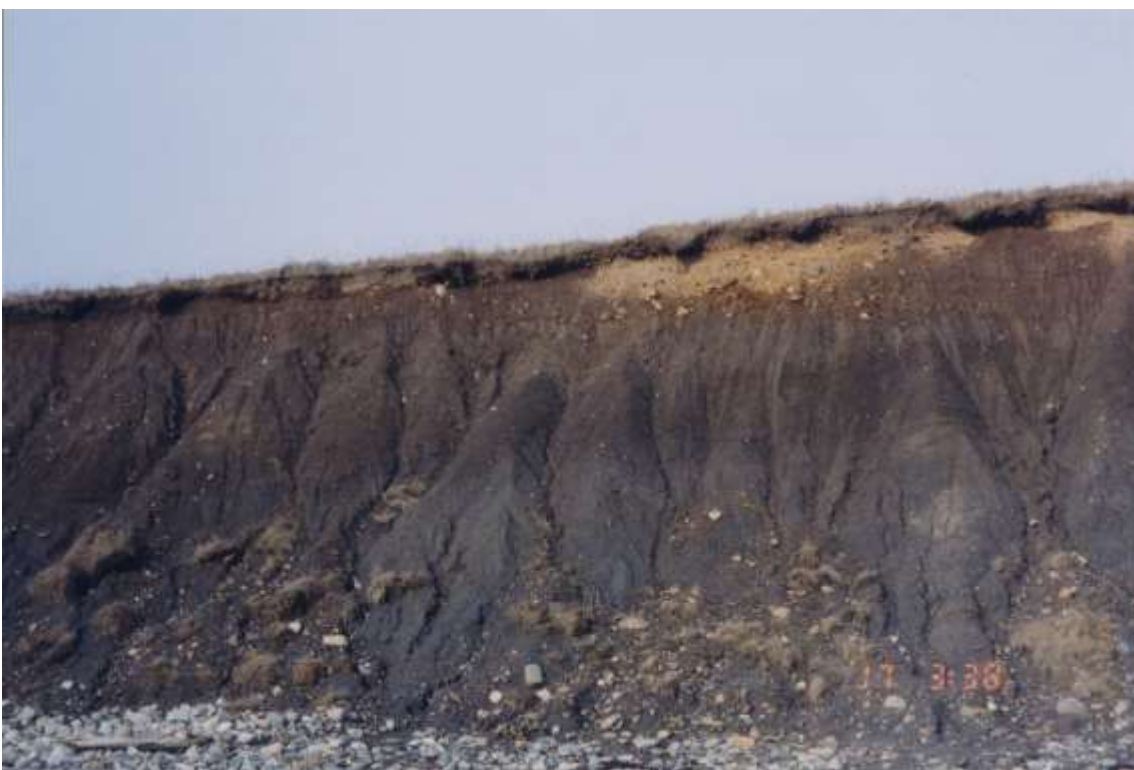
Figure 47 Photo of glacial till adjacent to the eroding drumlin at Hirtles Beach. Notice the layers within the till (grey to dark brown).

The glacial till is comprised of different materials. There are actually two layers of till present in the exposed costal section of the drumlin (Fig. 47).

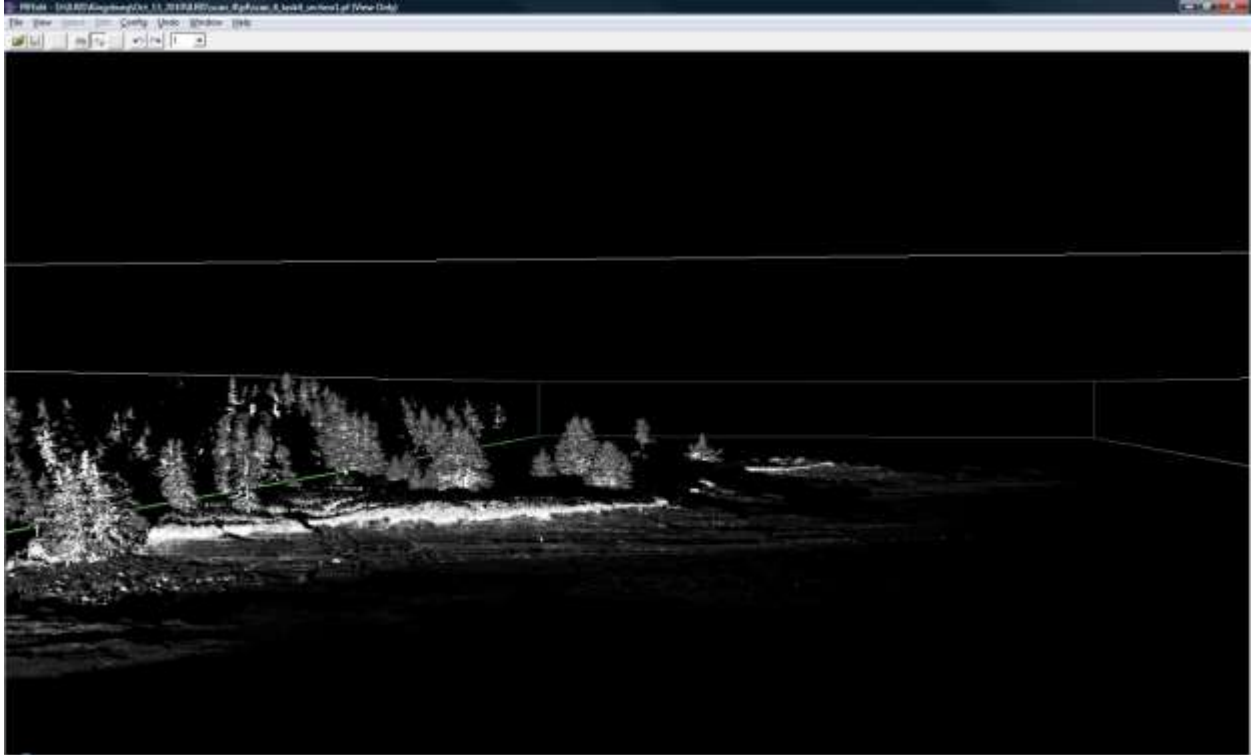
Figure 48 Low relief bedrock point laser scan at Kingsburg.
