# Tabusintac 2014 Topo-Bathymetric Lidar & Eelgrass Mapping Report

Public Works Government  
Services Canada

January, 2015

# PWGSC Bathymetric Lidar Report – Tabusintac, NB

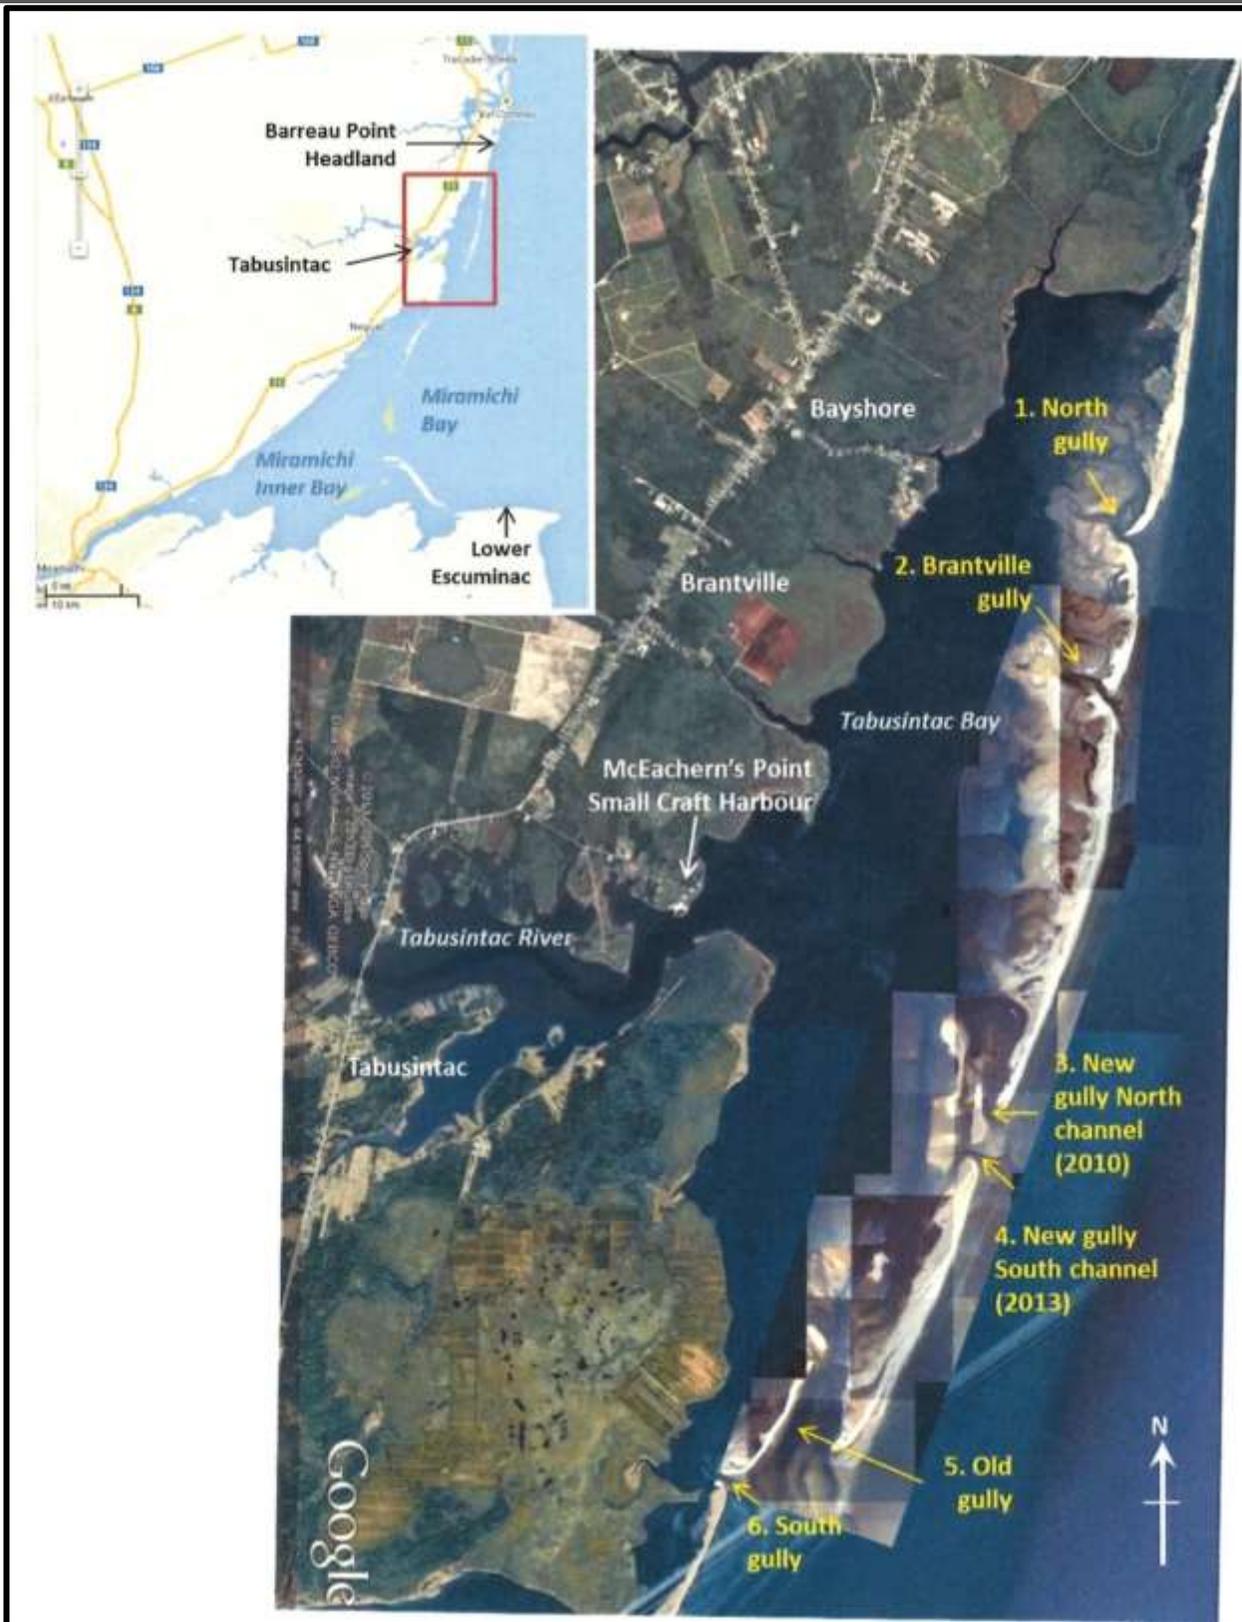
Figure 1: The study area shows new photography of the barrier islands that define the outer area of Tabusintac Bay. The lidar area included McEachern's Point wharf and the gullies 3, 4 and 5. Map supplied by PWGSC.

The Tabusintac Bay study area (Figure 1) was surveyed on September 26, 2014 in the afternoon. The survey was funded by Public Works and Government Services Canada (PWGSC) and two main deliverables: a digital elevation model (DEM) of the bathymetry, and a map of eelgrass distribution within the bay. Tabusintac Bay is a shallow, flat bay with dynamic sand spit barriers and a deep channel. The most recently formed gully (Figure 1, area 4, South Channel) is used by fishers to access the Northumberland Strait, and requires dredging to keep the sediment from filling in the channel. In May of 2013 three fishermen drowned at the site when their boat hit a sandbar and began taking on water. An accurate DEM of the bathymetry of Tabusintac Bay will allow managers to dredge the channel most effectively and efficiently to provide a safely navigable passage for fishers and recreational boaters. The second deliverable is an eelgrass map that will indicate eelgrass distribution with depth throughout the bay. Eelgrass plays an important biophysical role in the health of ecosystems and is widely accepted as an indicator of overall ecosystem health, but is experiencing some declines in the Southern Gulf of St Lawrence. Eelgrass is often used by regulators, such as DFO, as a measure of ecosystem health, but an efficient method of mapping eelgrass is required to enable eelgrass to be monitored through time. Bathymetric lidar

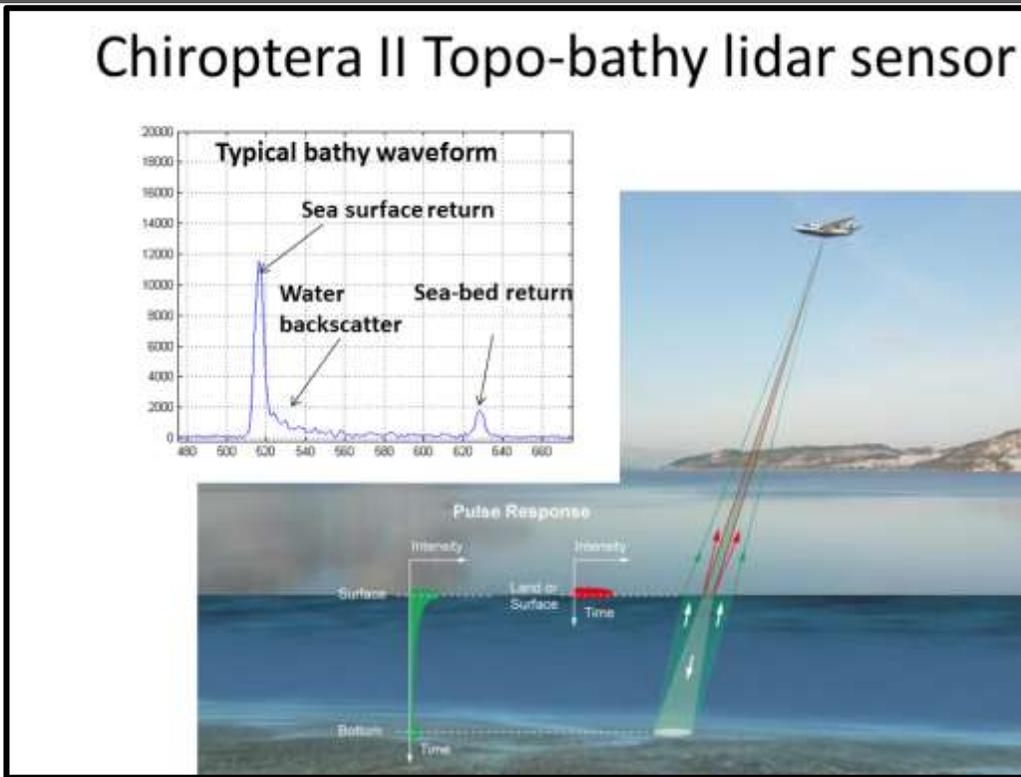
Figure 2 Principles of topo-bathymetric lidar. The system utilizes two lasers, a near infrared and a green laser to surface the land and marine topography.

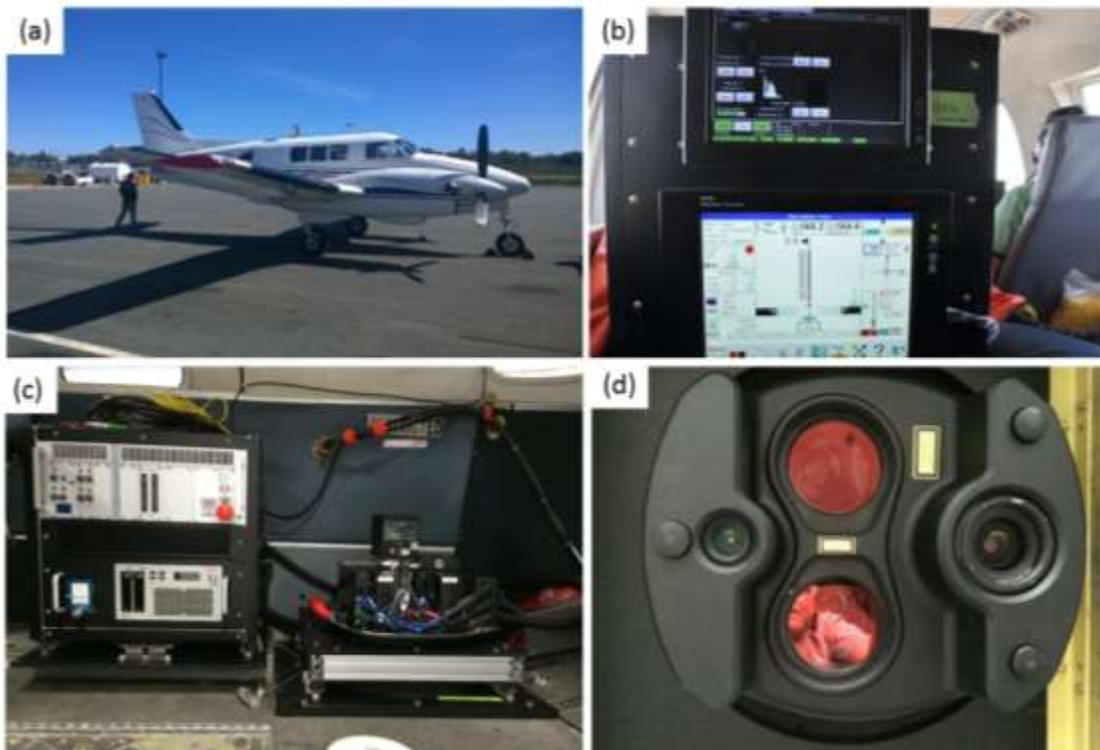
Figure 3: (a) Aircraft used for September 2014 lidar survey; (b) display seen by lidar operator in-flight; (c) main body of sensor (left) and laser pointing through a hole cut in the bottom of the plane (right); (d) large red circles are the lasers; the RCD30 lens (right) and low resolution camera (left).

AGR-NSCC does not own an aircraft, only the sensor. AGRG partnered with Leading Edge Geomatics to assist in the operations of the survey and arranging the aircraft. A twin engine aircraft was contracted that was certified to carry the Chiroptera II sensor suite and had a hole suitable to house the sensor head. The lidar sensor was installed in the aircraft in Fredericton, NB on Sept. 22. Calibration flights were conducted over Fredericton at altitudes of 400 m and 100 m on Sept. 23. The laser systems and camera were calibrated and aligned with the navigation system which consists of a survey grade GPS mounted on the roof of the aircraft and an inertial measurement unit (IMU) mounted above the laser system (Figure 3.)

The aircraft has a hole cut in the bottom for the laser to face the ground and installation involves fitting the control unit and the sensor head into the hole (Figure 3b). The system also includes a 5 megapixel quality assurance camera that the lidar operator is able to view during the flight, along with the waveform of the returning pulse and the flight plan (Figure 3c). Figure 3d shows the downward facing portion of the sensor head, including the red (topographic) and green (bathymetric) lasers, which shoot and return to the large red circles; the lenses on the left and right are the low and high resolution cameras, respectively.

The sensors were installed in the aircraft on Monday, September 22 (Figure 3a). The aircraft had a hole cut in the bottom for the laser and cameras to image the ground and installation involved fitting the sensor head into the hole (Figure 3c) and the associated control rack on the floor and user display screens on another rack in the aircraft (Figure 3b). Along with the lasers and high resolution camera, the lidar system also includes a 5 megapixel quality assurance camera that the lidar

operator is able to view during the flight, along with the waveform of the returning pulse and the flight plan (Figure 3b). Figure 3d shows the downward facing portion of the sensor head, including the red (topographic) and green (bathymetric) lasers, which shoot and return to the large red circles; the lenses on the left and right are the low and high resolution cameras, respectively. During installation the laser systems and camera were calibrated and aligned with the navigation system which consists of a survey grade GPS mounted on the roof of the aircraft and an inertial measurement unit (IMU) mounted above the laser system. Calibration flights were conducted over Fredericton at altitudes of 400 m and 1000 m on Tuesday, Sept. 23, following a wind and rain event on Sept. 22.

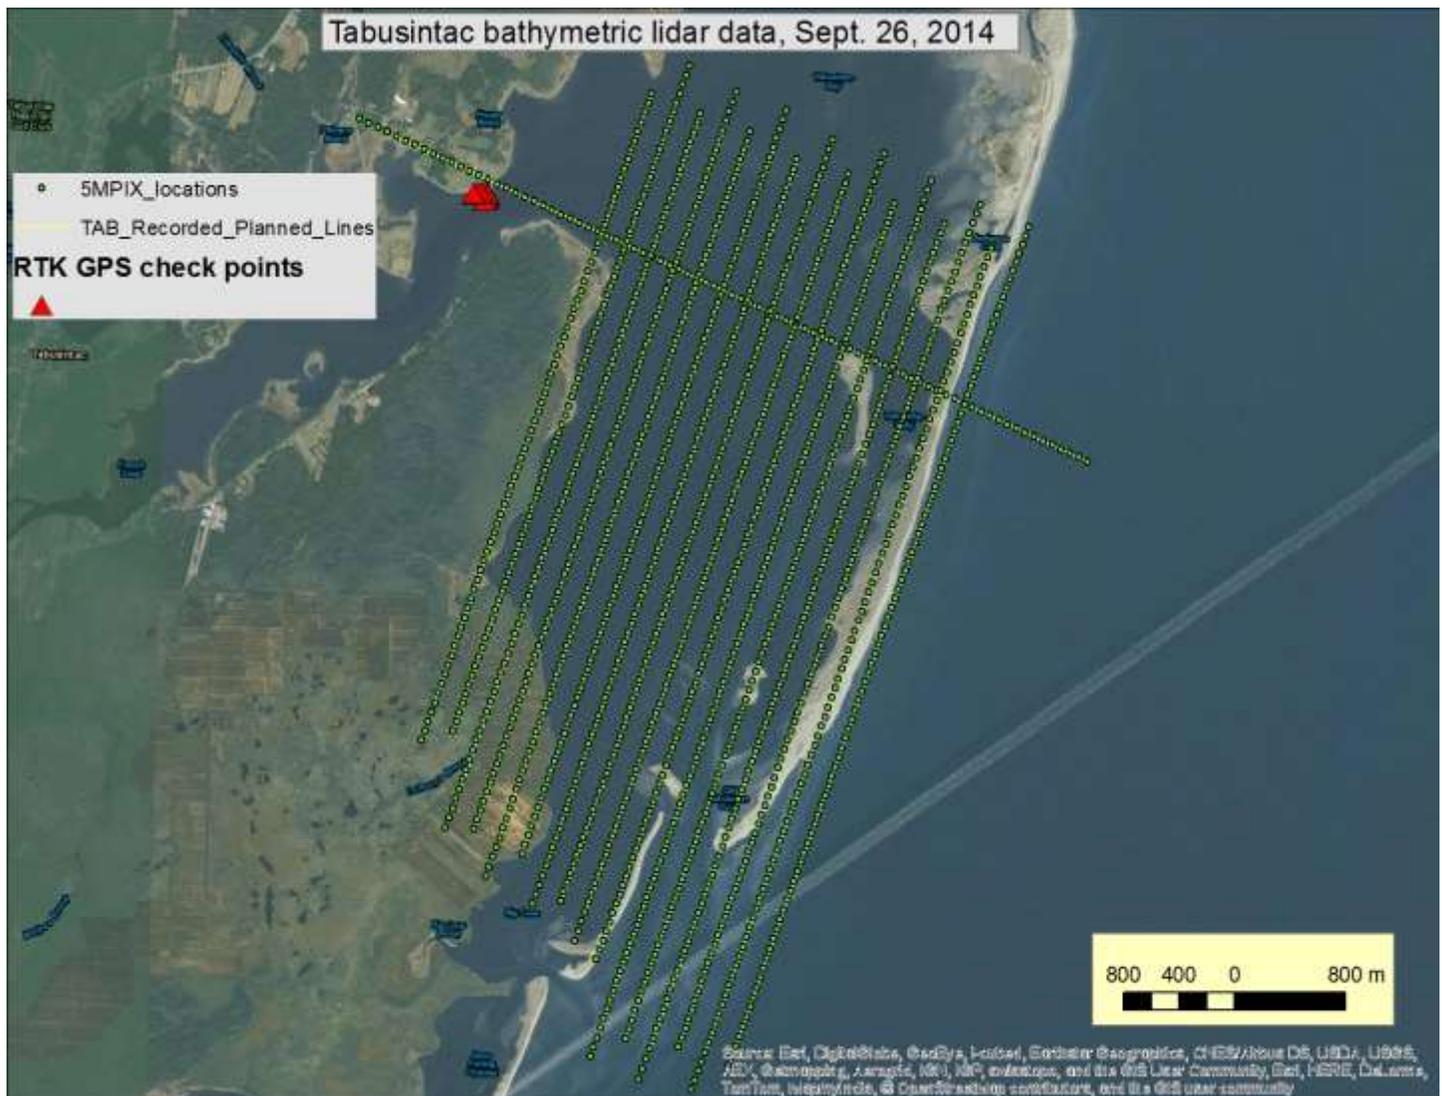
Figure 4 Planned flight lines (yellow lines) and photo capture events (green dots). GPS checkpoint used for validation are also shown in red triangles.

A lidar survey was conducted for Tabusintac on Friday September 26 starting near noon ADT. Low tide at Lower Escuminac was predicted to occur at 12:15 PM ADT on Sept. 26. The survey was planned using Mission pro software at an altitude of 400 m above ground at a flying speed of 140 knots. The planned flight lines and photo events are shown in Figure 4.

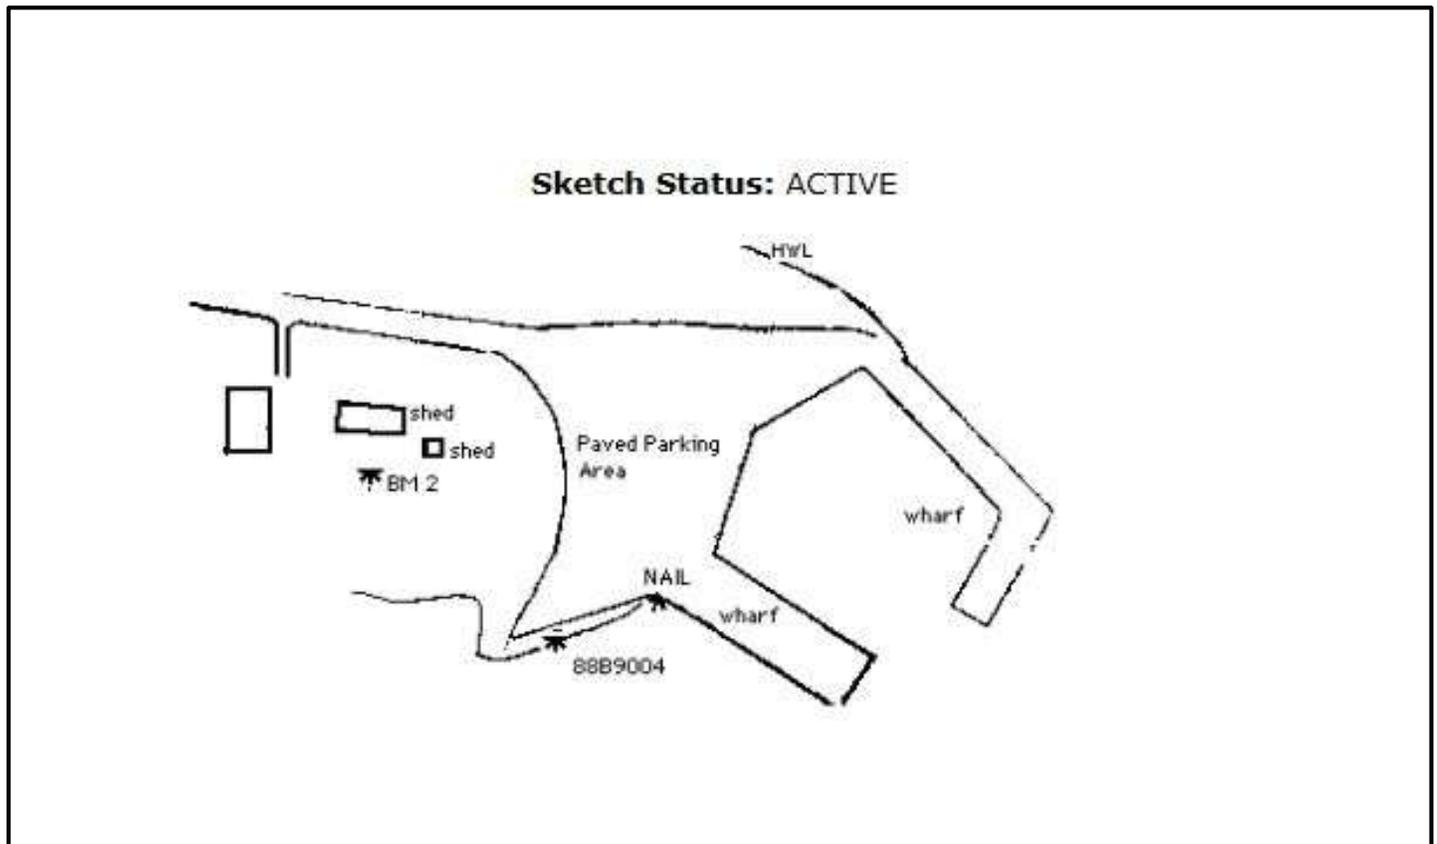
**Figure 5 Sketch of the CHS benchmark 88B9004 supplied by PWGSC to be used for GPS base station.**

A Canadian Hydrographic Service control benchmark was supplied by PWGSC to be used to establish the GPS base station for the aircraft. A sketch and description of the monument was supplied along with UTM easting and northing coordinates referenced to UTM Zone 20 NAD83 projection and datum and an elevation referenced to local chart datum (Figure 5) (Table 1).

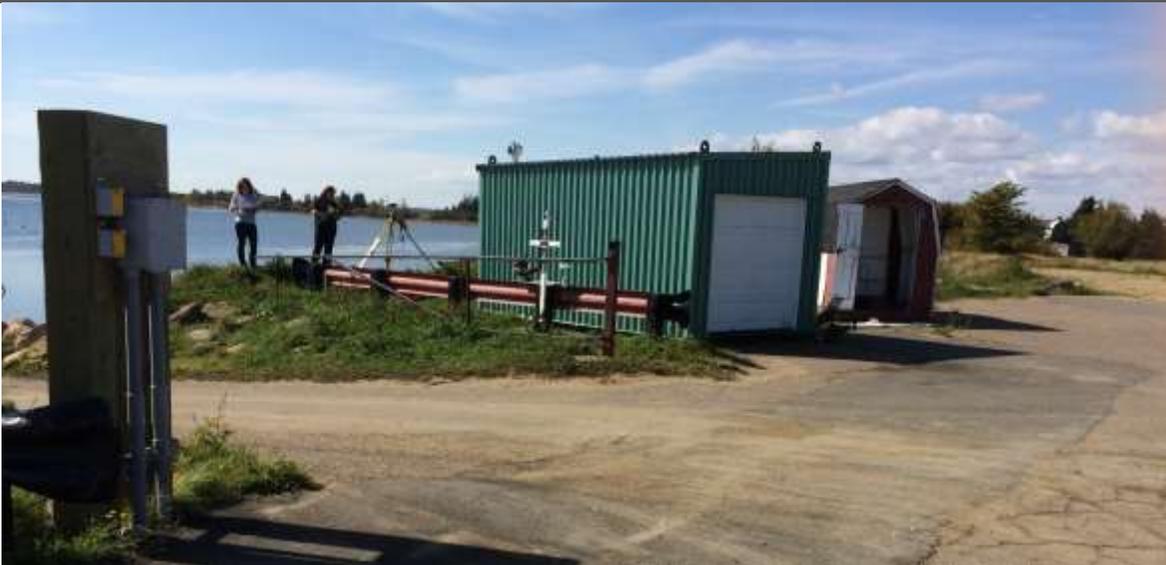
Figure 6 GPS base setup over CHS benchmark 88B9004. Note the memorial built on the guard rail for the fisherman who died after they ran aground in 2013.

The GPS base station was set to log observations at 1 second intervals and the RTK rover was used to collect lidar validation points on hard flat surfaces (Figure 6). These validation points were collected at the parking lot adjacent to the wharf as well as the wharf deck. The survey area was constrained to the coastal areas so there were very few roads that could be used to collect GPS check points to be used for validation (Figure 7). Depth measurements were taken with low precision echo sounders as well as manually using a graduated rope with the Secchi disk. These were measures of depth to the bottom from the water surface and positioned using a code based GPS solution from a Garmin 760, which has a horizontal accuracy of several metres. To compare to the lidar depth, which is measured relative to the chart datum, the water

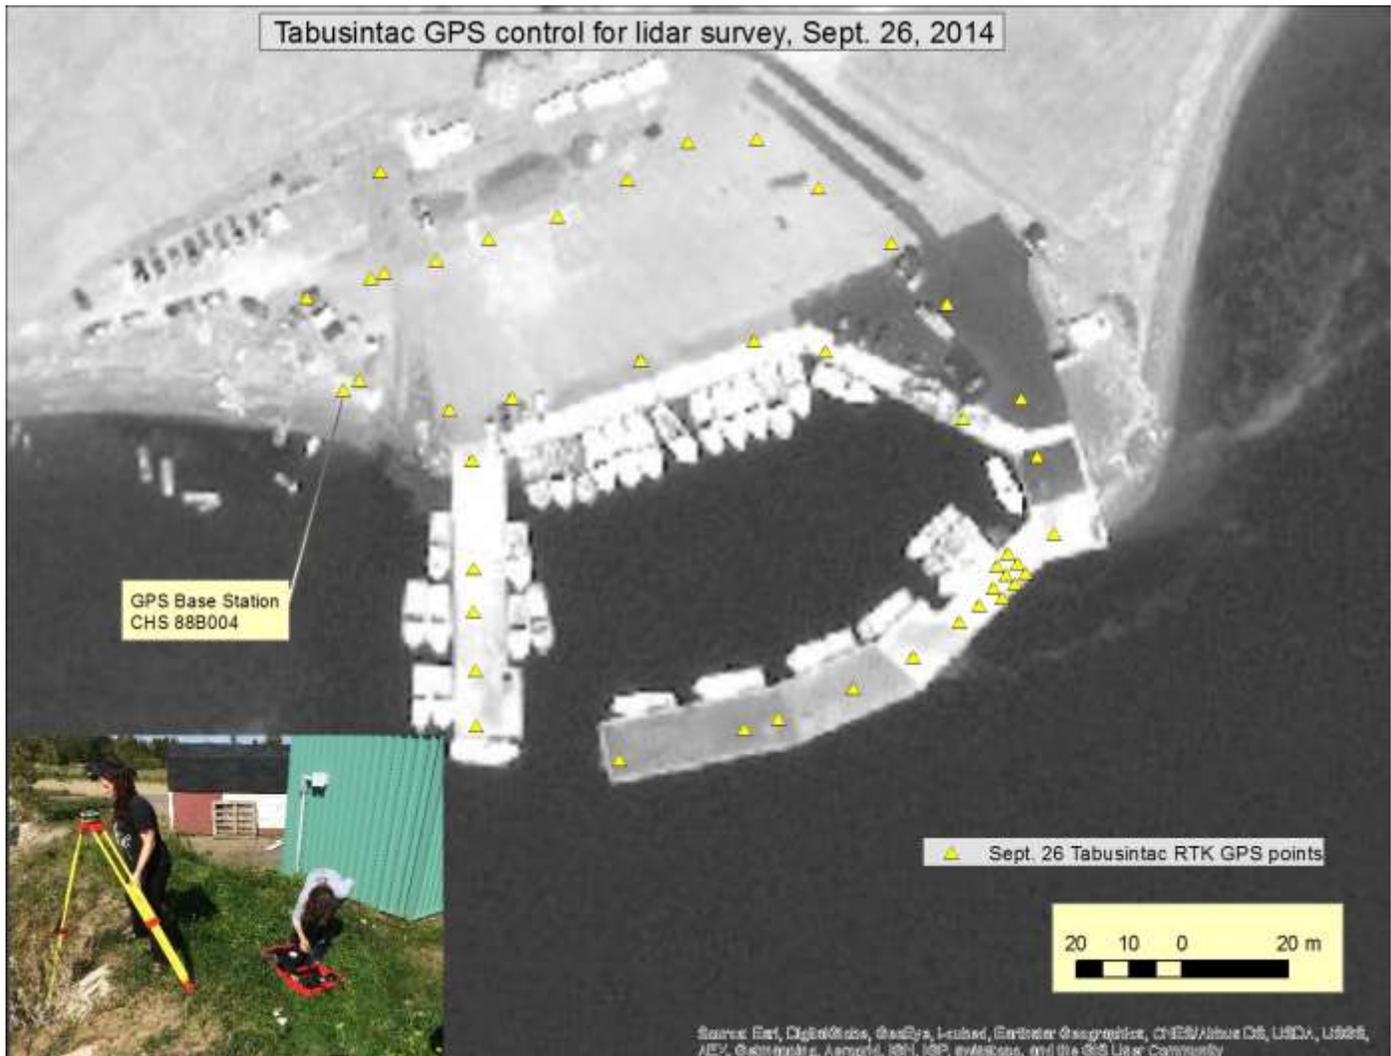
Figure 7 Survey grade GPS base station for aircraft trajectory and RTK check points.

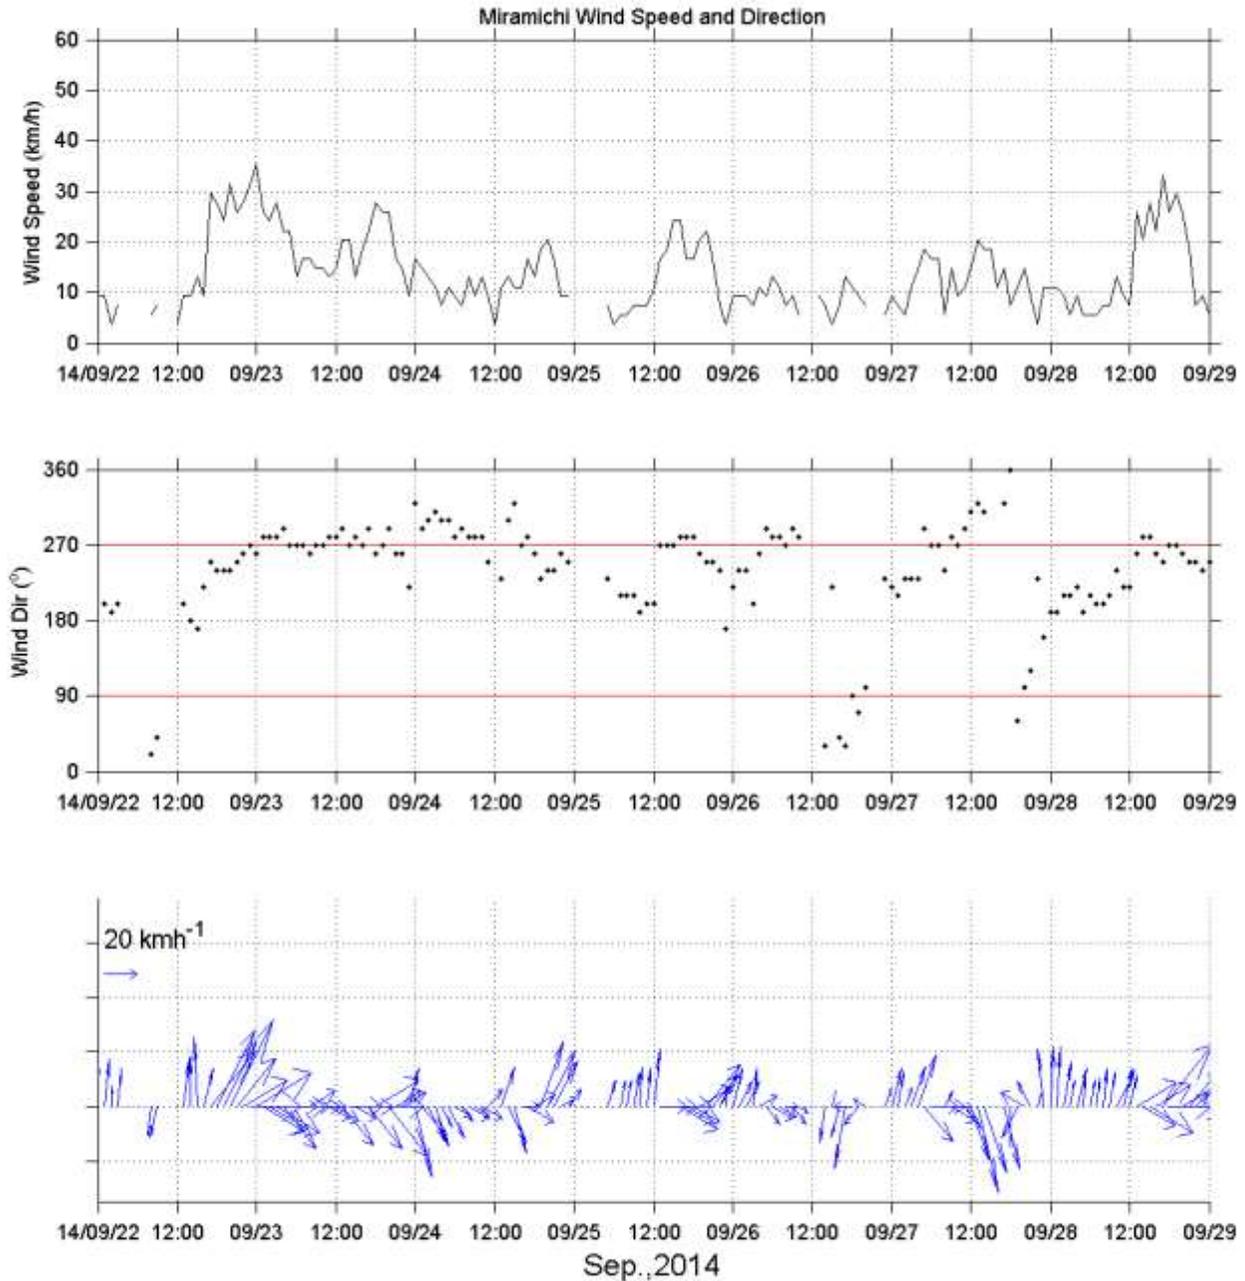
Figure 8: Wind speed (top panel) and direction (middle panel, where the wind is blowing from the direction shown) from Environment Canada weather station at Miramichi, NB. The lower panel shows vectors representing the direction the wind is blowing towards. Note the lower wind speeds preceding and during the lidar flight on Sept. 26.

Figure 8 shows wind data recorded at Miramichi in the days before the survey and shows a strong northerly wind event on Sept. 23. The wind speed slowed and rotated to the south on the 24<sup>th</sup>, then back to the north on the 25<sup>th</sup> to less than 20 km/hr. Prior to this it was reported that the water in the bay was extremely turbid and the bottom could not be seen visually. Eventually the winds died down, and this gave the water in the bay enough time to clear. However, in the very early morning of the 26<sup>th</sup> the winds exceeded 20 km/hr but died off by late morning and did not cause too much increased turbidity. From noon onward on the 26<sup>th</sup> winds were 10 km/hr or less from the north. They picked up again on the 27<sup>th</sup> and another event of winds greater than 20 km/hr occurred late on the 28<sup>th</sup>.

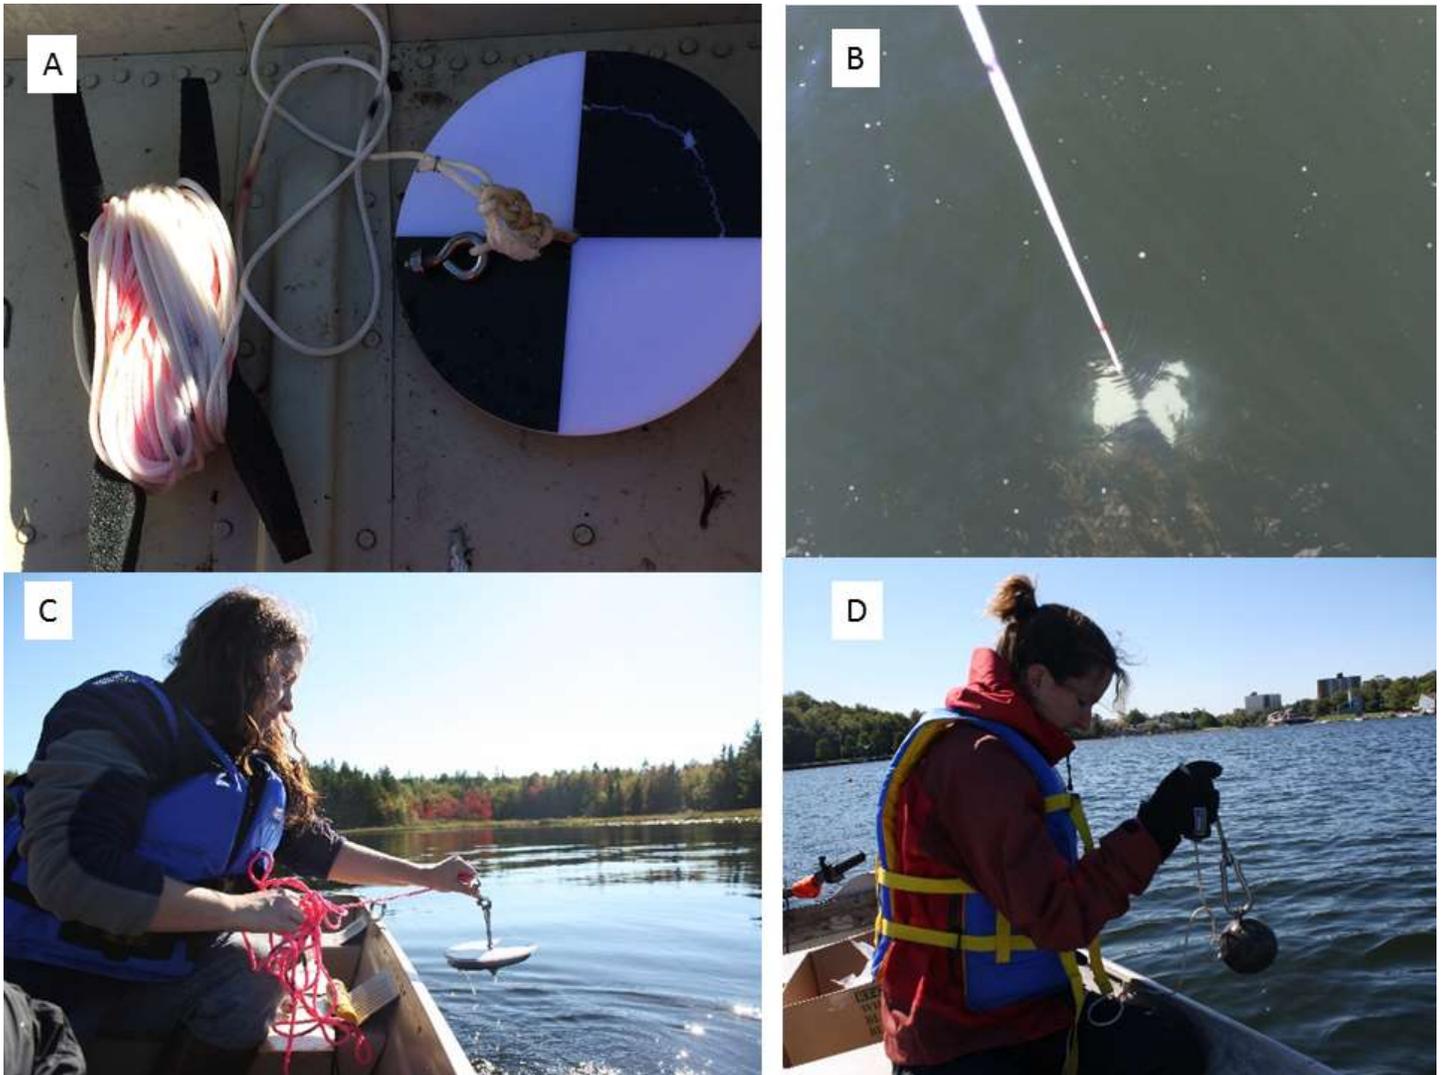
**Figure 9 Example of a Secchi disk used to measure water clarity during the lidar survey. Panel A is the secchi disk with graduated rope. Panel B is the disk lowered in the water until it cannot be seen. Panel C is an AGRG researcher deploying the disk. Panel D is an AGRG researcher using the lead ball for a depth measurement.**

Ground truth data is another important aspect of topo-bathy lidar data collection. A Humminbird echo sounder with a consumer grade GPS was used to survey the depths within the bay and various point observations were made to sample the water column and bottom conditions. The method consisted of taking a Garmin GPS waypoint, taking a Secchi disk measurement and a depth measurement using a lead ball or the Secchi disk (Figure 9), as well dropping a 1 m by 1 m

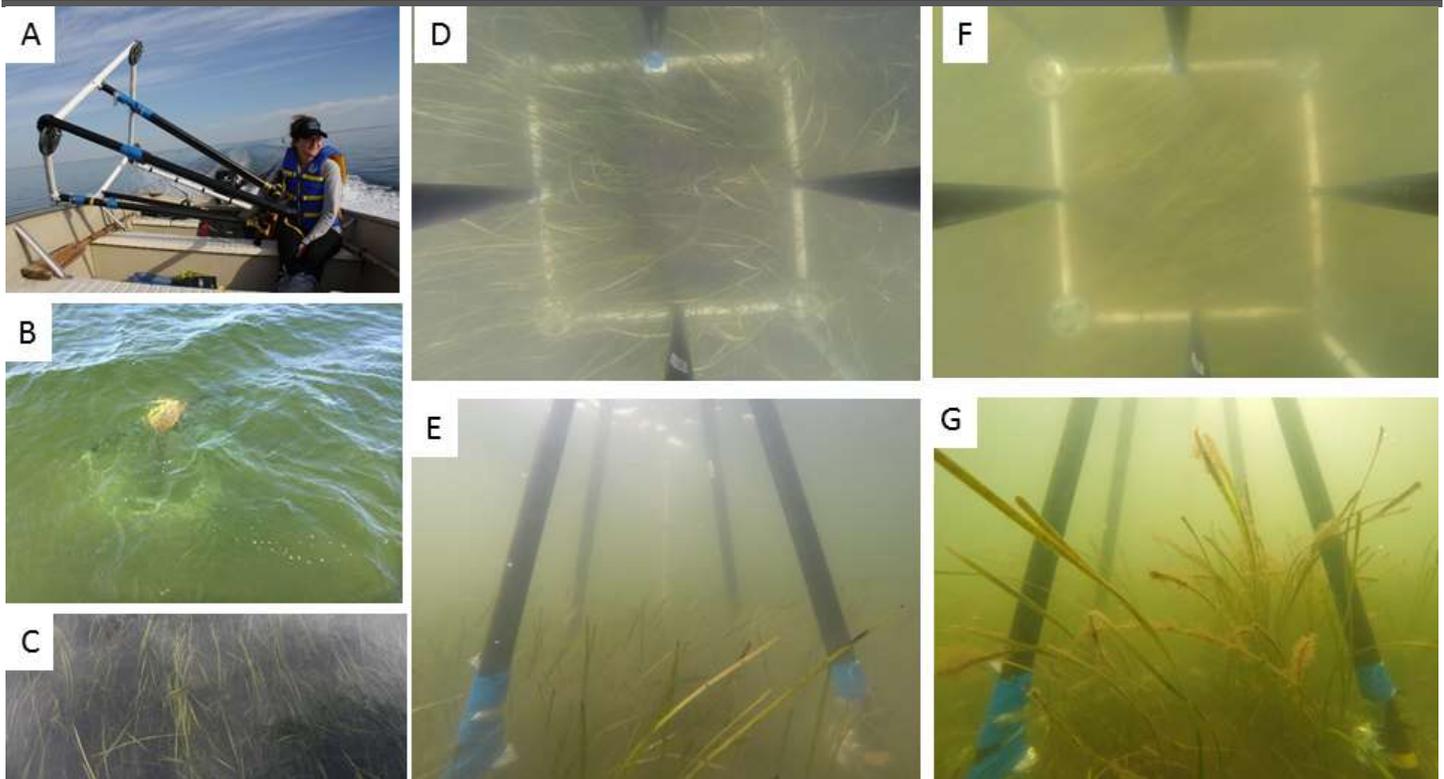
**Figure 10** Example of the 1 m by 1 m quadrat used to photograph the seabed. Panel A shows the quadrat on its side in the boat. Panel B shows it submerged. Panel C shows an example of eelgrass. Panel D and E show quadrat photos of eelgrass from top and side cameras. Panel D and E show quadrat photos of eelgrass with algae from top and side cameras.

As can be seen in the photos in Figure 10 the water clarity was still a bit cloudy on Sept. 26. However, Secchi depth measurements indicated that the disk usually hit the bottom before the disk was no longer visible. The lidar sensor specifications state that the depth penetration is expected to be at least 1.5 times the Secchi depth.

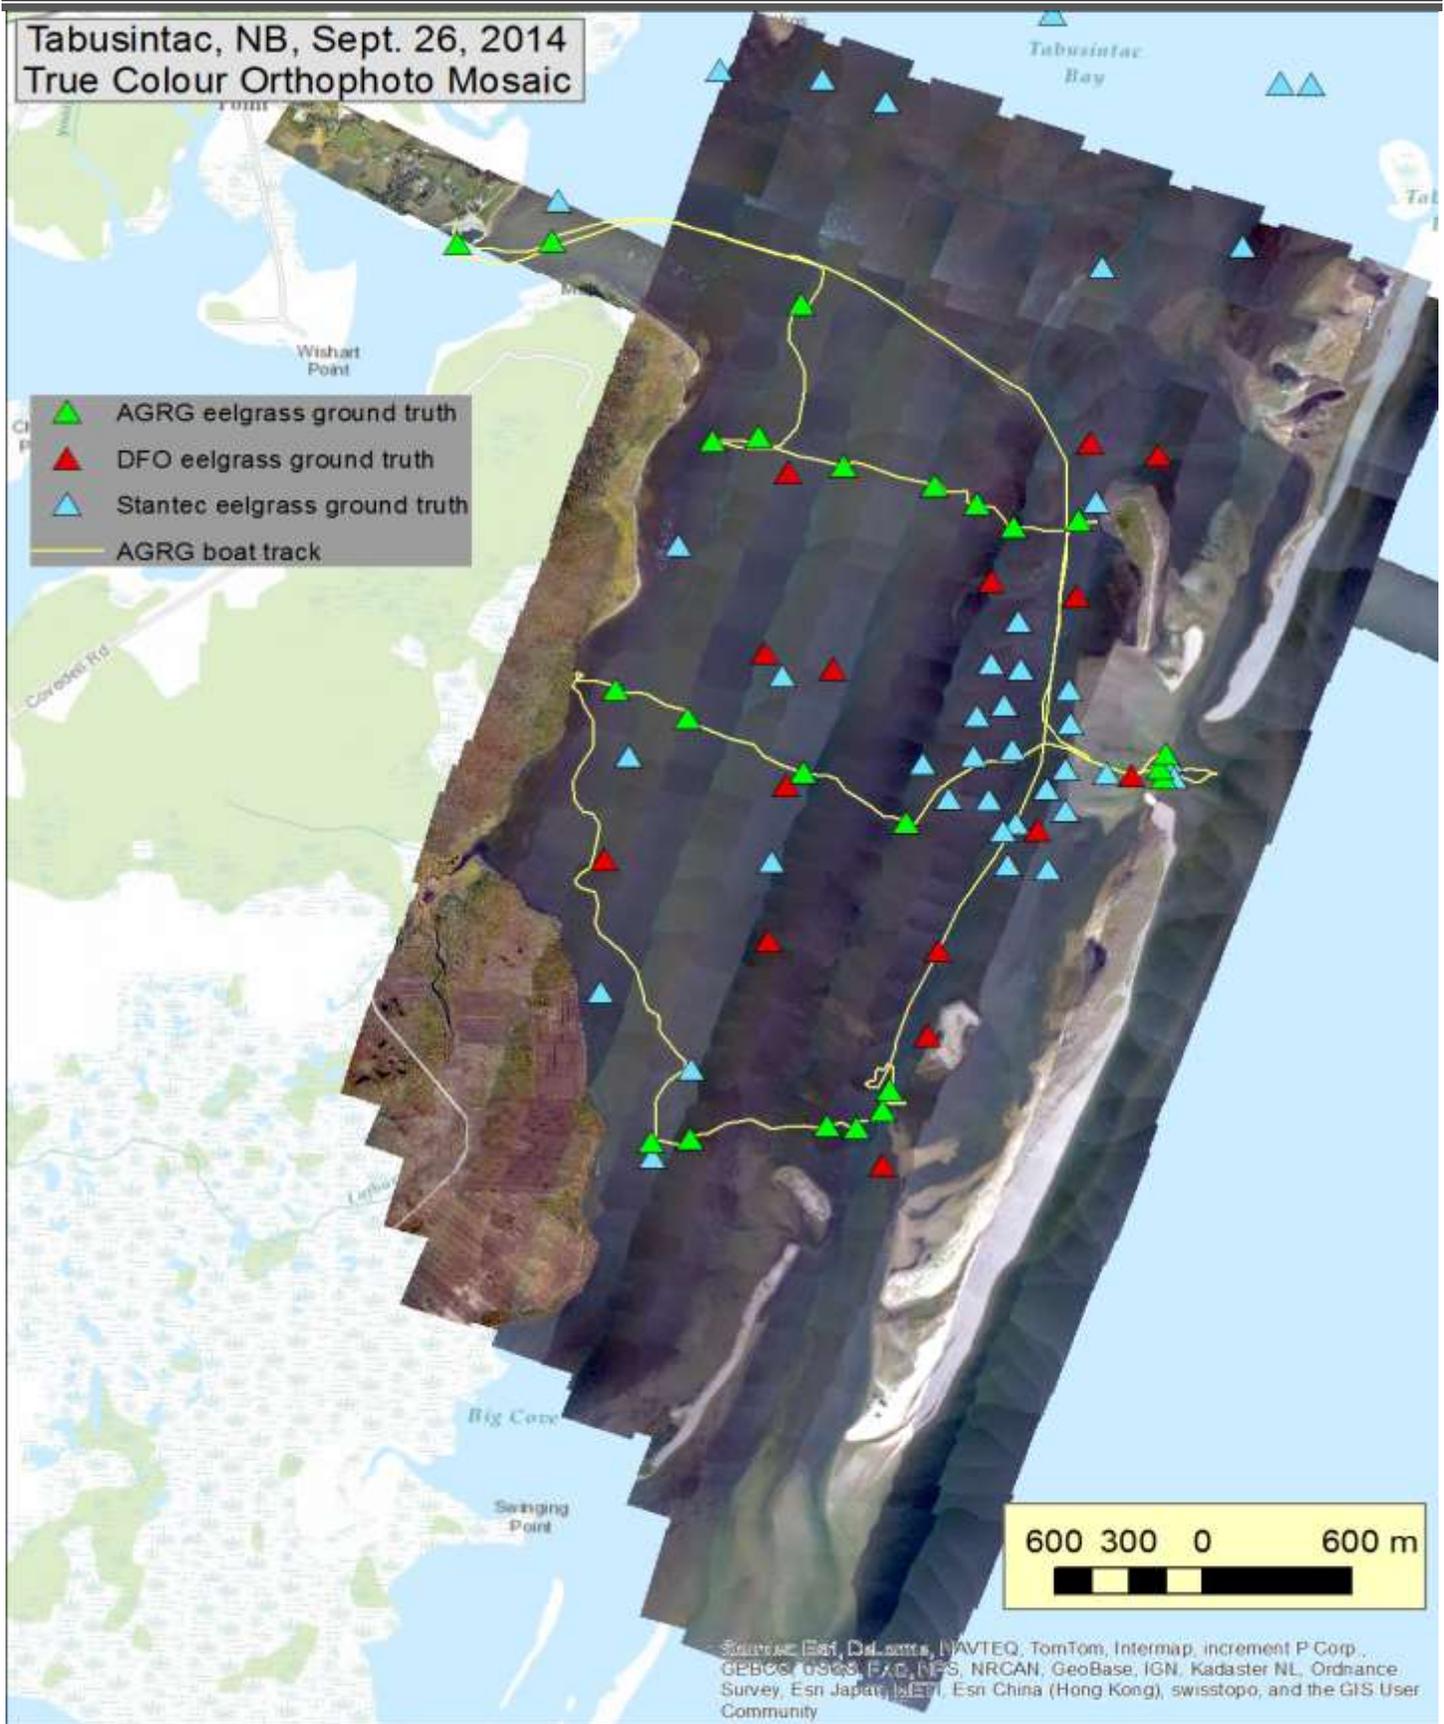
Figure 11 AGRG RCD430 true colour orthophoto mosaic of Tabusintac Bay with eelgrass ground truth survey locations.

In addition to AGRG conducting a ground truth survey, scientists (Marc Ouellette and Monique Niles) from DFO Gulf Region from Moncton, NB also collected information on eelgrass near the time of the survey. As well Marc Skinner from Stantec Consulting collected ground truth information on eelgrass as part of a study to use World View 2 satellite imagery to map eelgrass in the bay. The location of the ground truth surveys of the three parties is presented in Figure 11 along with the track of the boat used by AGRG during the sampling campaign. The high resolution aerial photos acquired by the RCD30 system, which is part of the Chirptera II lidar sensor have been processed to orthophotos and used to construct a seamless mosaic of the bay which serves as a backdrop to Figure 11.

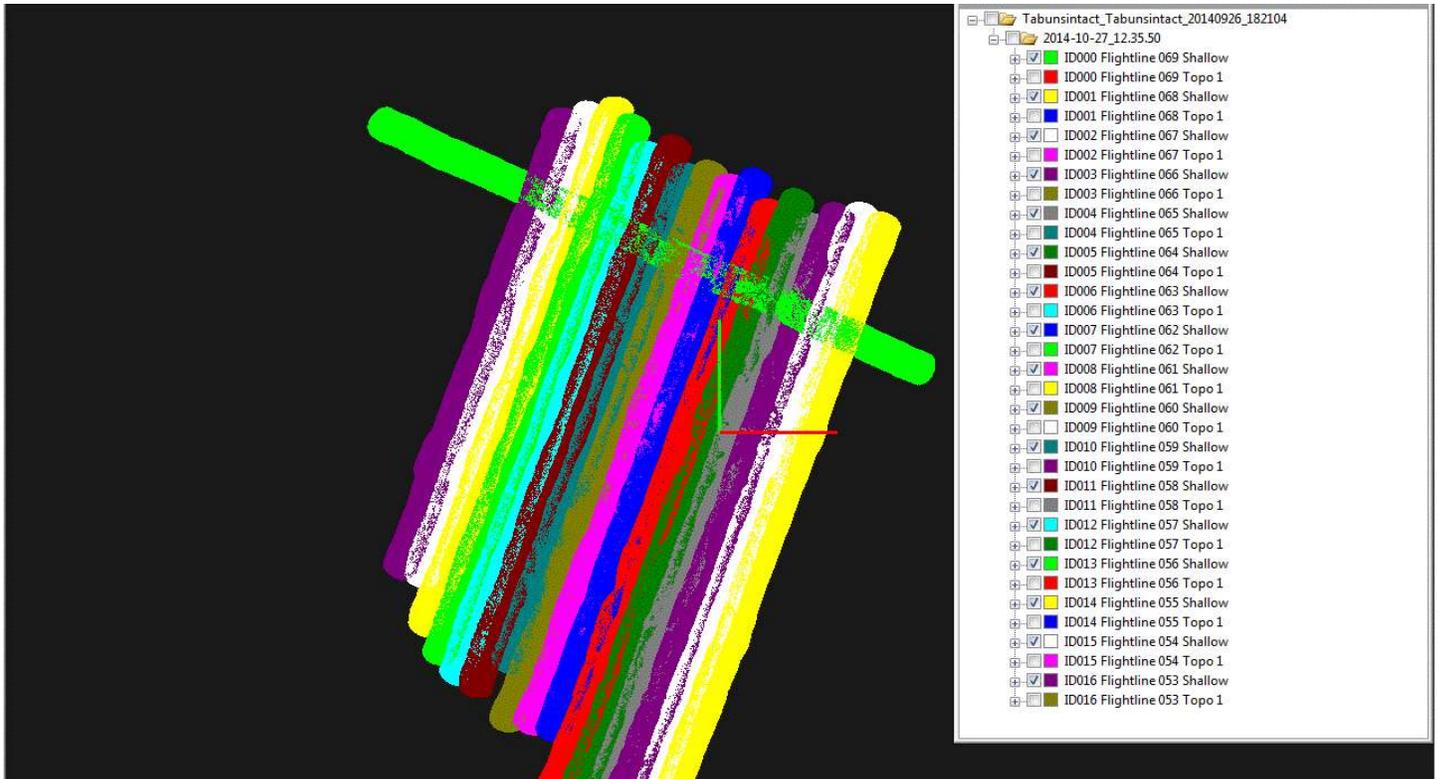
**Figure 12 Swath coverage of lidar flight lines acquired for Tabusintac. The survey was flown with 30% overlap.**

Once the GPS trajectory was processed for the aircraft utilizing the GPS base station and aircraft GPS observations and combined with the inertial measurement unit, the navigation data was linked to the laser returns and georeferenced. Lidar Survey Studio (LSS) software accompanies the Chiroptera II sensor and is used to process the lidar waveforms into discrete points. The data can then be inspected to ensure there was sufficient overlap and no gaps exist in the lidar coverage (Figure 12).

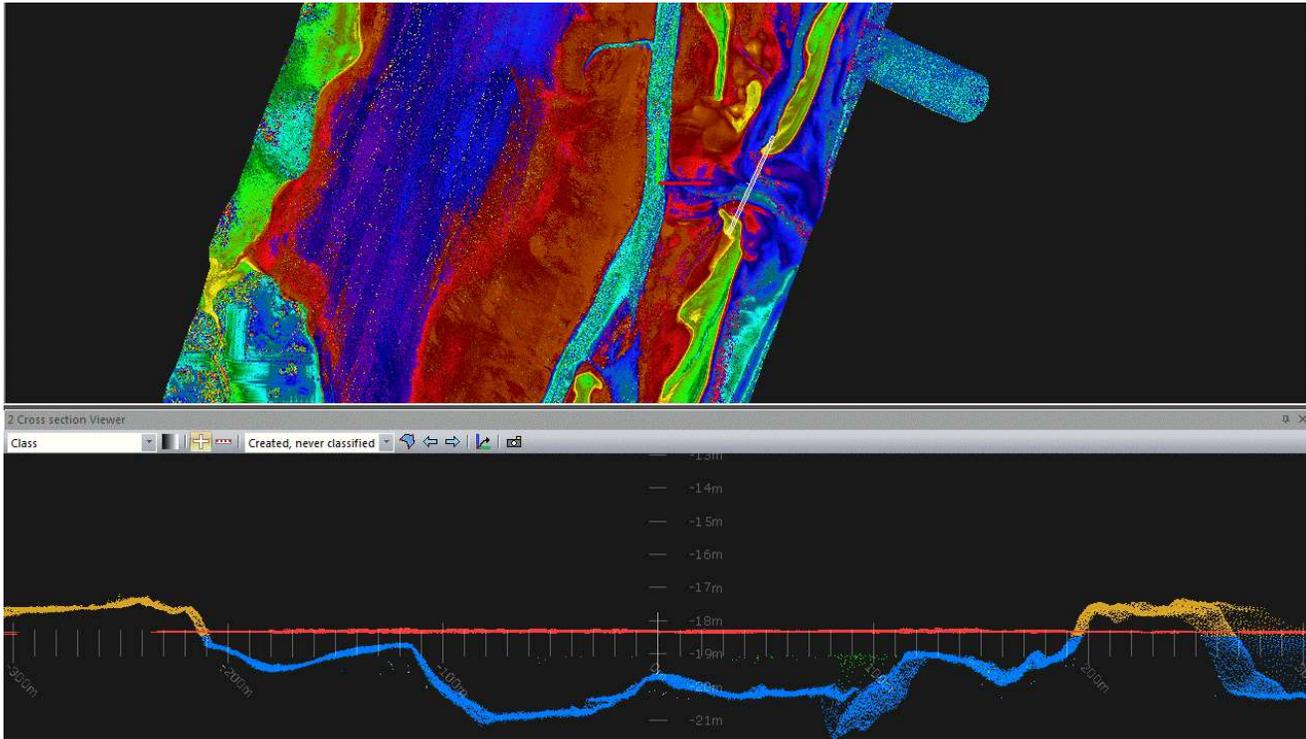
**Figure 13** Example of LSS where the lidar points coloured by elevation and a cross-section extracted across the channel between the two outer dunes. Panel below represents the cross-section where the points are coloured by class; brown is ground, blue is bathymetry, and red is the computed water surface.

in cross-section view (Figure 13). The waveforms can be queried for each point so that the location of the waveform peak can be identified and the type of point defined, for example water surface and bathymetry (Figure 14).

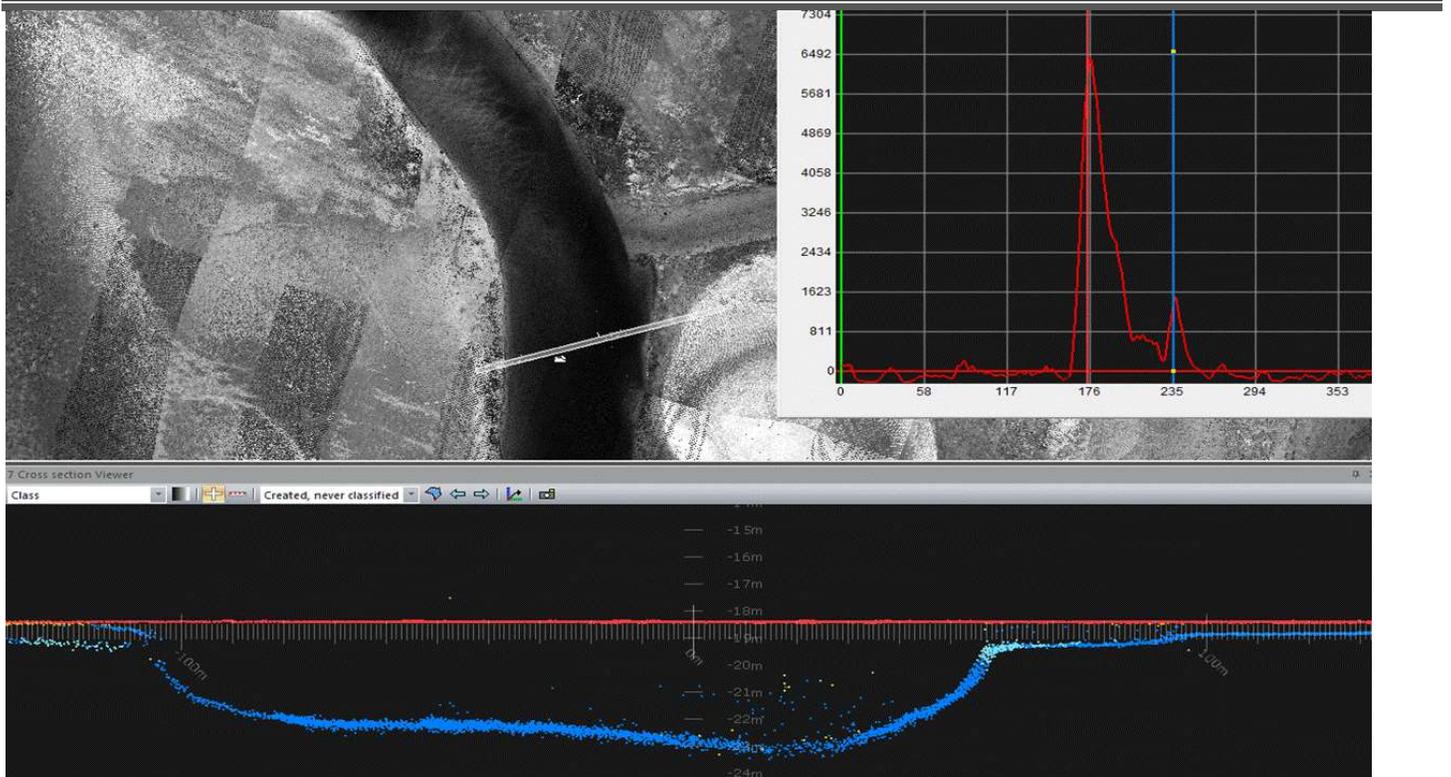
**Figure 14** Example of LSS waveforms. The background image represents the lidar points in greyscale representing the green laser reflectance and the cross-section at the channel. The cross section of the classified point is in the lower panel. The right panel is the waveform of the water surface (red vertical line) and seabed (blue line).
