# Tabusintac 2014 Topo-Bathymetric Lidar & Eelgrass Mapping Report

Public Works Government  
Services Canada

January, 2015

# PWGSC Bathymetric Lidar Report – Tabusintac, NB

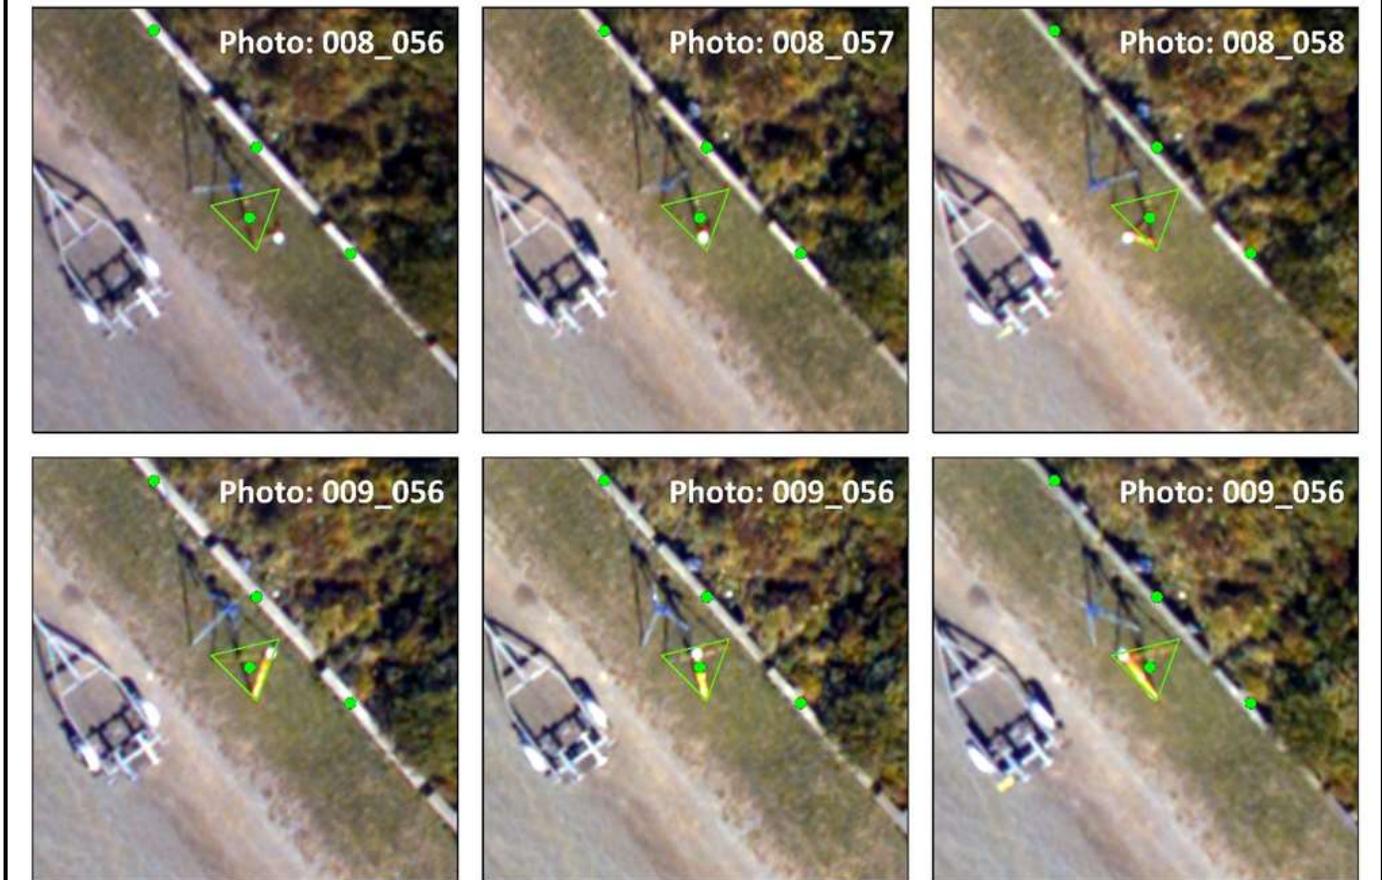
## Little Harbour Ortho Photos: RCD30 Camera Calibration

Figure 15: Example of multiple frames (56, 57, and 58) from multiple flight lines (008 on top and 009 below) of the GPS base station location at Little Harbour after orthorectification. The green dots are GPS locations along the parking lot rail and the aircraft control benchmark on the ground below the tripod where the bottom of the legs are represented by the green diamond.

The RCD30 60 MPIX imagery was processed using the aircraft trajectory and direct georeferencing. The low altitude and high resolution of the imagery required that the lidar data be processed first to produce bare-earth digital elevation models (DEMs) that were used in the orthorectification process. The aircraft trajectory, which blends the GPS position and the IMU attitude information into a best estimate of the overall position and orientation of the aircraft during the survey. This trajectory, which is linked to the laser shots and photo events by GPS based time tags, is used to define the Exterior Orientation (EO) for each of the RCD30 aerial photos that were acquired. The EO, which has traditionally been calculated by selecting ground control point (x,y, and z) locations relative to the air photo frame and calculating a bundle adjustment, was calculated using direct georeferencing and exploiting the high precision of the navigation system. The EO file defines the camera position (x,y,z) for every exposure as well as the various rotation angles about the x,y and z axis known as omega, phi and kappa. The EO file along with a DEM can be used with the aerial photo to produce a digital orthophoto. Initially processing was attempted to produce the orthophotos without the lidar DEM. This resulted in orthophotos from adjacent frames not lining up. After the lidar data was processed and classified into ground points, the lidar-derived DEM (above and below the water line) was used in the orthorectification process in Erdas Imagine software and satisfactory results were produced. An example from another mission area of the relative alignment between the photos can be seen in Figure 15. In figure 15, the GPS tripod (yellow legs) is setup over our temporary benchmark. The location of the tripod yellow legs and GPS antenna (white dot) move because of the different perspectives of the photo frames and flight lines. A green triangle has been drawn on the figure to represent the base of the tripod and the green dot represents the GPS benchmark on the ground. These features do not change significantly in the photos from frame to frame demonstrating the accuracy of the resultant orthophotos (Figure 15).

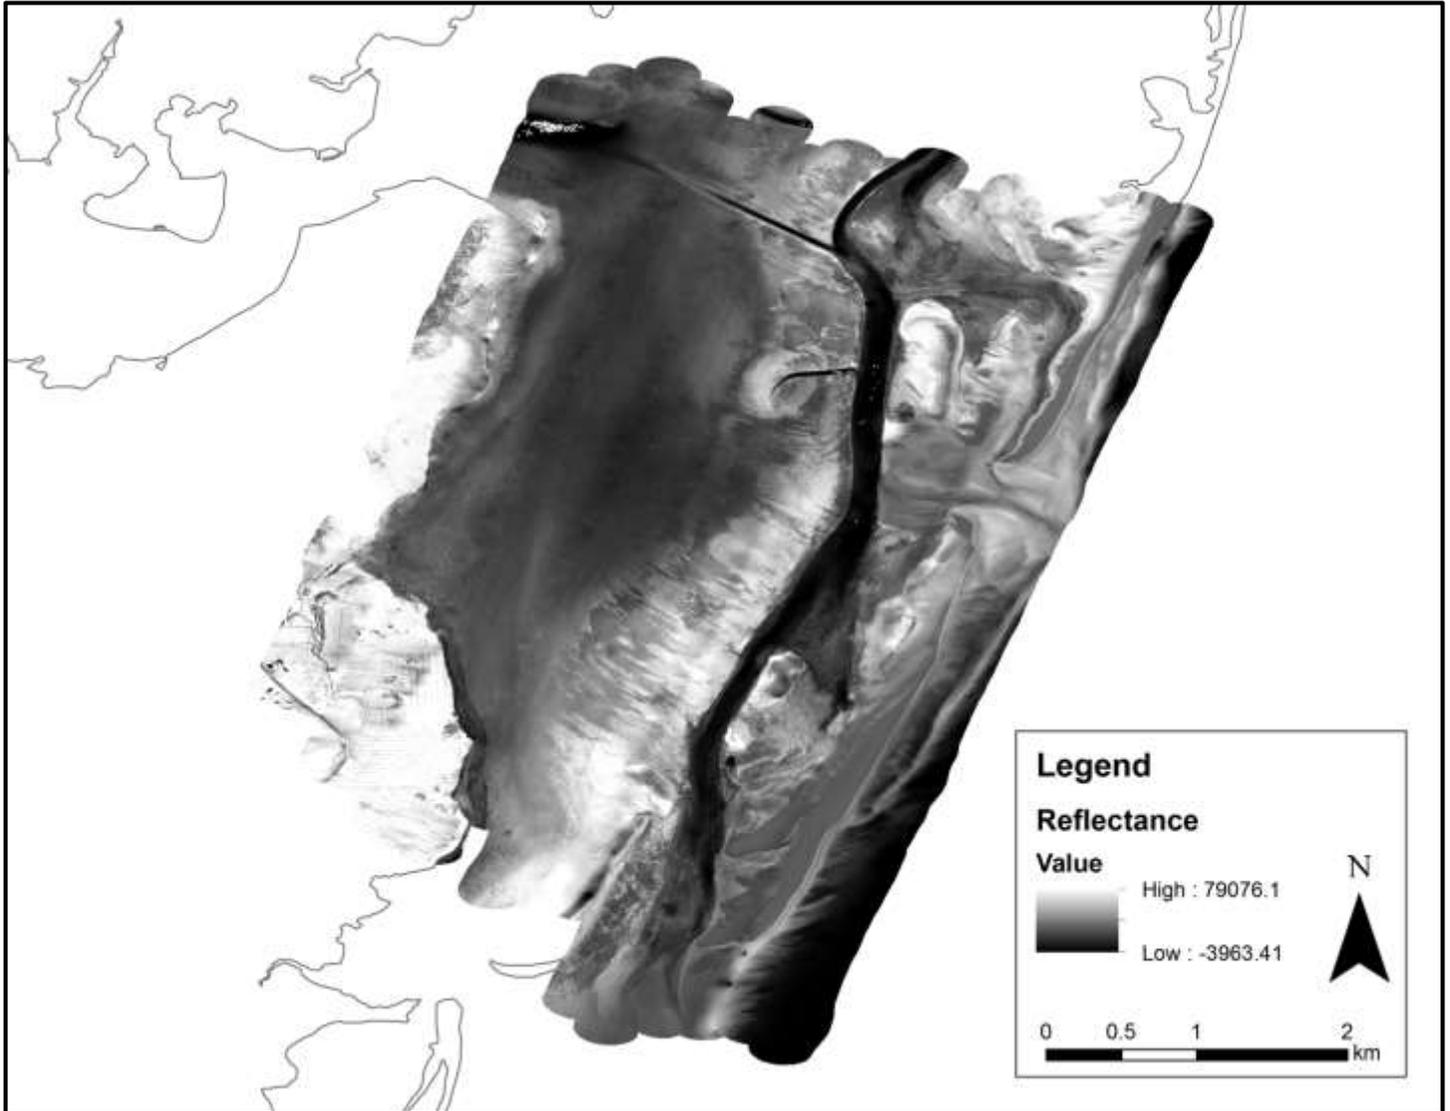
**Figure 16** Example of the green lidar seabed reflectance. High values of reflectance indicate more light is being reflected (less light being absorbed, e.g. bright materials), and low values indicate less light is being reflected (more light being absorbed, e.g. dark materials). Note that this map of reflectance has not been normalized for depth.

The lidar intensity-reflectance data is a measurement of the backscatter of the laser returns, and varies according to bottom type (Figure 16). We expect that research into how reflectance is derived from intensity will lead to more advanced algorithms which will allow us to more accurately classify the bottom type as sand, eelgrass, rockweed, etc.

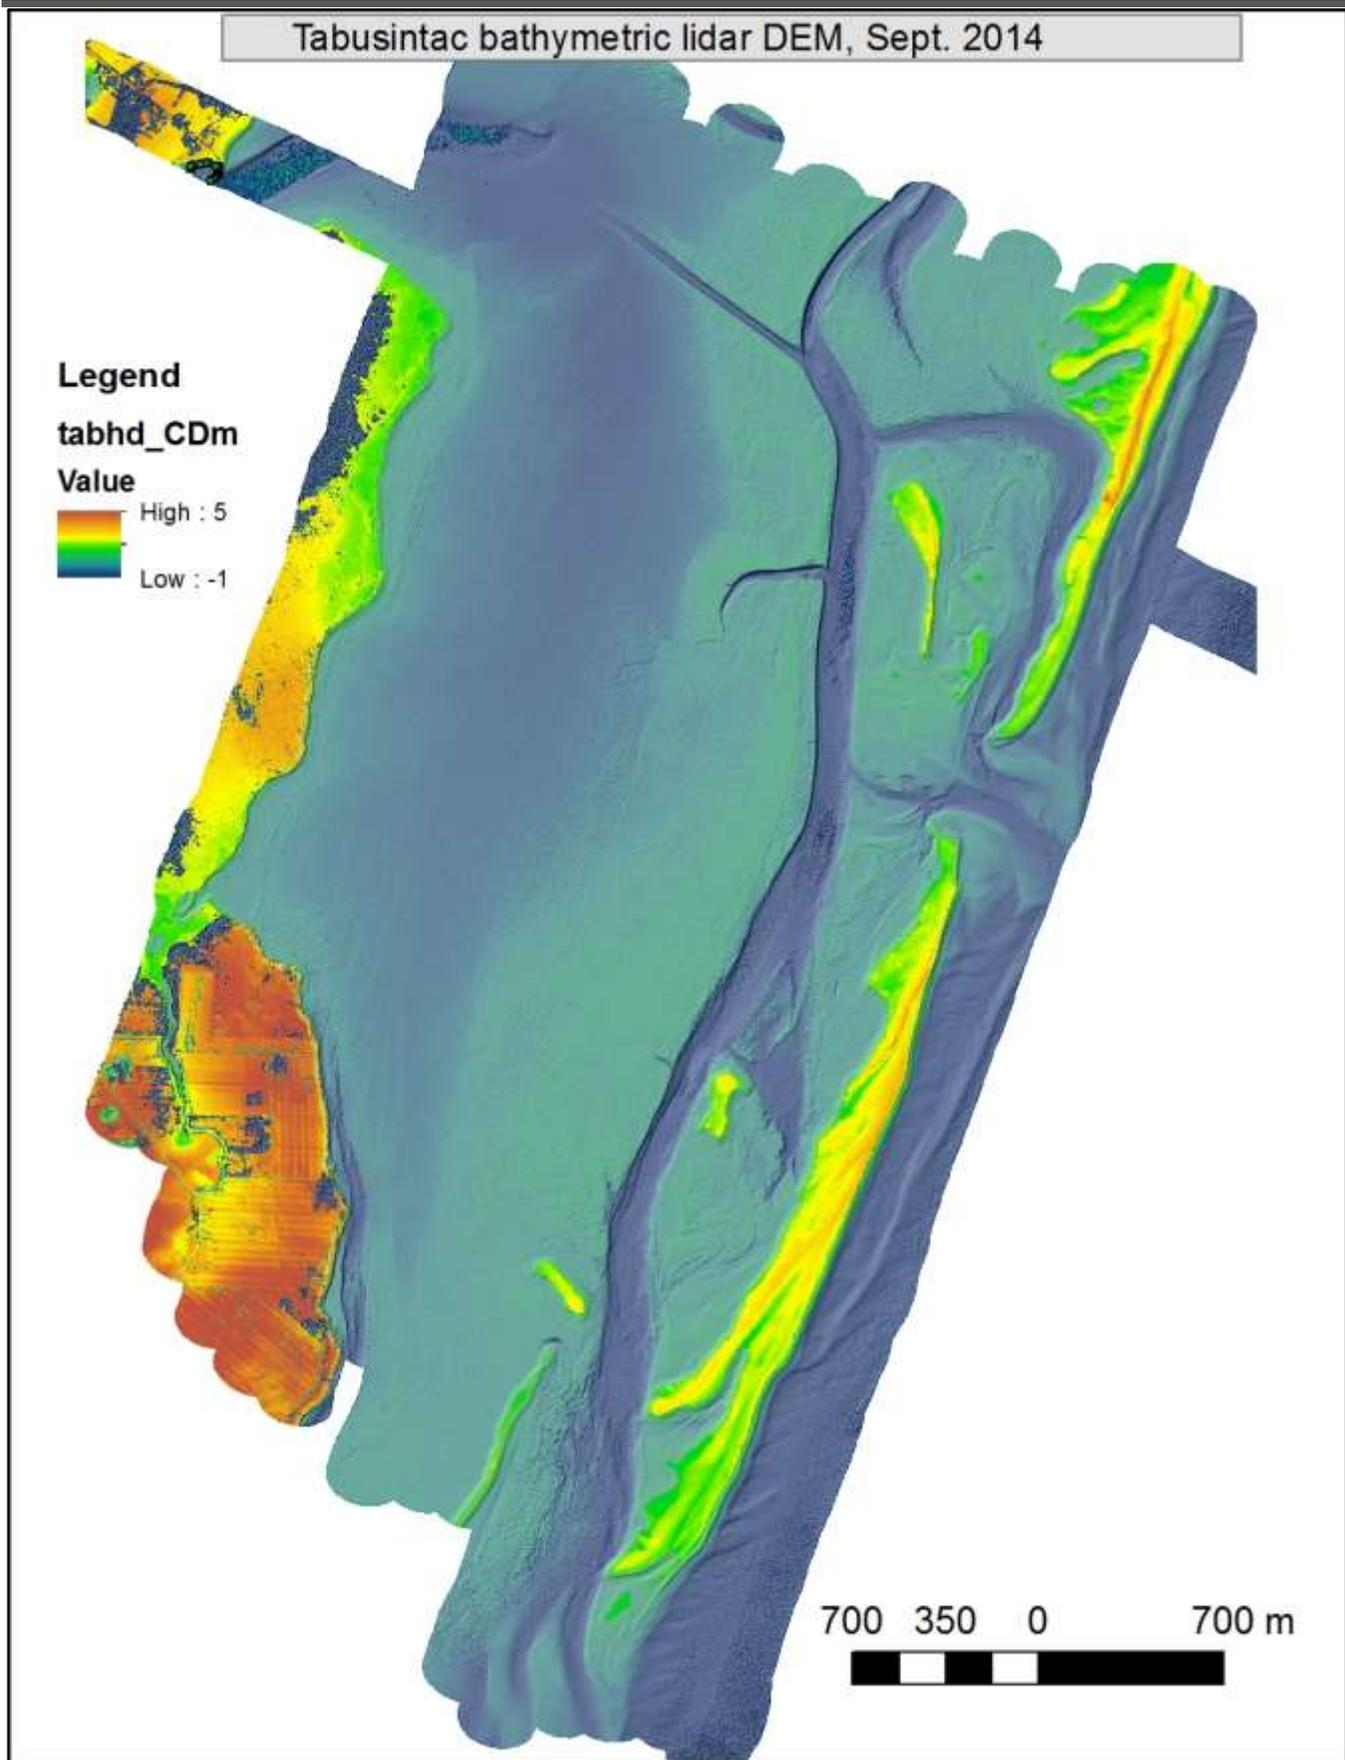
Figure 17 Lidar derived bathymetric map, elevations referenced to chart datum.

The Digital Elevation Model is referenced to chart datum Figure 17.

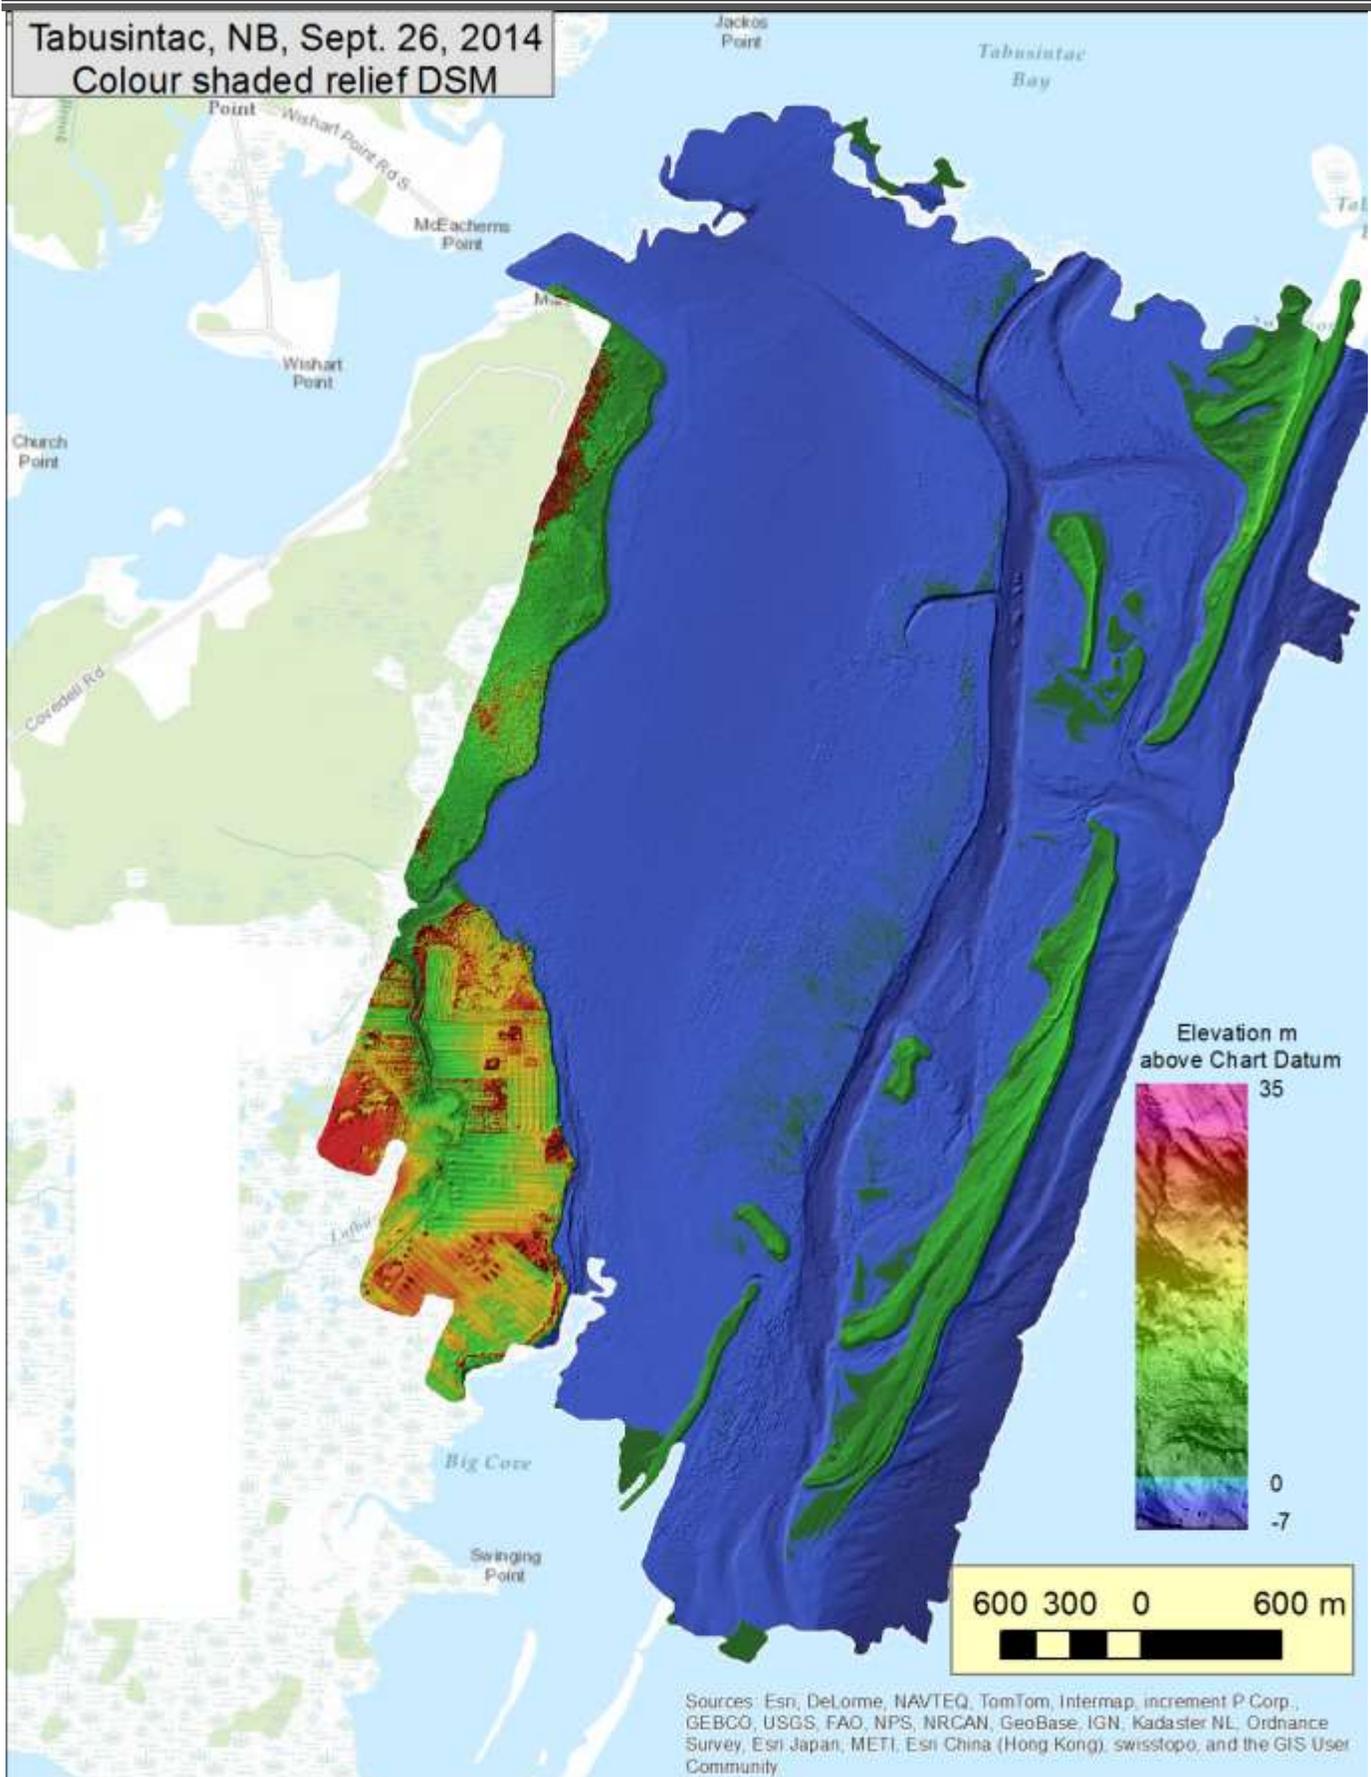
Figure 18 Colour shaded relief map of Tabusintac.

In order to easily interpret the lidar surface models, colour shaded relief (CSR) models were constructed from the DSM for Tabusintac. This map is meant to be for interpretation and is geocoded and compressed in Jpeg 2000 format. If the lidar elevation is required, the lidar DEM or DSM must be used. The CSR map has been colourized to take advantage of Chroma-stereoscopy where the lower elevations are colour coded from the short wavelength blue to higher elevations at longer wavelength red. When the map is viewed with ChromaDepth glasses, it appears in 3-D. The map displays a strong contrast in the physiography and geomorphology of the area, especially in the DEM (Figure 18). The intensity-reflectance was also blended into this map to further enhance the interpretability of the bathymetry and seabed (Figure 19).

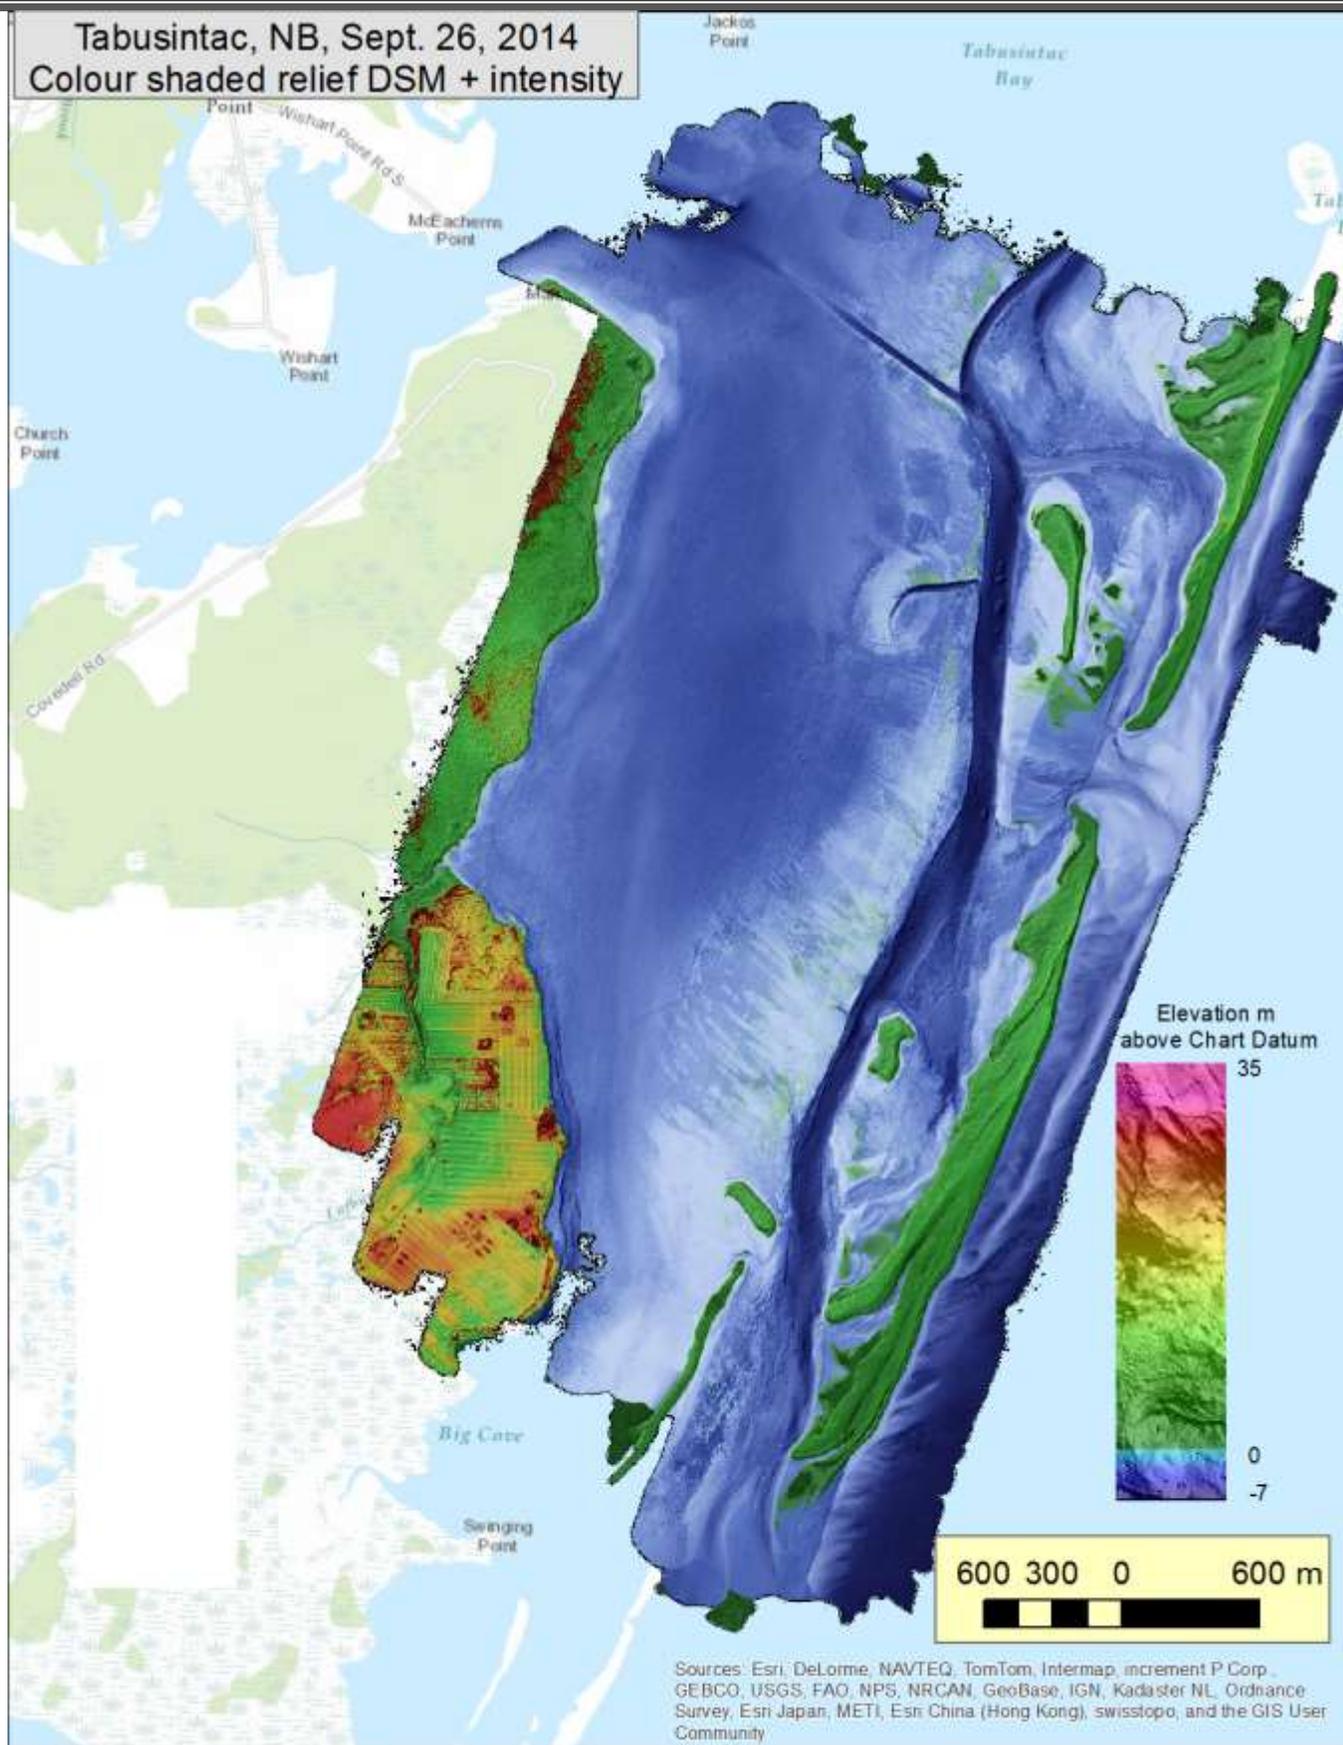
Figure 19 Colour shaded relief with intensity-reflectance map of Tabusintac.

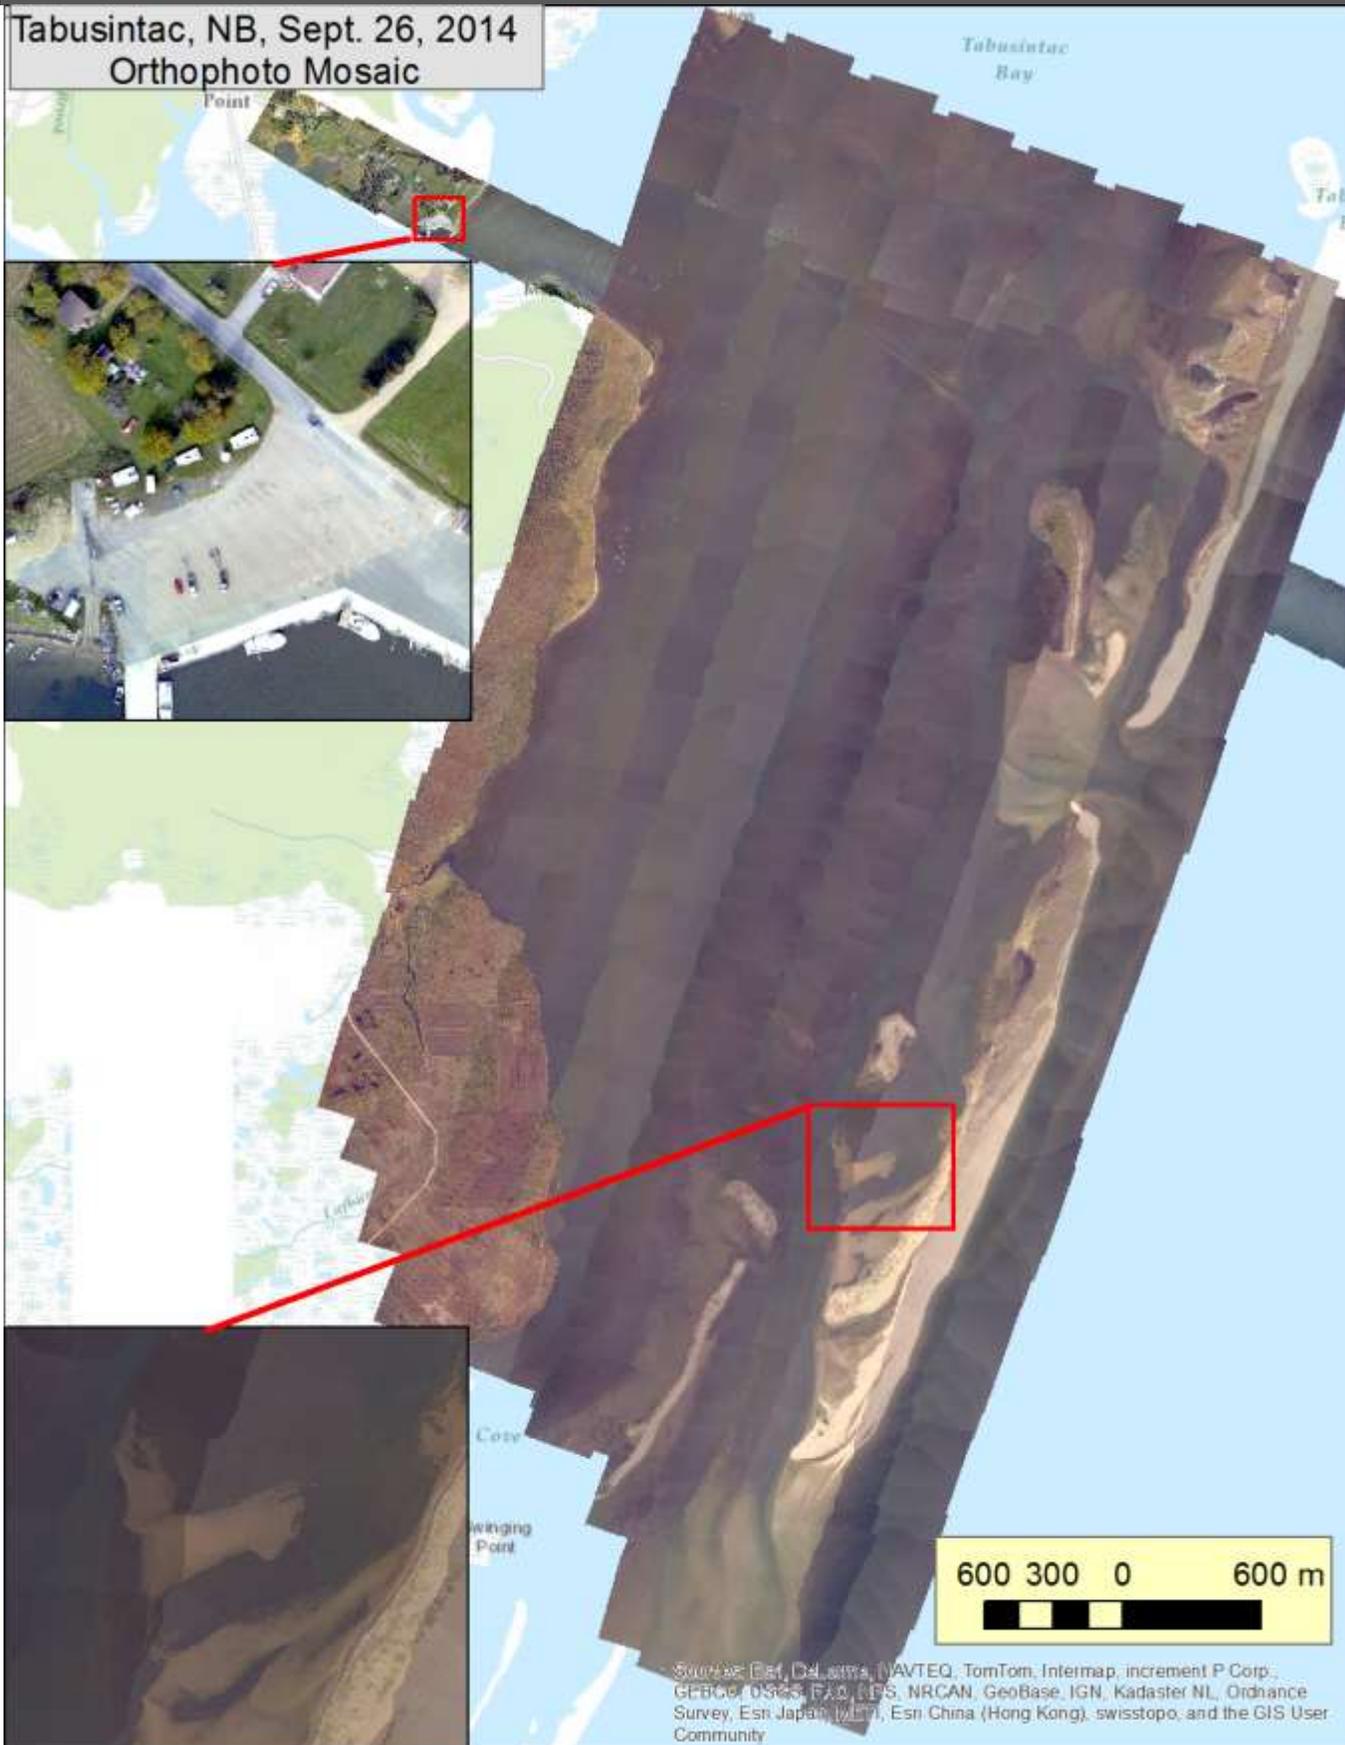
Figure 20 True colour composite of the Tabusintac orthophoto mosaic.

The aerial photos for Tabusintac were taken mid-day and the amount of sunlight was not an issue. Photos taken at this time of day, however, have the potential problem of sun glint over the water. The individual orthophotos were used to build a mosaic where the minimum pixel value was selected for the most nadir image to build the mosaic. This resulted in very few areas in the mosaic where sun glint was a problem and the imagery highlights the seabed very well (Figure 20). The RCD30 camera system used to collect the aerial photographs and produce the orthophotos acquired RGB imager (Figure 20) as well as near-infrared (NIR). A colour NIR composite is also presented to highlight this bands sensitivity to vegetation exposed above the water line and to a lesser degree below the water surface (Figure 21). The seabed is visible on the orthophoto mosaic for shallow areas, however it becomes difficult to interpret the cover in deeper parts of the bay.

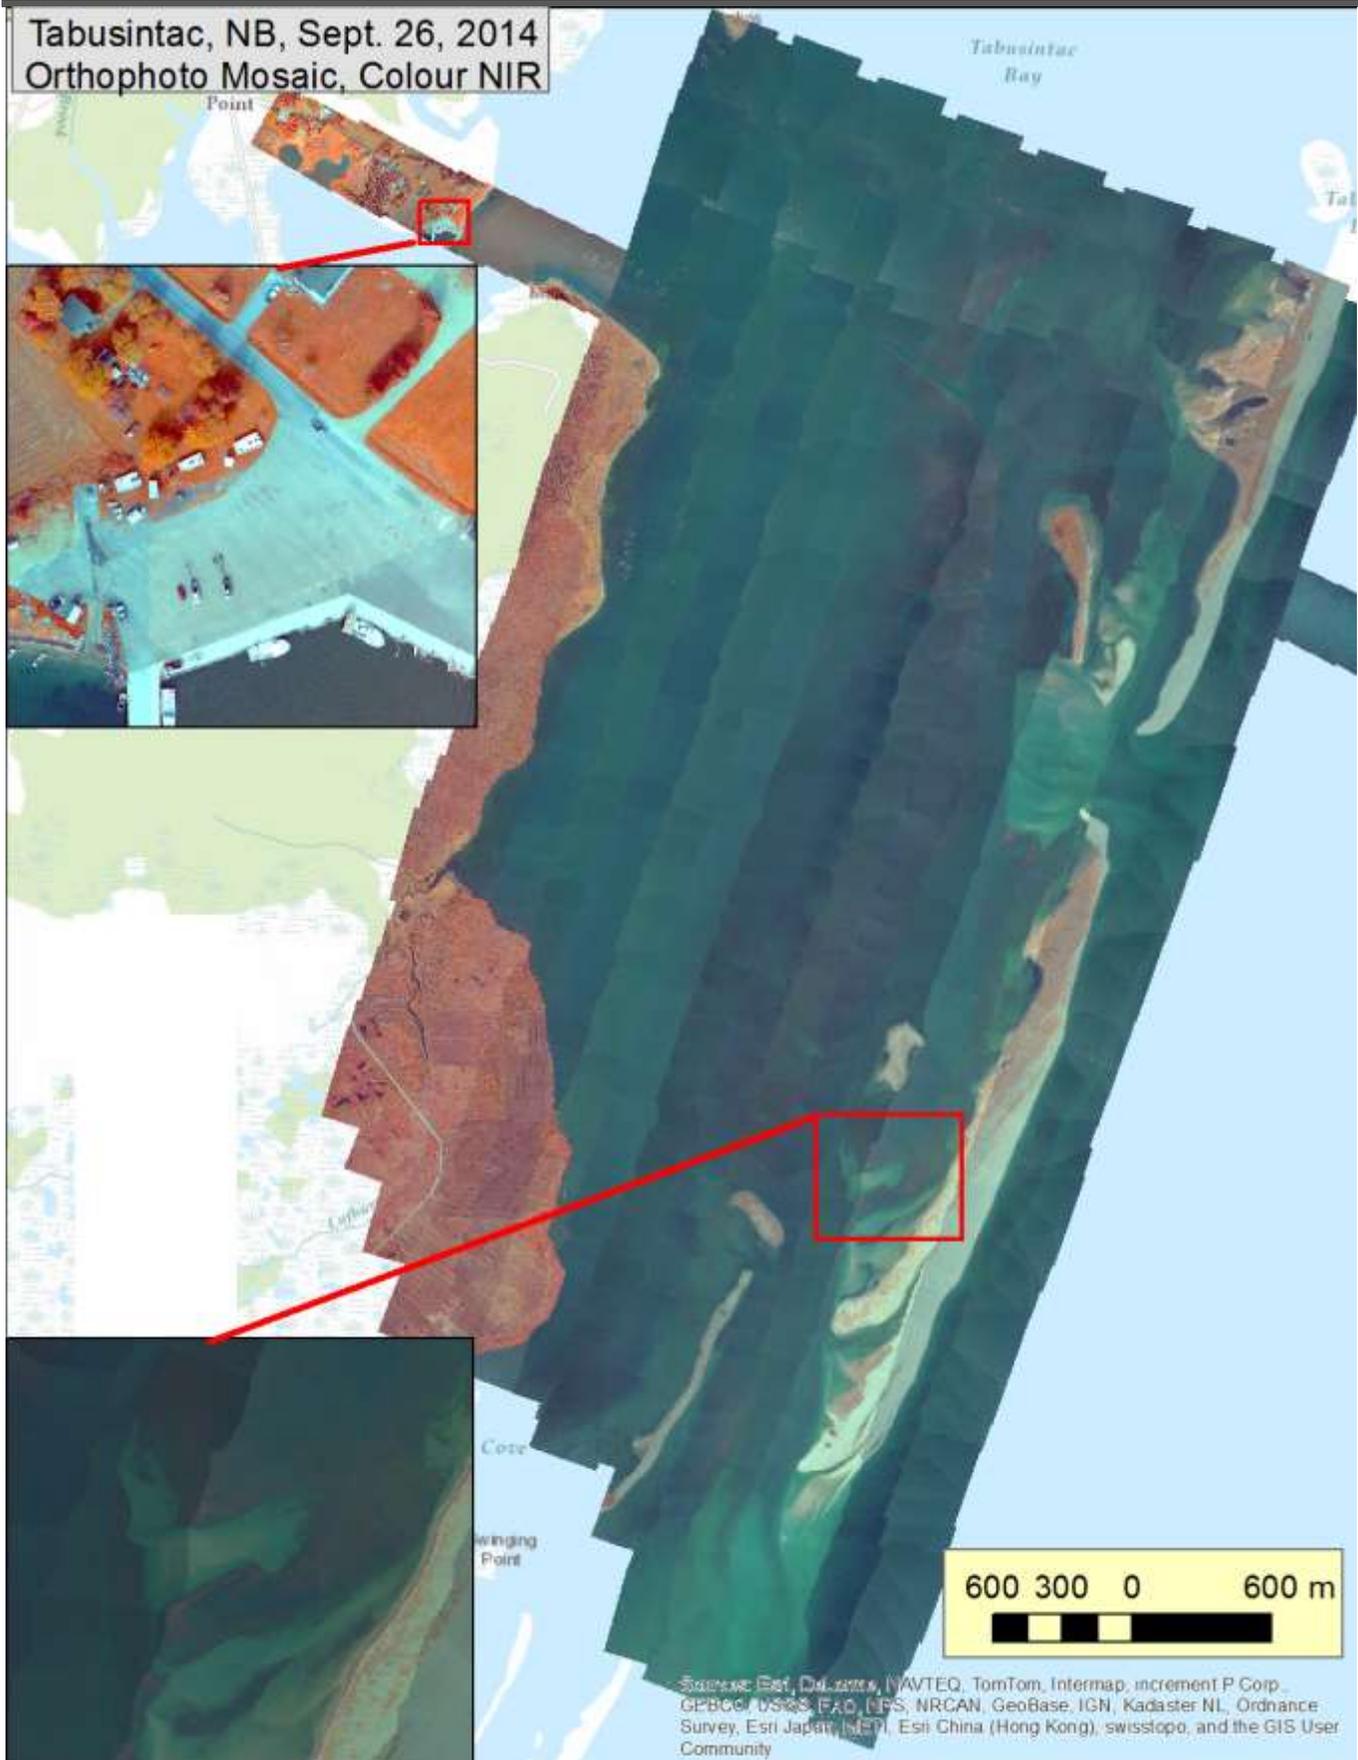
Figure 21 Colour NIR composite of the orthophoto mosaic of Tabusintac.

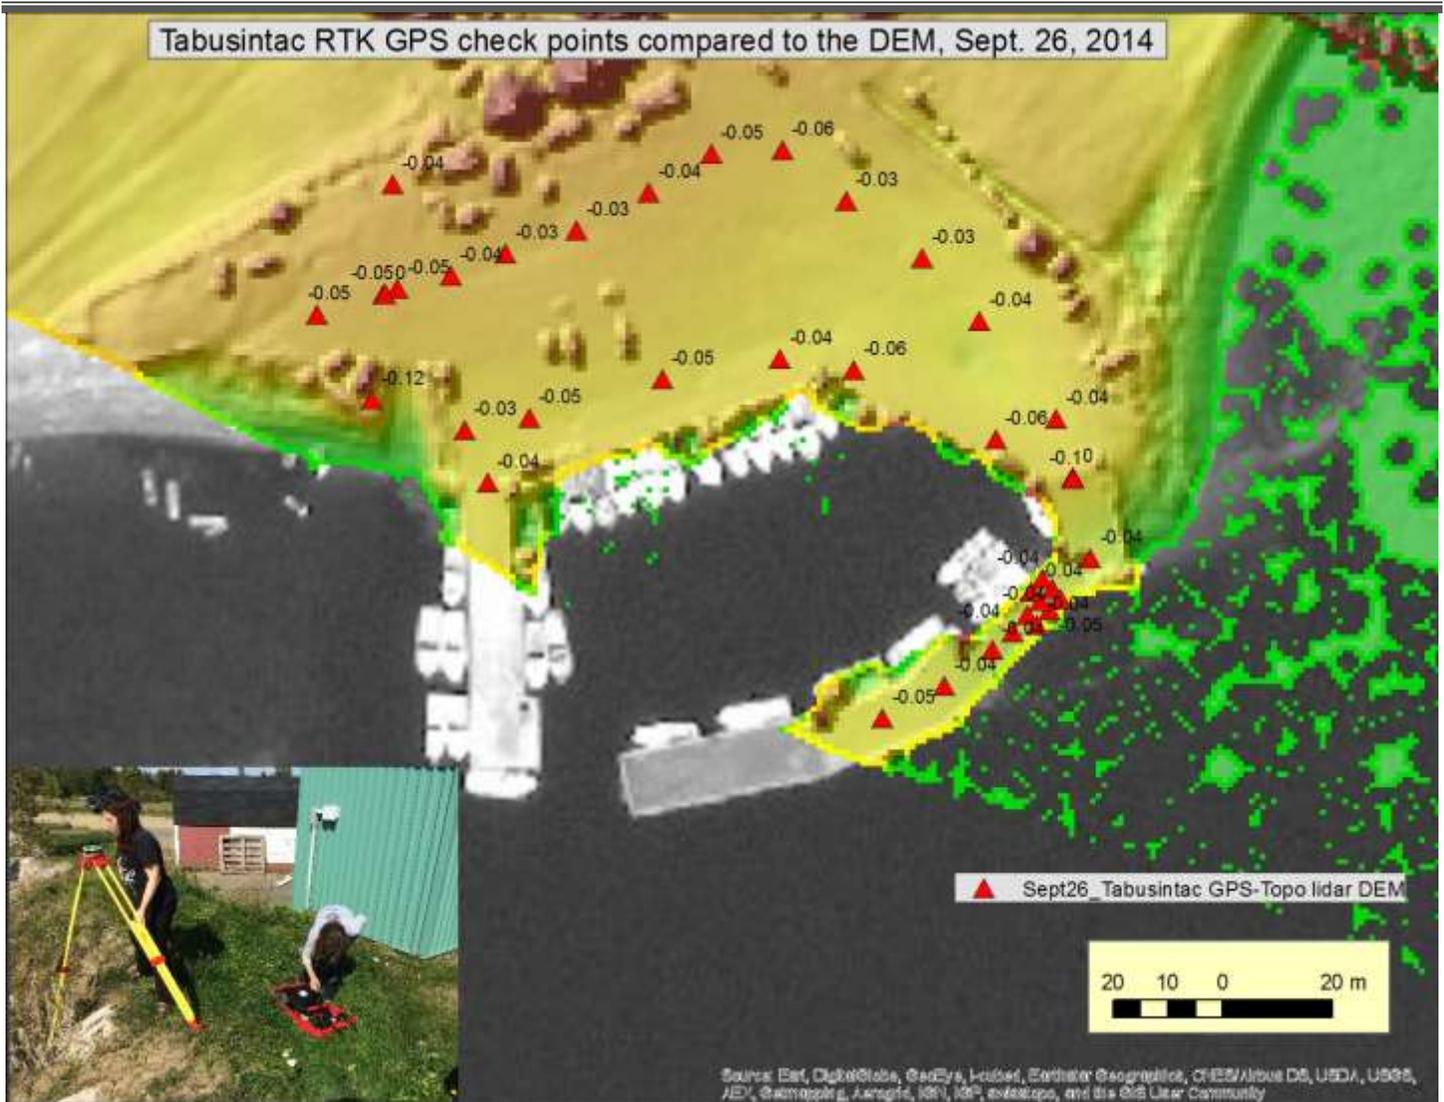
**Figure 23 DEM derived from the topo laser at 2 m grid cells with the RTK GPS checkpoints overlaid (red triangles). The labels indicate the difference in elevation between the GPS and lidar DEM in metres.**

As can be seen in Figure 23 there is good agreement between the GPS check points and the lidar DEM. Figure 24 shows the frequency distribution of the difference in elevation between the GPS and DEM. The majority of the data show a difference very close to zero and are roughly symmetric about zero. The mean difference in elevation is 5 cm with a standard deviation of 2 cm for the 37 checkpoints around the wharf, which were mostly points were collected on hard flat surfaces. In general it appears that the DEM may be too high by 5 cm, although this difference is well within the specifications of the vertical accuracy of the lidar.

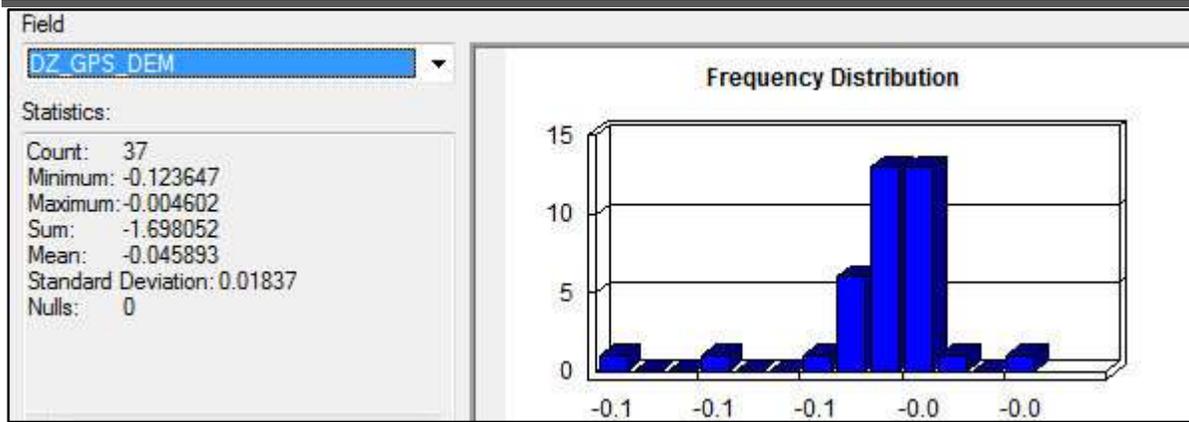
**Figure 24 Histogram of the difference in elevation, DZ, between the GPS checkpoints and the lidar DEM. The mean difference of -0.05 m with a standard deviation of 0.02 m.**

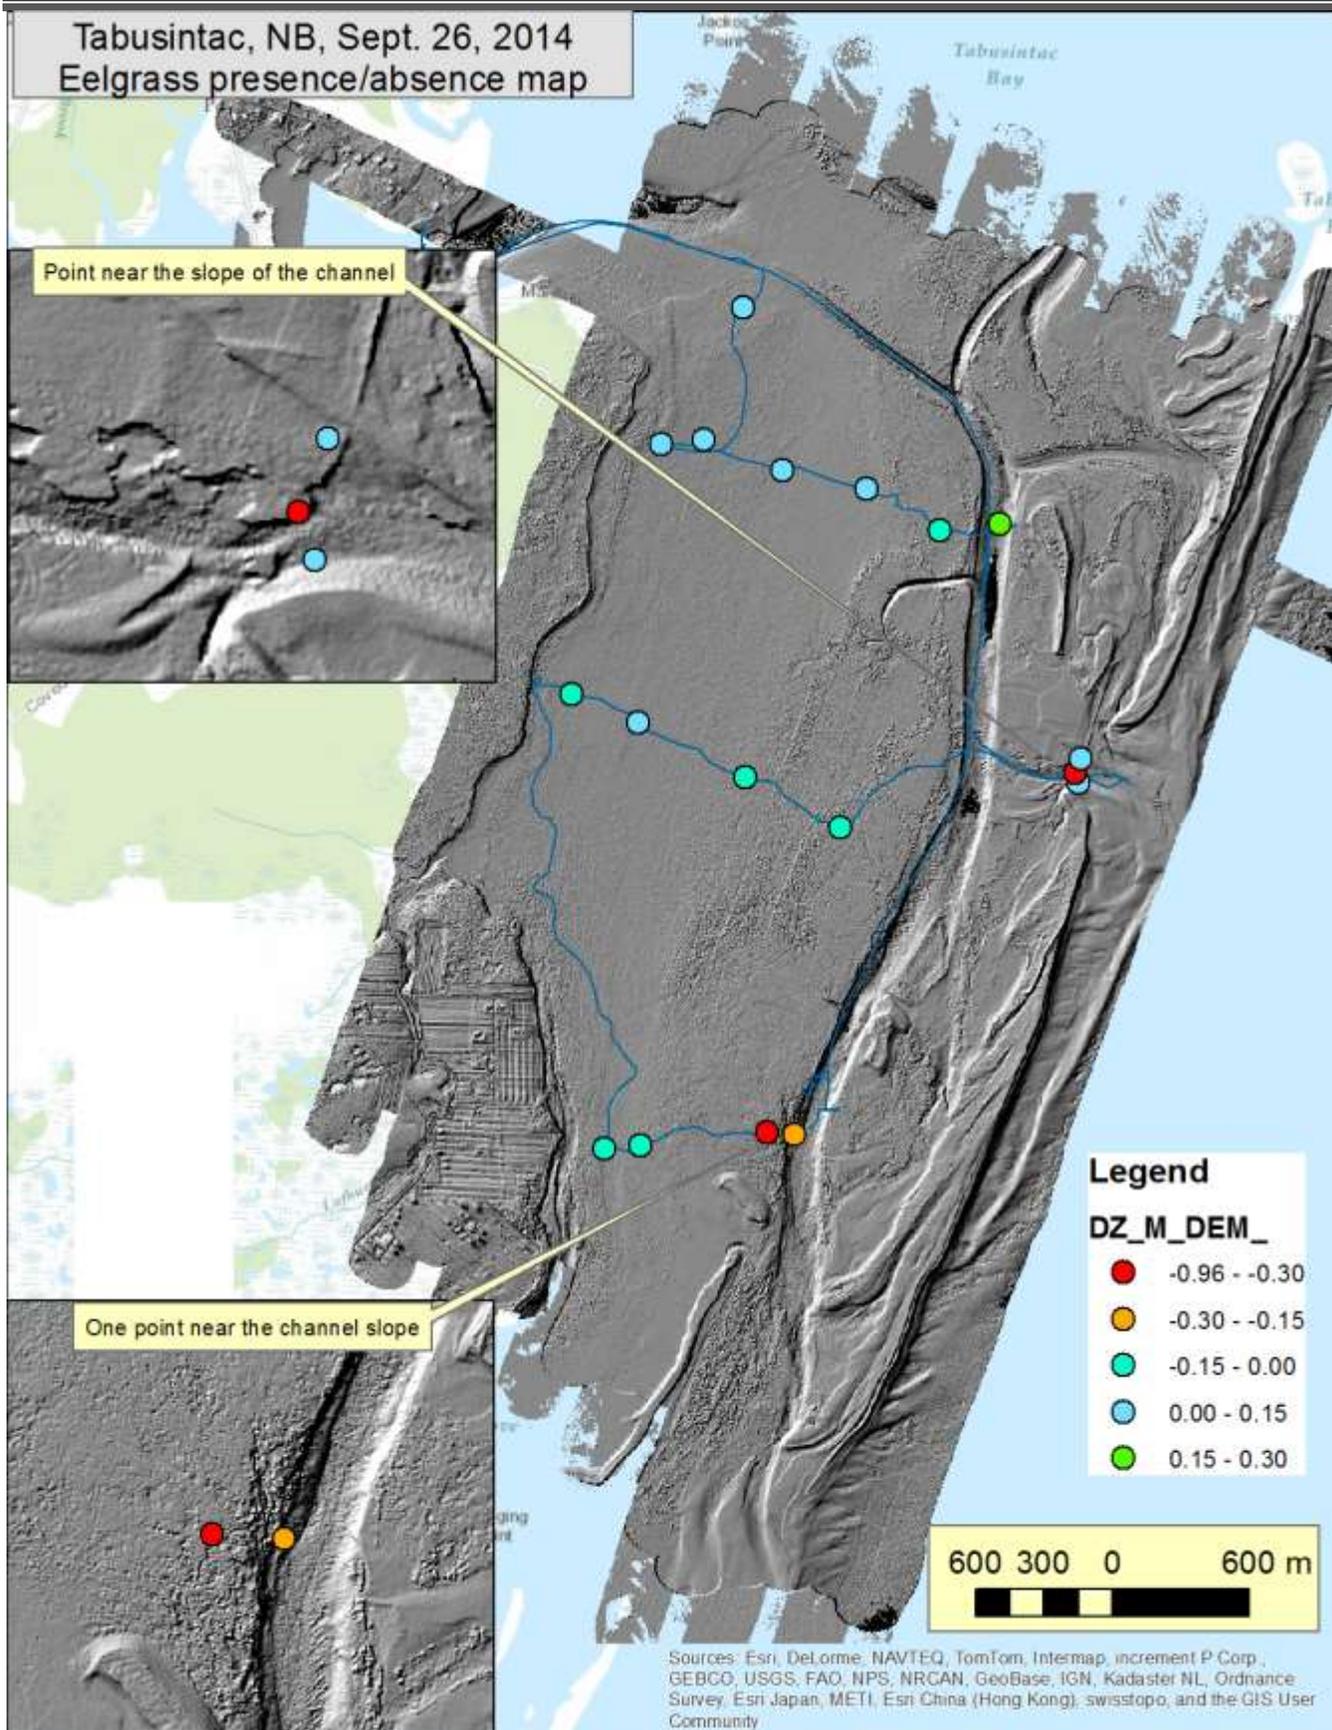
Figure 25 Tabusintac seabed elevation validation. The difference in elevation between the ground truth manual measurements and the lidar elevation is presented in metres as DZ\_m\_DEM.

The validation of the depths was accomplished using manual depth measurements and extracting the water surface elevation from the lidar. The depth was then subtracted from the lidar water surface and compared to the lidar elevation model. It should be noted that the horizontal positional accuracy of the depth measurements were based on a code GPS solution which has several metres of uncertainty. Of the 18 seabed computed elevation points the mean difference between them and the lidar seabed elevation was -0.075 m with a standard deviation of 0.26 m. The largest errors appear to be points collected near the channel slope and maybe related to the positional accuracy of the ground truth data (Figure 25).
