# Tabusintac 2014 Topo-Bathymetric Lidar & Eelgrass Mapping Report

Public Works Government  
Services Canada

January, 2015

# PWGSC Bathymetric Lidar Report – Tabusintac, NB

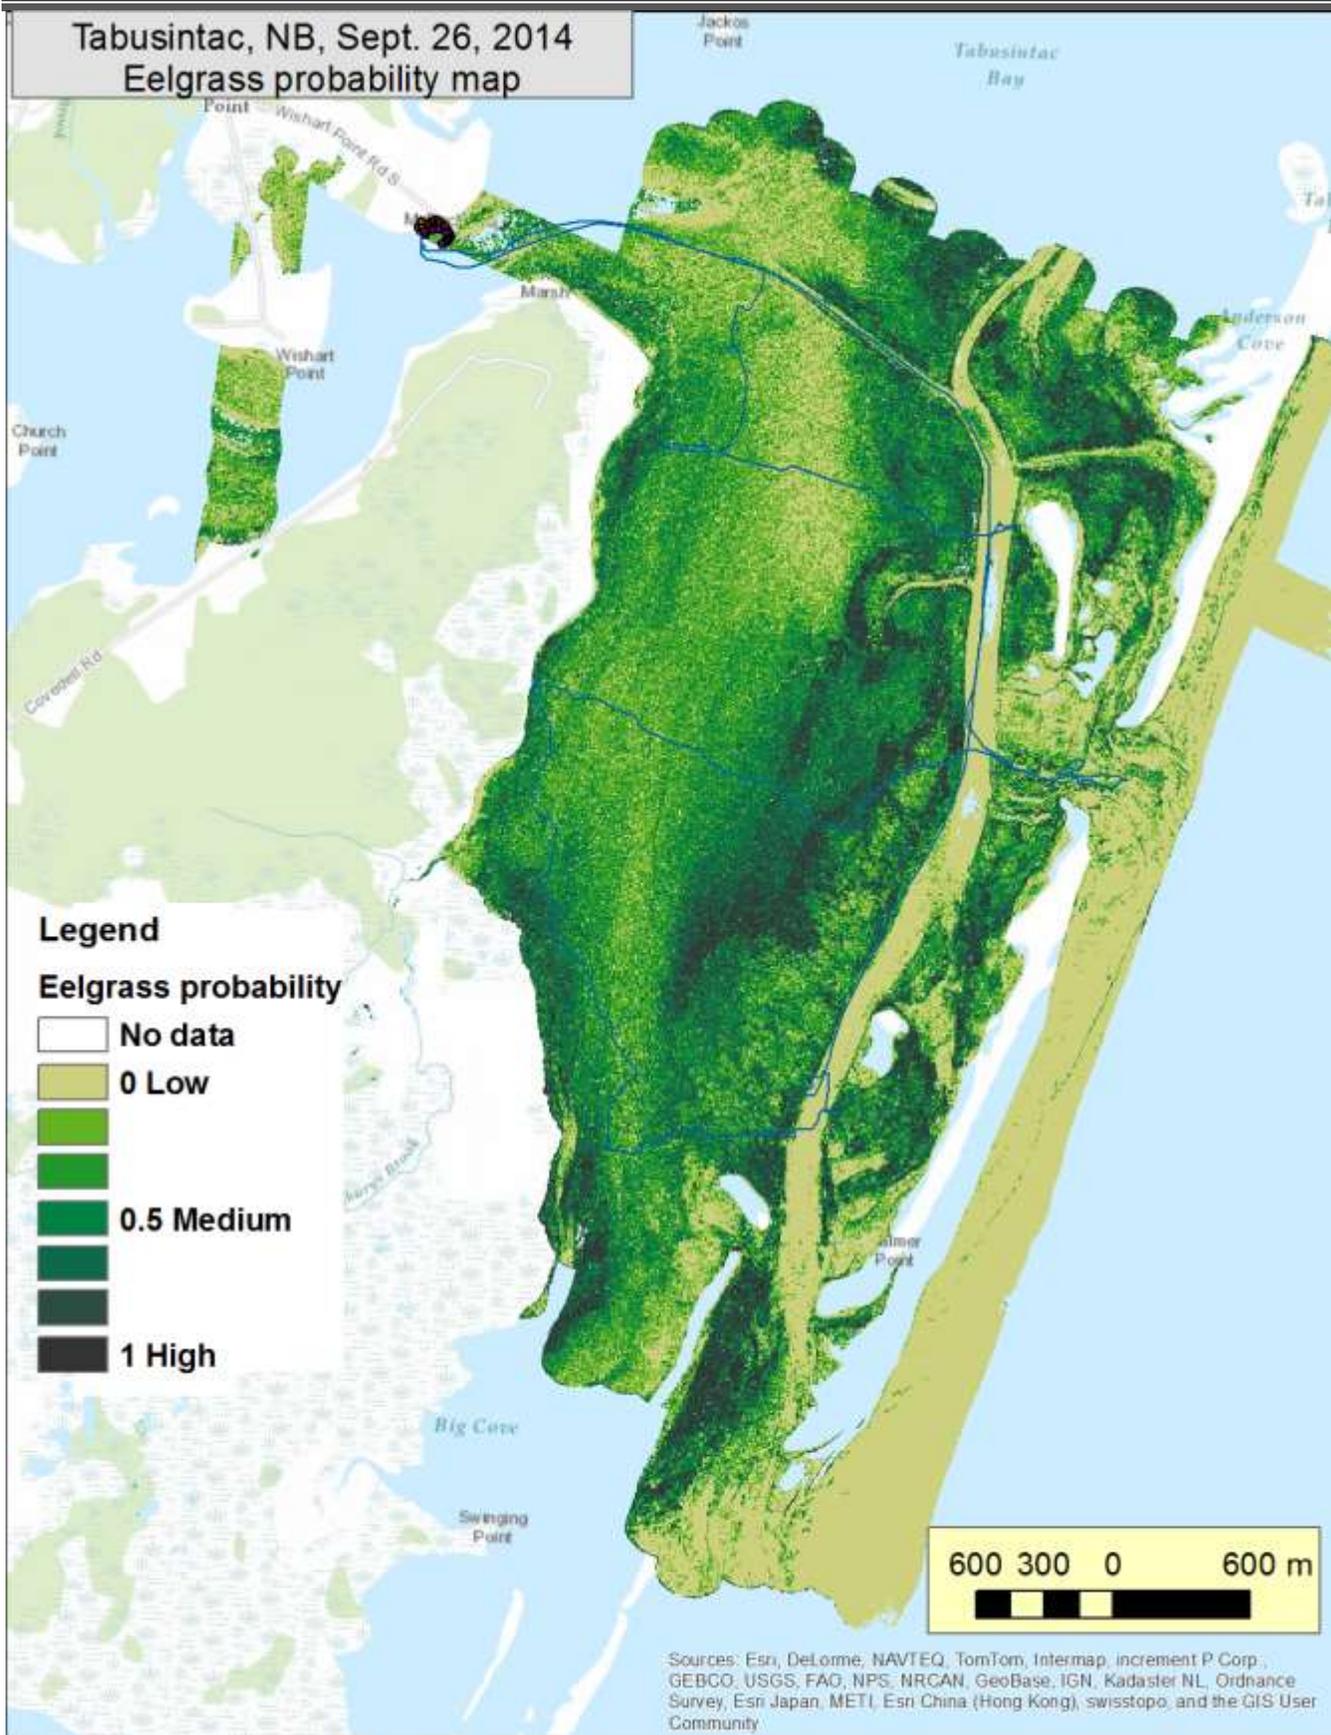
Figure 26 Eelgrass probability map, darker green indicates a higher probability of eelgrass occurrence.

The eelgrass map was derived from the lidar elevation parameters only. The use of the lidar intensity is still an area of research that we feel offers a great deal of potential. However, for this project we exploited the variability in the elevation of the lidar returns where a rougher bottom corresponded to eelgrass compared to a smooth sandy bottom. The map was constructed by combining a variety of lidar elevation derivatives including depth, and the variability of slope and aspect. This produced a map with a range of values representing different levels or probabilities of eelgrass occurrence (Figure 26). This map is compared to the boat based ground truth where the presence or absence of eelgrass has been determined (Figure 27). This map has been further simplified into a presence/absence map for eelgrass (Figure 28) where the ground truth has been plotted and those that match the map are highlighted by a yellow circle. Of the 69 ground truth points, 55 match the map in terms of presence or absence of eelgrass which indicates an 80% agreement.

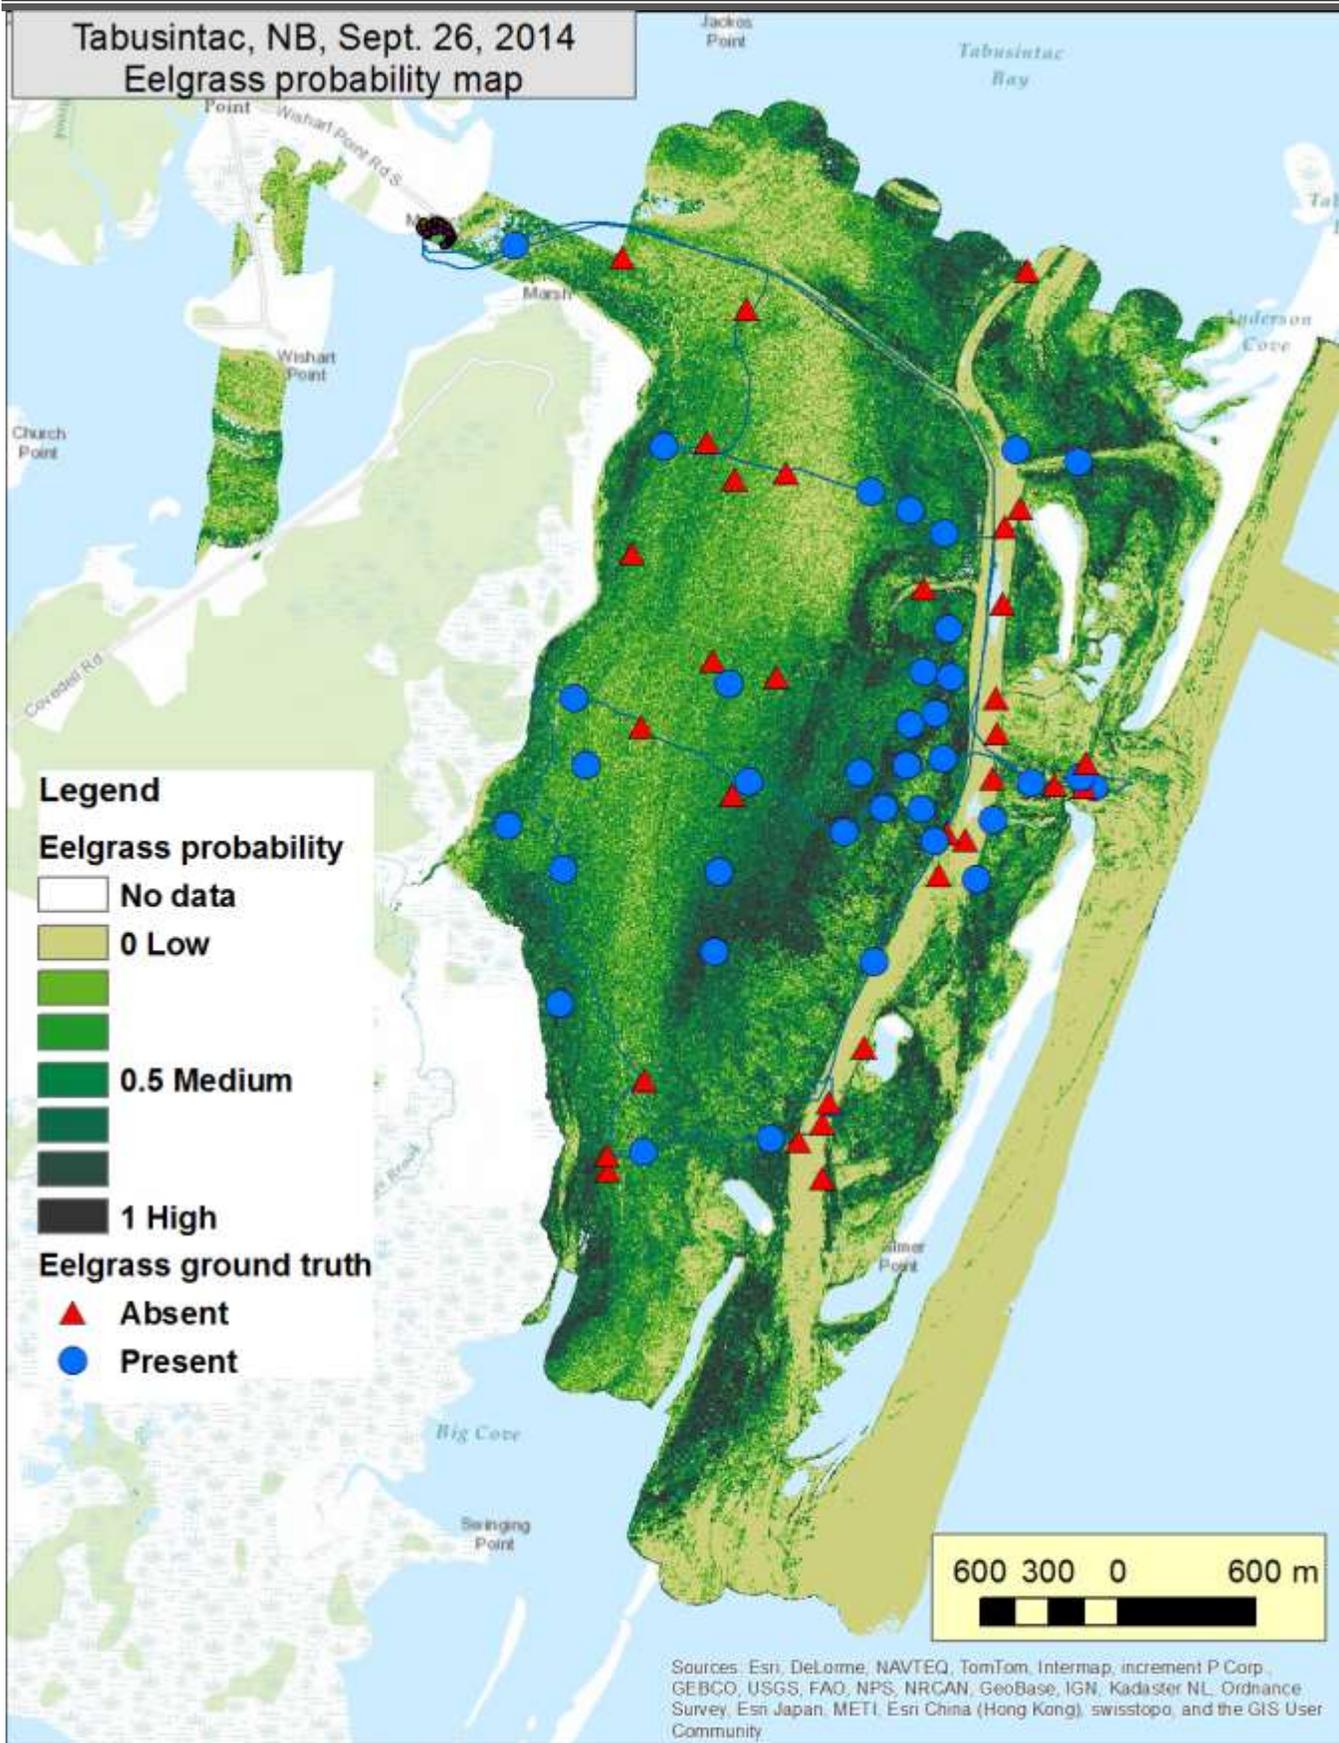
Figure 27 Eelgrass probability map with ground truth, eelgrass presence is a blue dot, absence is a red triangle.

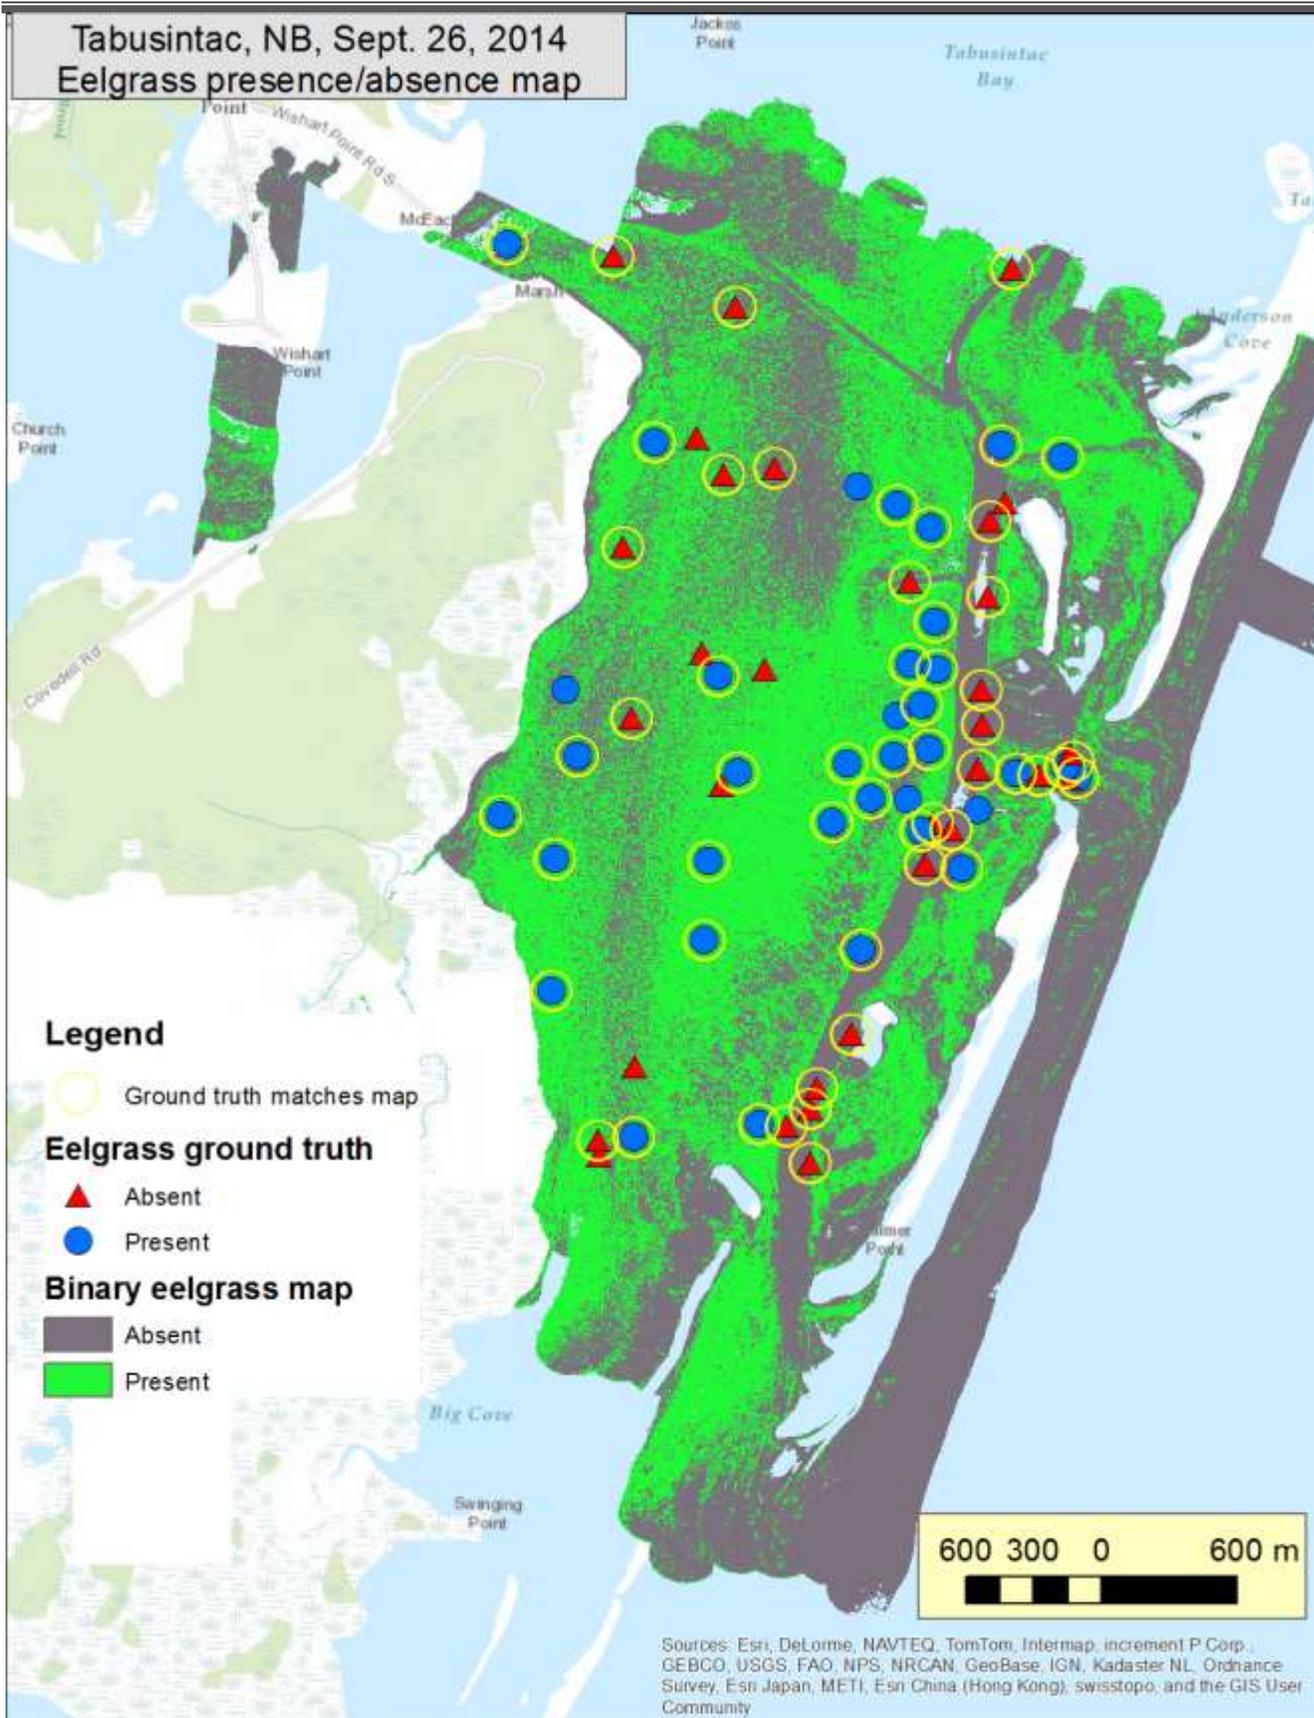
Figure 28 Presence-absence eelgrass map derived from lidar with ground truth (red triangle, blue dot) and where the ground truth matches the map (yellow circles).

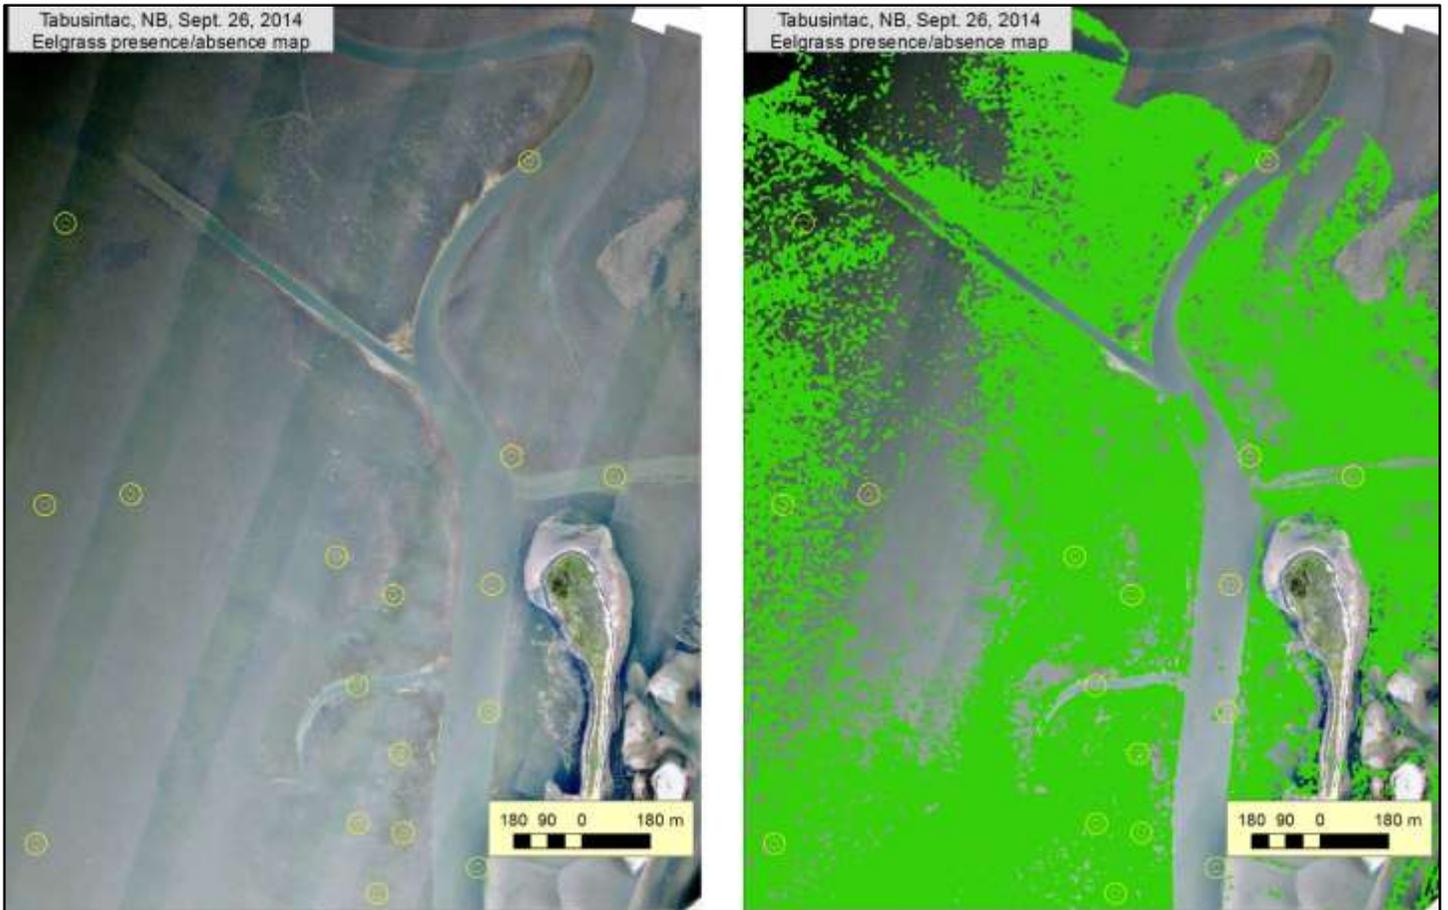
**Figure 29 Orthophoto on the left of the dredged channel with ground truth points that agree with the map. Right is the orthophoto with lidar derived eelgrass (green) and ground truth points.**

The orthophoto can be examined in combination with the ground truth and eelgrass map to make a visual assessment. The eelgrass map has been smoothed using a 5 by 5 kernel where the central pixel is replaced with the majority value. The resultant eelgrass presence class has been superimposed over the orthophoto along with the ground truth points that agree with the classification. The extent of the orthophoto is slightly larger than that of the lidar and derived eelgrass map (Figure 29, Figure 30 and Figure 31).

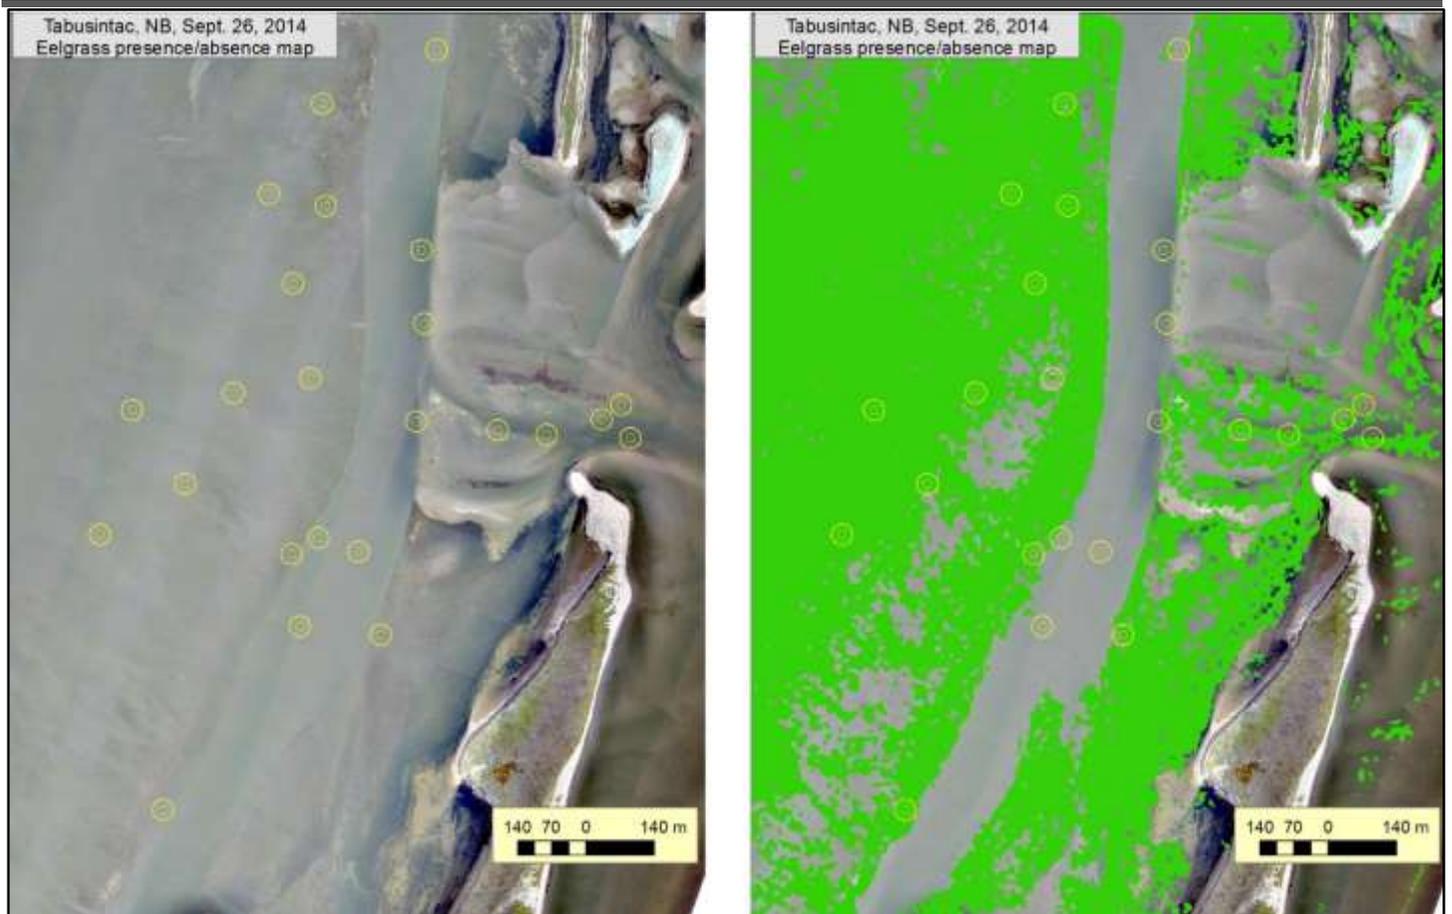
**Figure 30** Orthophoto on the left of the main channel and opening with ground truth points that agree with the map. Right is the orthophoto with lidar derived eelgrass (green) and ground truth points.

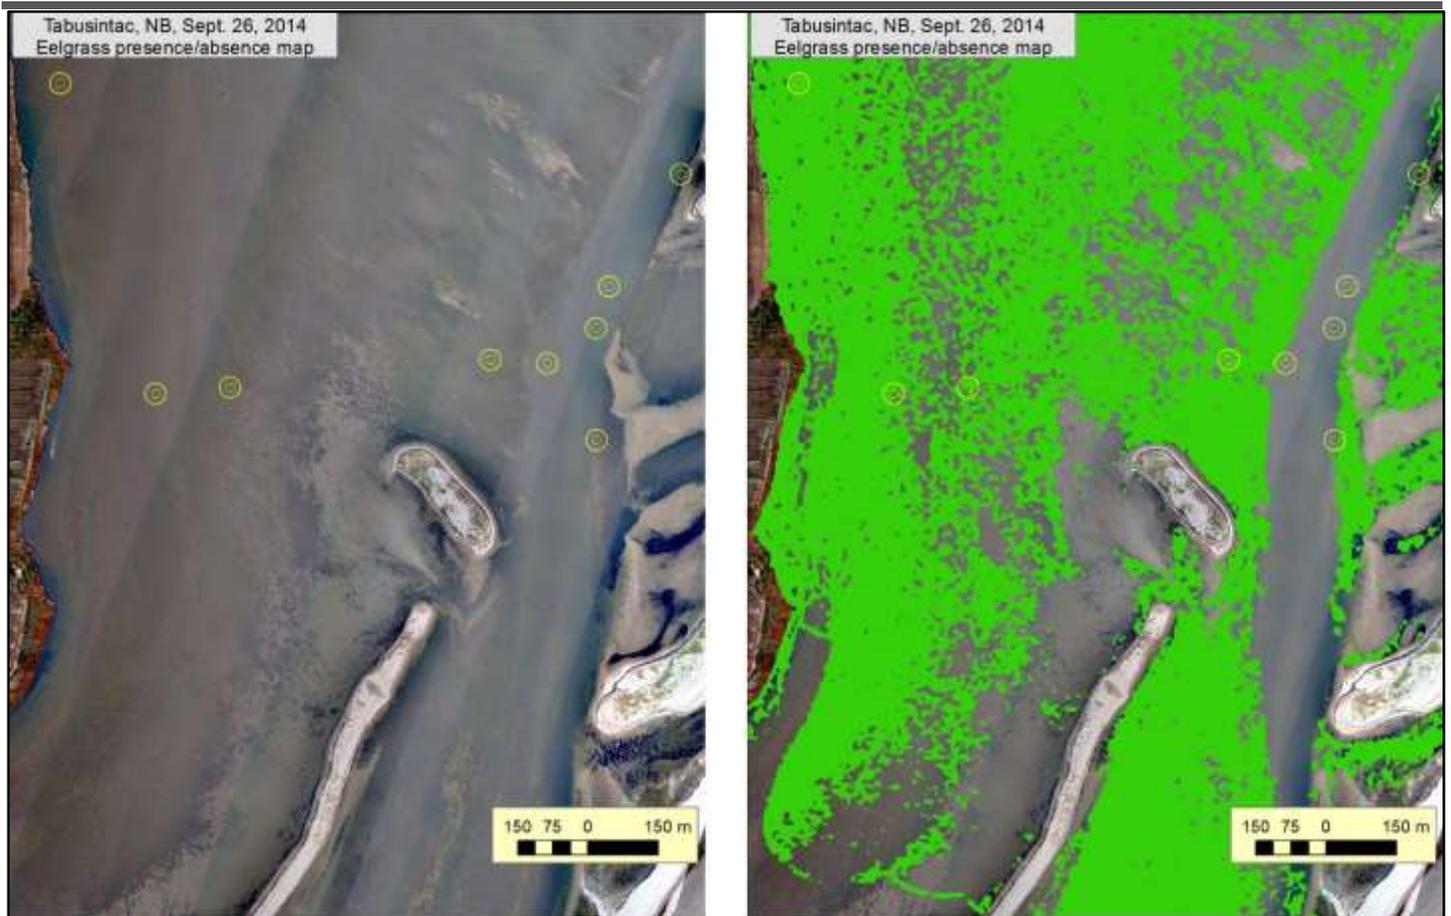
**Figure 31 Orthophoto on the left of the southern channel with ground truth points that agree with the map. Right is the orthophoto with lidar derived eelgrass (green) and ground truth points.**
